**From:** Hansen, Edward J., EMNRD  
**Sent:** Wednesday, April 18, 2012 4:11 PM  
**To:** 'Hack Conder'  
**Cc:** Leking, Geoffrey R, EMNRD; 'Katie Jones'; 'Laura Pena'; 'Scott Curtis'  
**Subject:** Remediation Plan (1R425-11) Termination - ROC Vacuum Jct K-30 Site

RE: Termination Request  
Vacuum Jct. K-30 (1R425-11): UL/K, Sec. 30, T17S, R35E  
RICE Operating Company – Vacuum SWD System

**RICE OPERATING COMPANY  
JUNCTION BOX FINAL REPORT**

# Vacuum jct. K-30

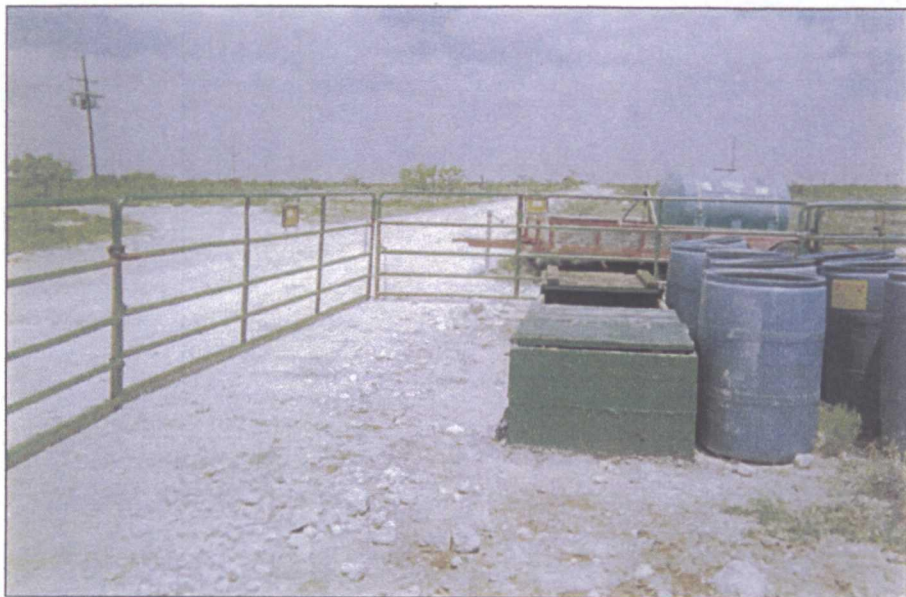
6/1/2005

undisturbed junction box

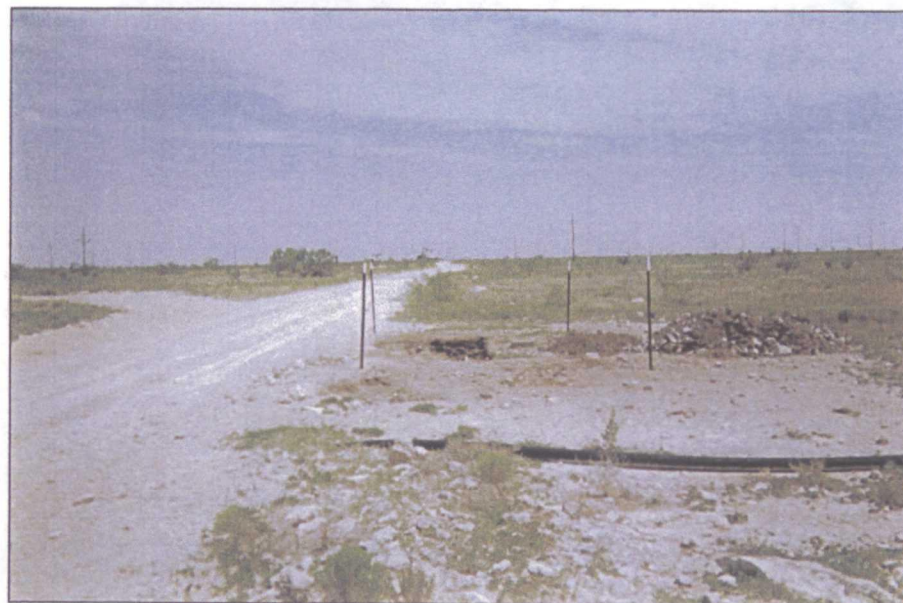
7/12/2005

box removed

part of the Vacuum SWD System abandonment. After removal of the box materials, a delineation trench was made at the former junction site using a backhoe while soil samples were collected 2-7 ft BGS. Chloride field tests were conducted on the samples and exhibited very low concentrations similar to background level. PID screenings were also performed on each sample and VOC concentrations were also considerably low. A grab sample at 7 ft BGS was analyzed at a laboratory for confirmation of field tests. TPH was not present within the lab's detection limits (<10.0 ppm), meeting NMOCD guidelines. The excavated soil was blended on site and then backfilled into the trench and contoured to the surrounded terrain. The disturbed surface was seeded with a blend of native vegetation and is expected to return to productive capacity at a normal rate. Since the System is no longer active, a new junction box is not required.

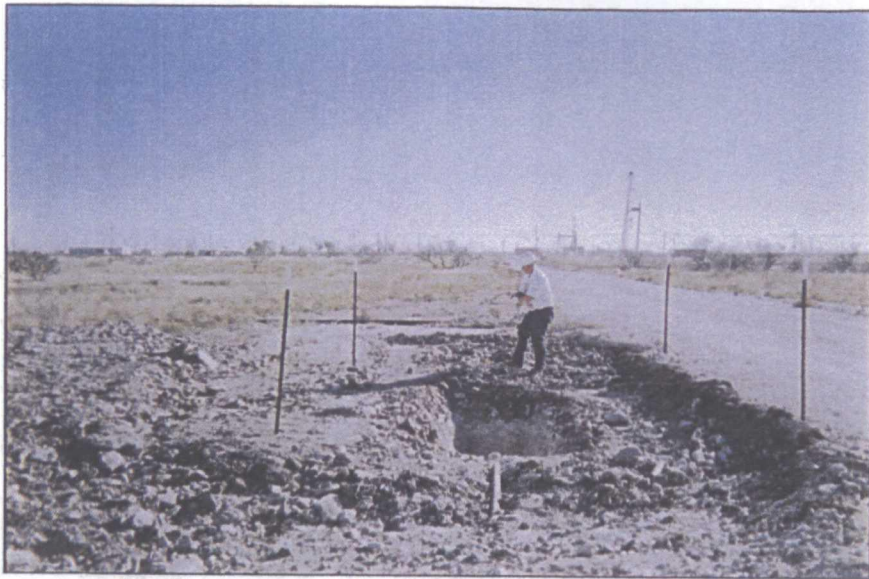
11/21/2005

delineation trench before backfilling

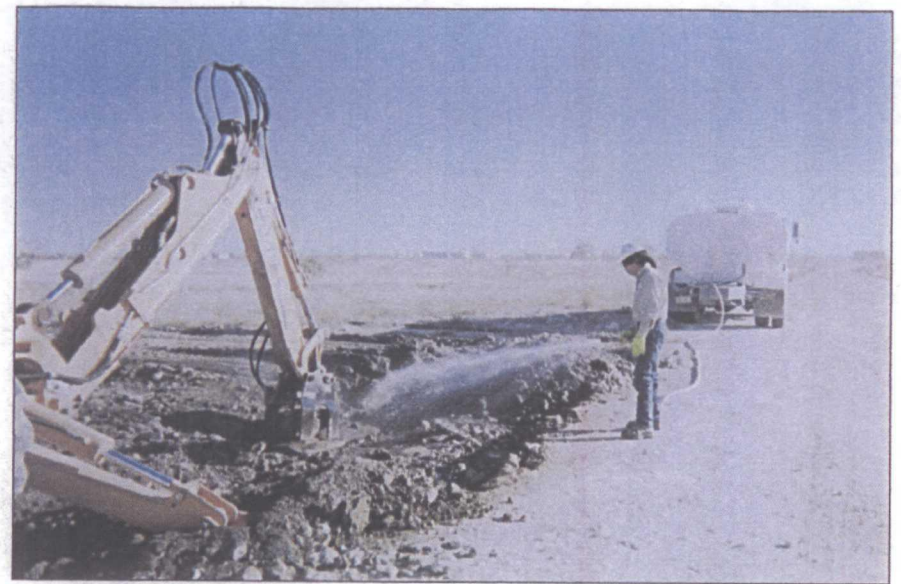
11/21/2005

backfilling and compacting

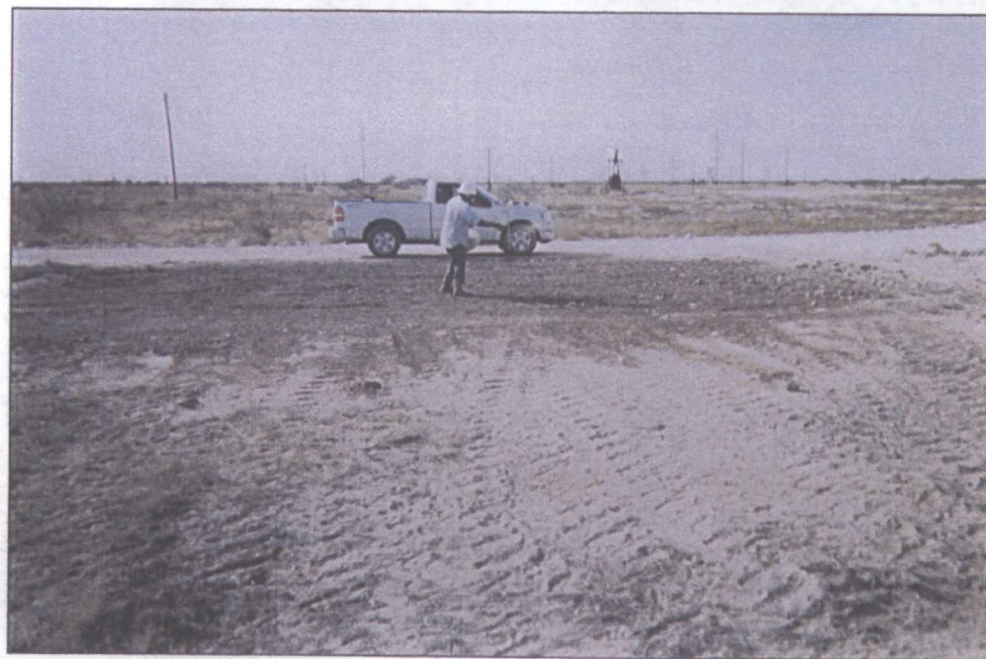
11/23/2005

seeding
