**RE: Termination Request  
for the Rice Operating Company's  
Vacuum Chevron 4-27 EOL Site  
Unit Letter J, Section 27, T17S, R35E, NMPM, Lea County, New Mexico  
Remediation Plan (1R425-23) Termination**

RE: Termination Request  
Vacuum Chevron 4-27 EOL (1R425-23): UL/J, Sec. 27, T17S, R35E  
RICE Operating Company – Vacuum SWD System

**RICE OPERATING COMPANY  
JUNCTION BOX FINAL REPORT**

# Vacuum Chevron 4-27 EOL

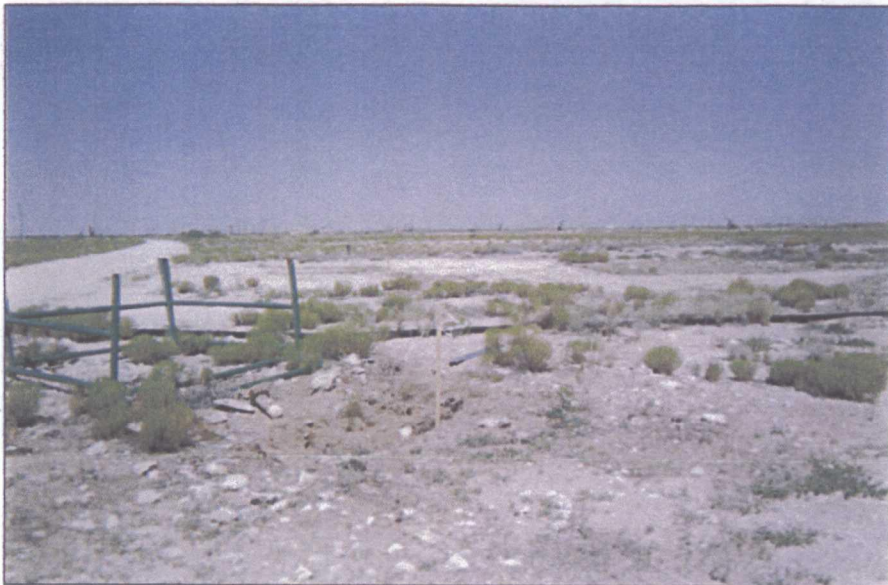
7/11/2005

former junction box site

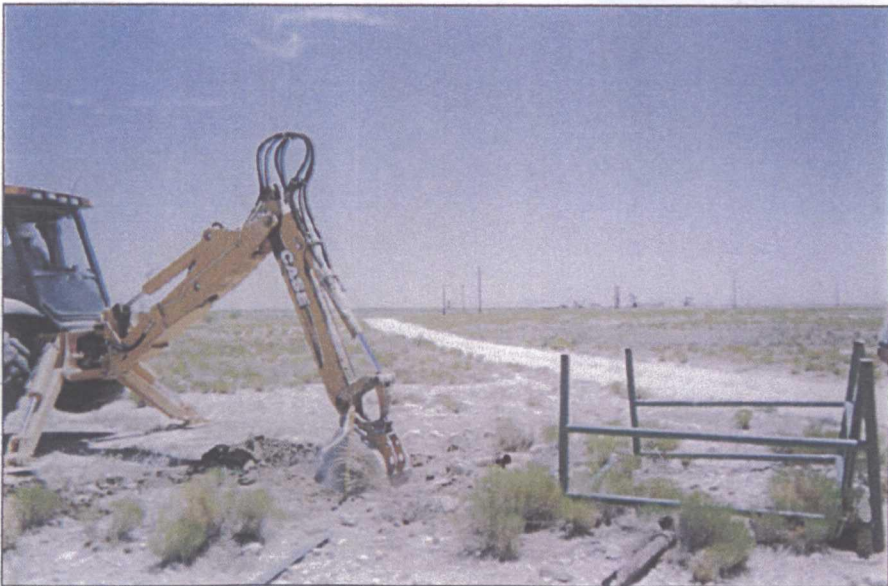
7/25/2005

delineation trench at former box site

This junction box was addressed  
as part of the Vacuum SWD System Abandonment. After the box materials were removed,  
a delineation trench was made at the junction while soil samples were collected every ft of depth  
to 10 ft BGS. Chloride field tests were performed on the samples and concentrations exhibited  
a conclusive trend of decline, indicative of non-saturated historical vadose conditions. PID screenings were also performed on the samples and yielded  
very low concentrations. A grab sample at 10 ft BGS was collected for laboratory analysis and confirmed the field tests. TPH concentrations were not  
present within the lab's detection limits (<10.0 ppm), meeting NMOCD guidelines. The excavated soil was blended on site and then backfilled  
into the trench and contoured to the surrounding surface. The disturbed area was seeded with a blend of native vegetation and is expected to return to

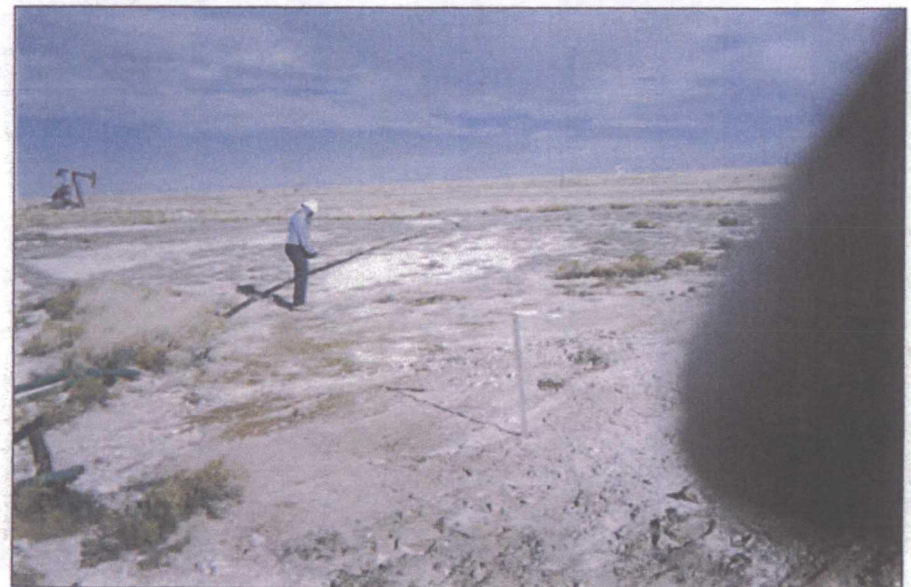
12/23/2005

seeding backfilled site
