RE: Termination Request
Vacuum Jct. P-27 (1R425-42): UL/P, Sec. 27, T17S, R35E
RICE Operating Company – Vacuum SWD System

**RICE OPERATING COMPANY
JUNCTION BOX FINAL REPORT**

Vacuum jct. P-27

Unit P, Sec. 27, T17S, R35E

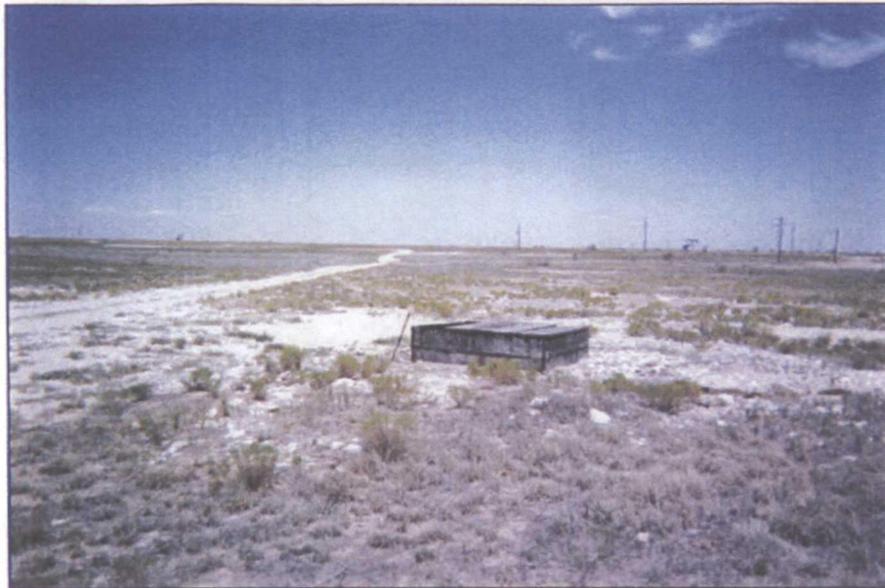
8/22/2005

undisturbed junction box

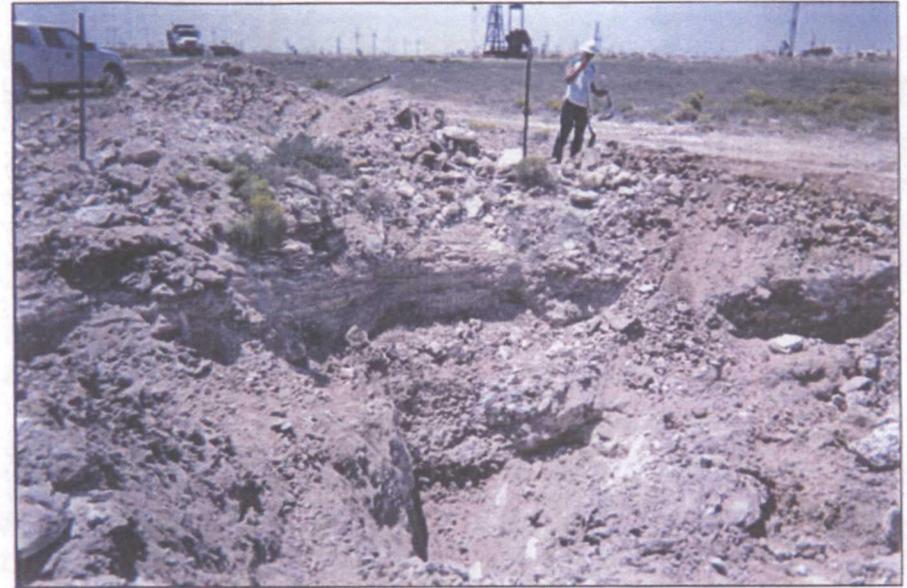
8/21/2007

9-ft delineation trench prior to backfill

This junction box was addressed as part of the Vacuum SWD System abandonment. After the box lumber was removed and the pipelines were capped, a delineation trench was made at the site to collect soil samples. Excavation was difficult due to hard caliche rock but the trench was extended to 9 ft BGS. Chloride field tests were conducted on the samples and yielded very low concentrations. Organic vapors were measured and also yielded very low concentrations. The grab samples from the deepest part of the trench (9 ft) was sent to a laboratory for confirmation and TPH analysis. TPH results meet NMOCD guidelines. The excavated soil was returned to the trench and the remainder of the hole (from removal of the junction box) was backfilled with clean, imported soil which was also spread on the surface to encourage regrowth. The surface was seeded with a blend of native vegetation on 8/29/2007 and is expected to return to productive capacity at a normal rate.

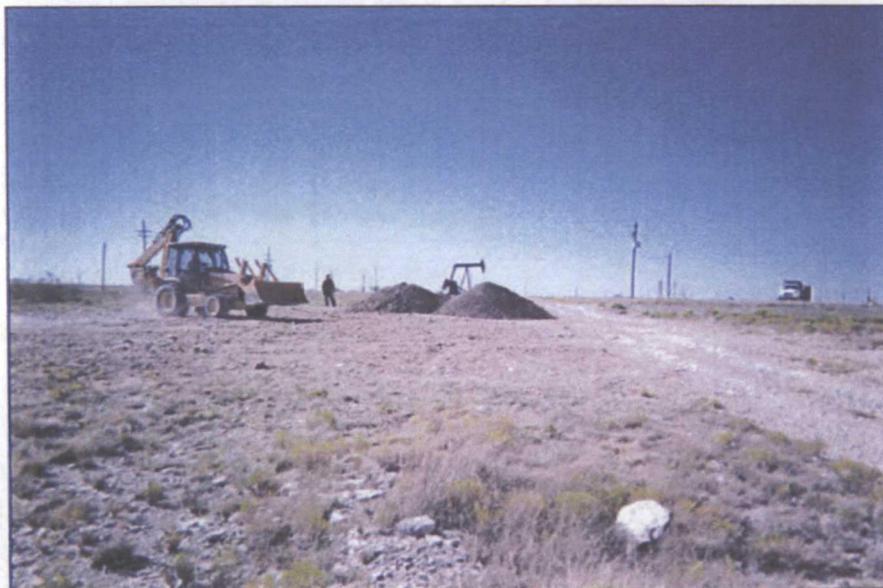
8/29/2007

spreading imported soil

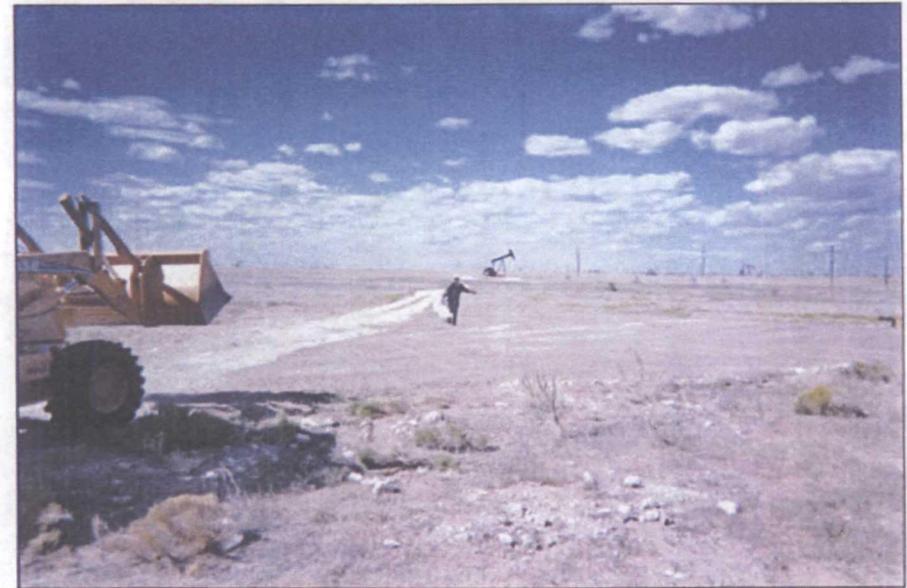
8/29/2007

seeding
