From: Hansen, Edward J., EMNRD
Sent: Monday, May 21, 2012 1:33 PM
To: Hack Conder (hconder@riceswd.com)
Cc: Leking, Geoffrey R, EMNRD; Katie Jones <kjones@riceswd.com> (kjones@riceswd.com); Laura Pena (lpena@riceswd.com); Scott Curtis (scurtis@riceswd.com)
Subject: Remediation Plan (1R425-48) Termination - ROC Vacuum Jct B-5-2 Site

RE: Termination Request
Vacuum Jct. B-5-2 (1R425-48): UL/B, Sec. 5, T18S, R35E
RICE Operating Company – Vacuum SWD System

**RICE OPERATING COMPANY
JUNCTION BOX FINAL REPORT**

Vacuum Jct. B-2-1

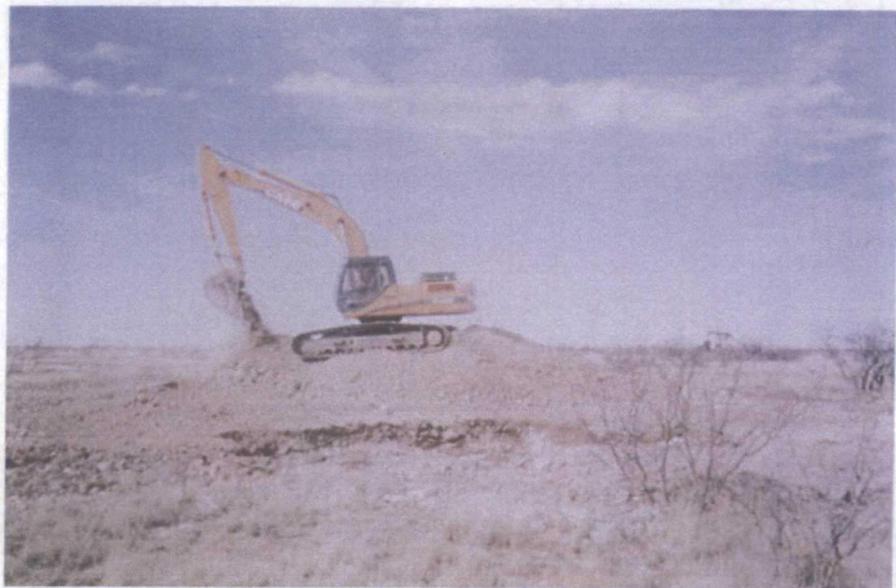
3/15/2006

trackhoe delineation

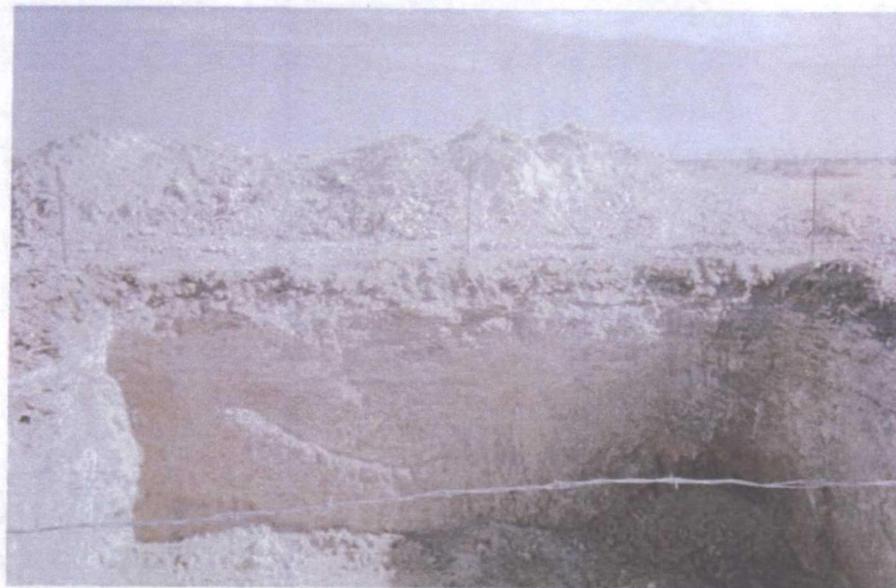
3/16/2006

excavation, facing south

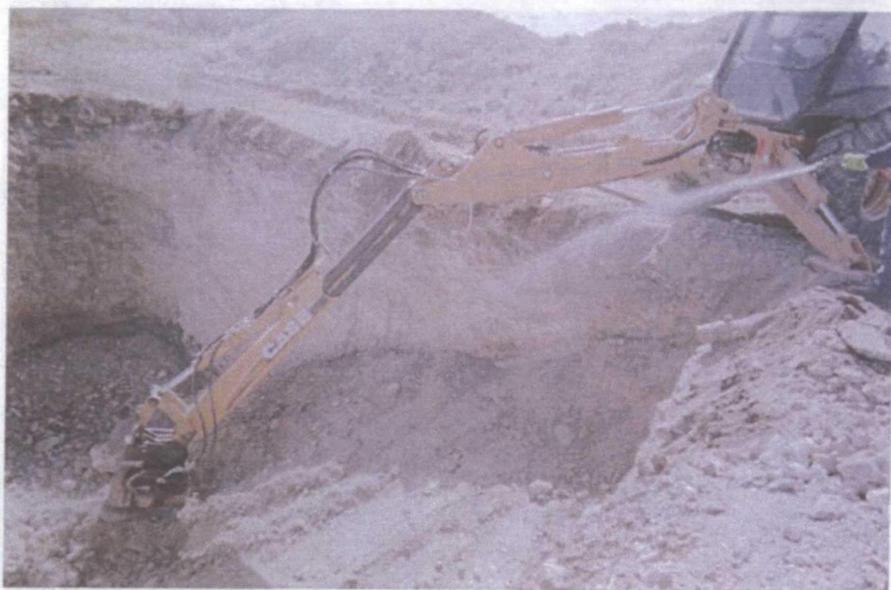
3/30/2006

backfilling excavation site, facing north

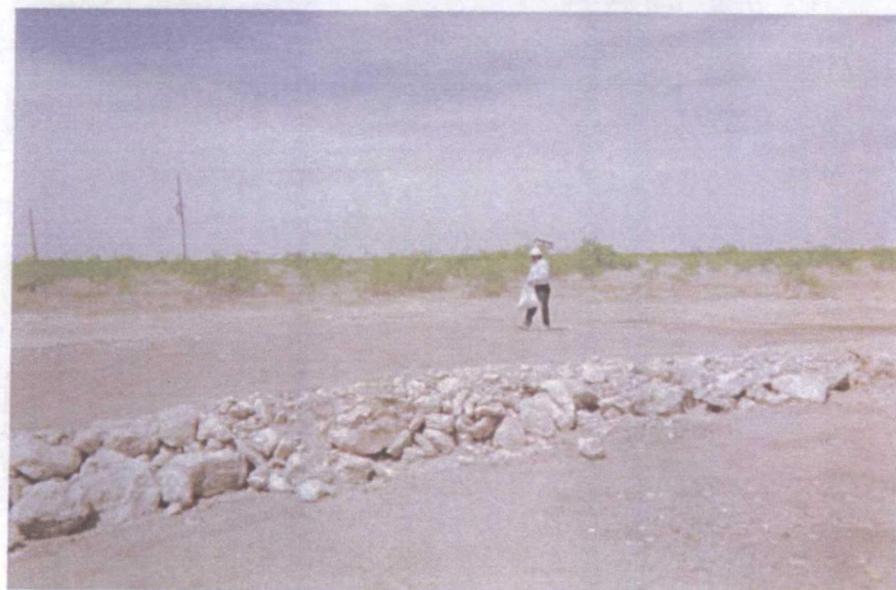
4/25/2006

seeding backfilled site

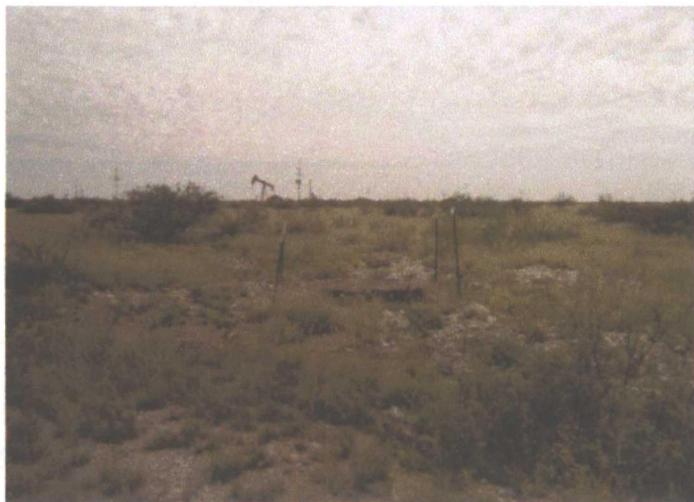
9/13/2005

Facing north

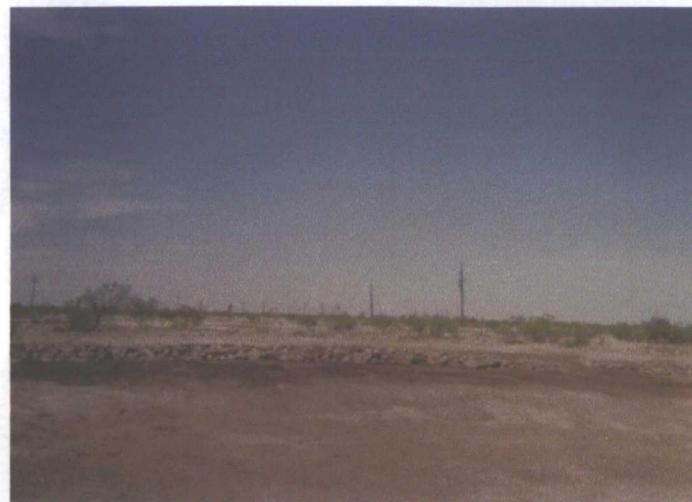
4/21/2006

Facing south

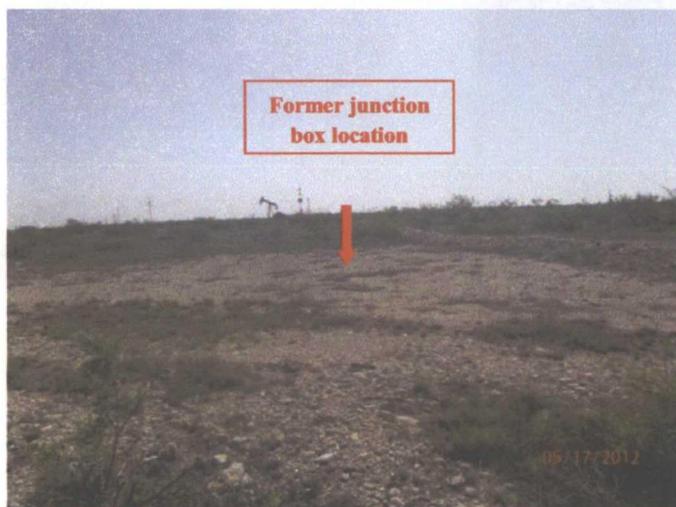
5/17/2012

Facing north

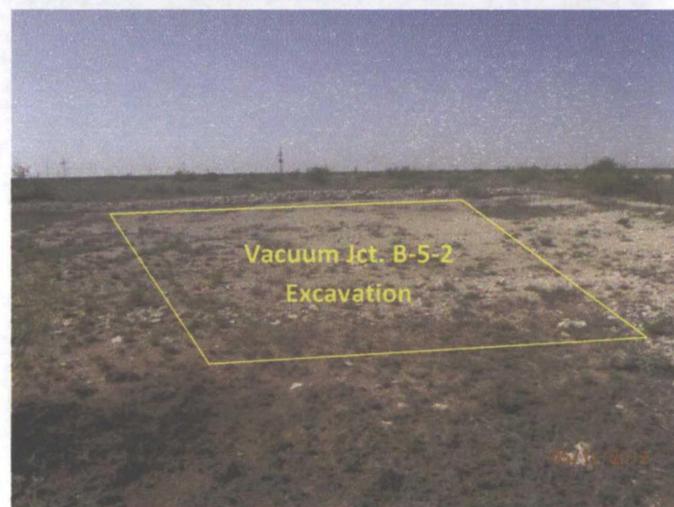
5/17/2012

Facing south
