EME I-35 EOL  
2011

**RICE OPERATING COMPANY  
JUNCTION BOX DISCLOSURE\* REPORT**

Unit I, Section 35, T19S, R36E

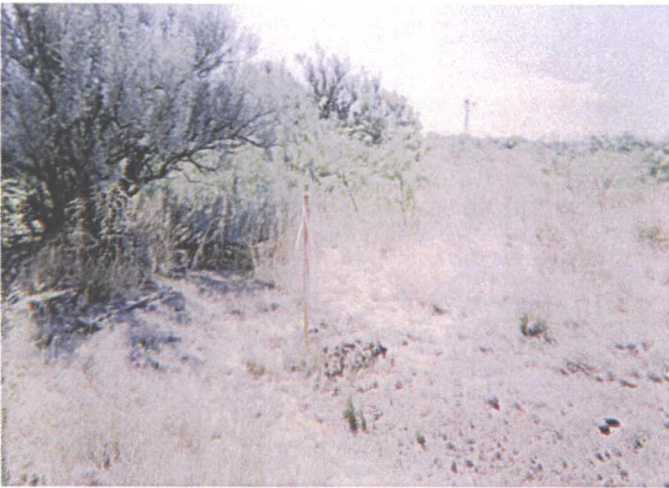
Site prior to excavation, facing east 7.29.11

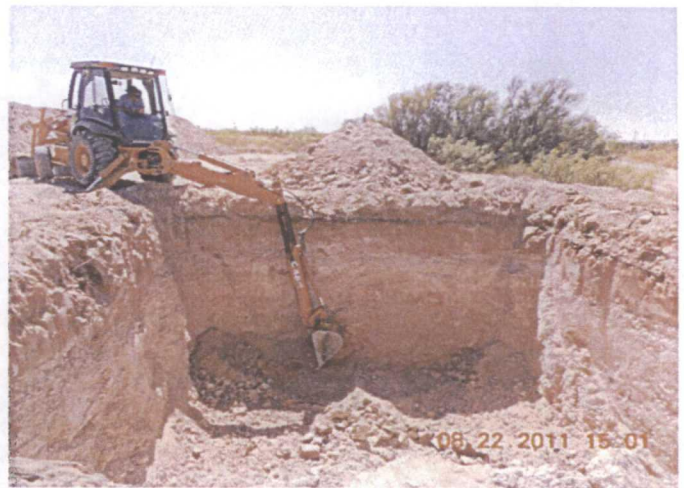
Excavating site, facing west 8.22.11

at regular intervals producing a 30x30x12-ft excavation. Chloride field tests performed

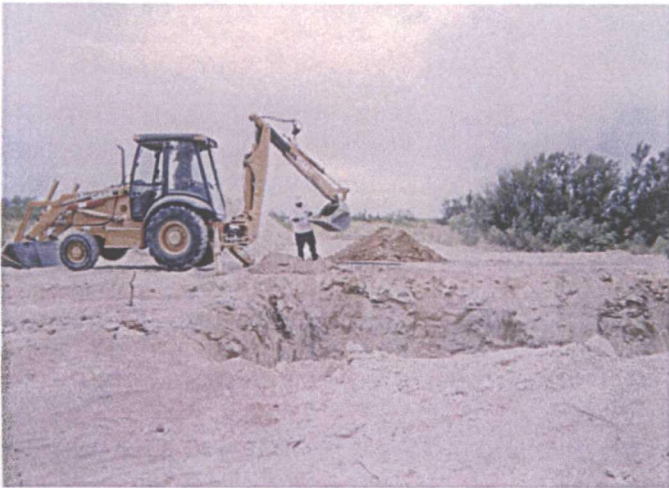
Collecting sample, facing east 8.24.11

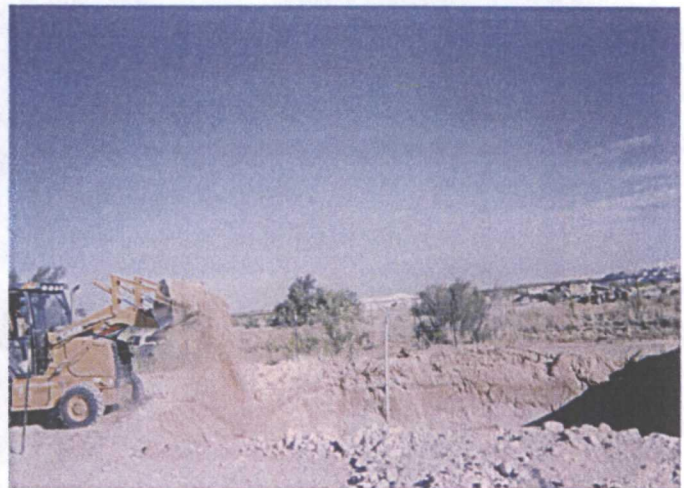
Backfilling site, facing north 9.27.11

backfill was returned to the excavation to a depth of 5-ft BGS. On 9/28/2011, a 20-mil reinforced plastic liner was installed at 5 ft. BGS and the

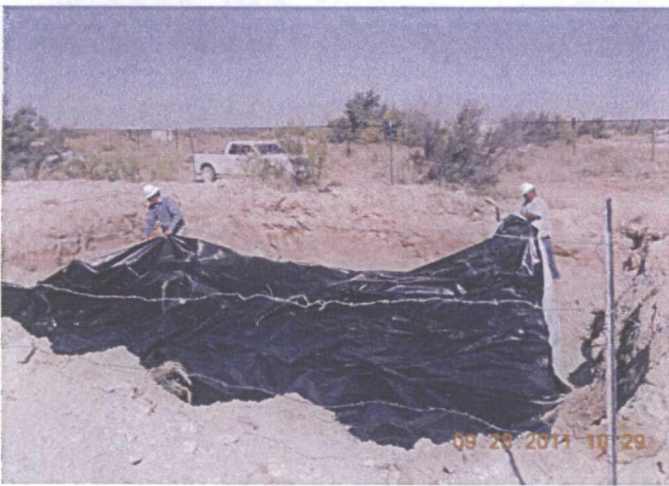
Installing liner, facing northwest 9.28.11

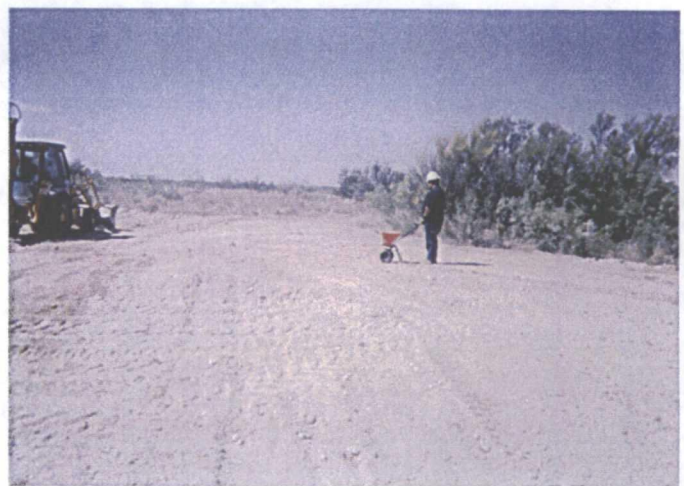
Seeding site, facing east 9.29.11

seeded with a blend of native vegetation and is expected to return to a productive capacity at a normal rate. NMOCD was notified of potential

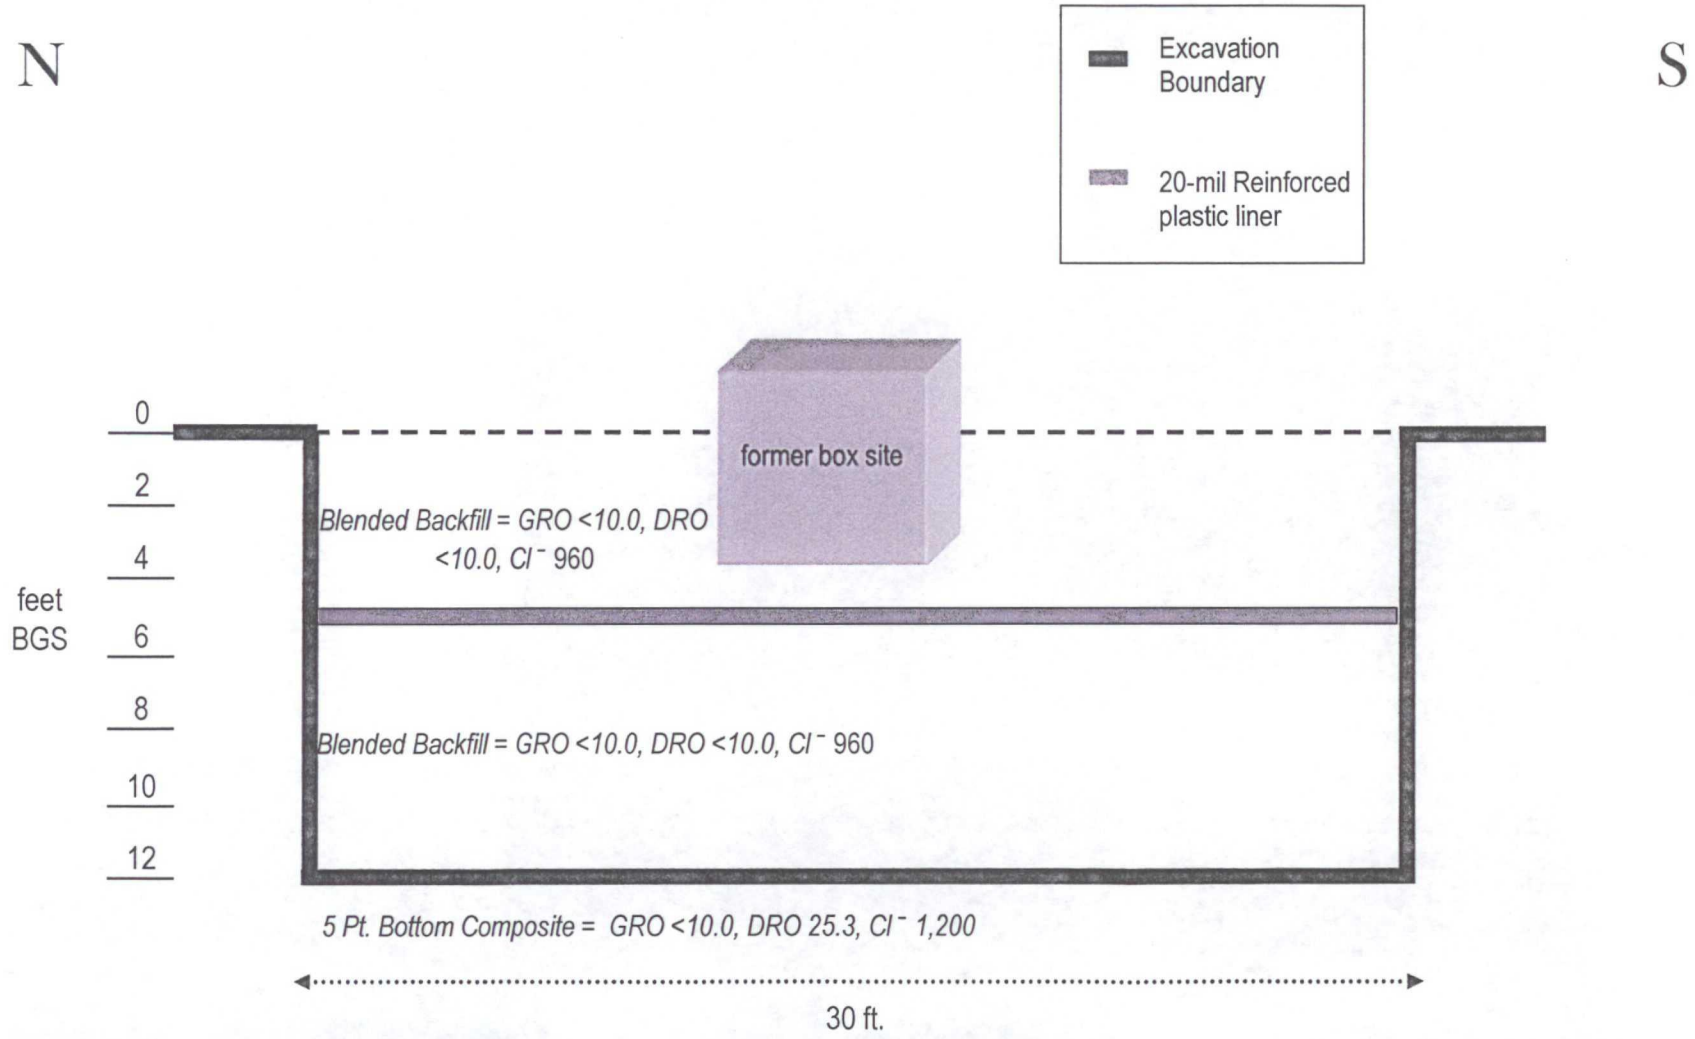
Excavation Cross-Section

Soil Excavated 400.0 cubic yards Excavation Length 30 Width 30 Depth 12 feet

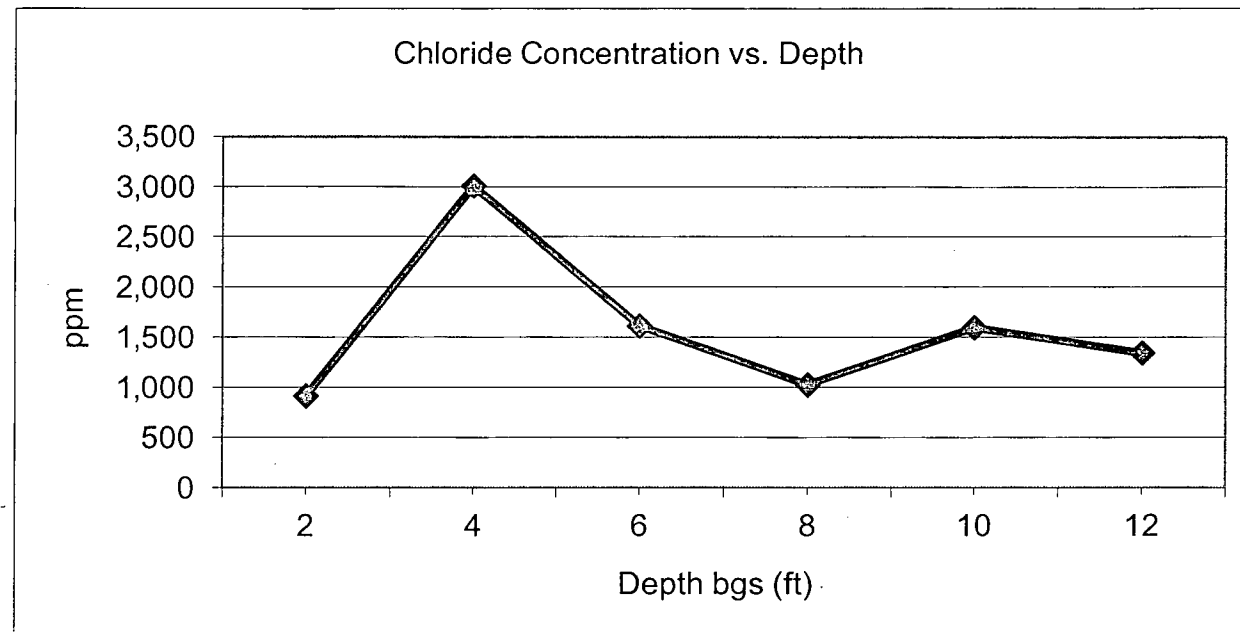
## CHLORIDE CONCENTRATION CURVE

Backhoe samples at 10 ft West of the junction (source)

Depth bgs (ft)	[Cl <sup>-</sup> ] ppm
2	915
4	3,009
6	1,614
8	1,026
10	1,596
12	1,345

Groundwater = 46 ft
