EME Jct. C-13

**RICE OPERATING COMPANY
JUNCTION BOX DISCLOSURE* REPORT**

Unit C, Section 13, T20S, R36E

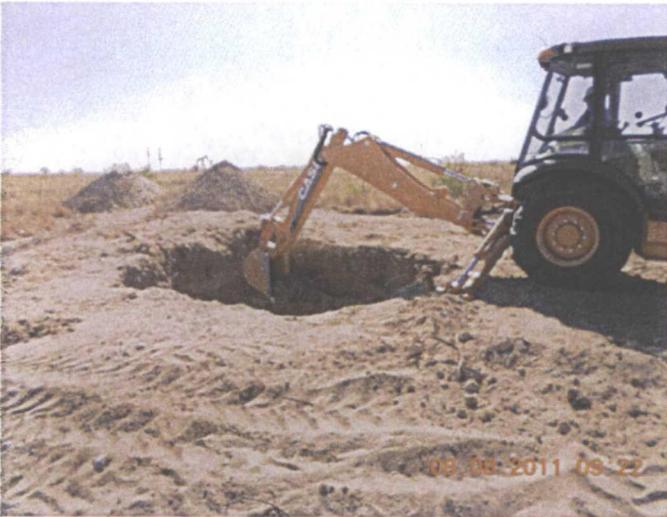
Excavating the former junction box, facing south
8.8.11

General Description of Remedial Action: This junction was eliminated during the pipeline replacement/upgrade program. After the former junction box was removed, an investigation was conducted using a backhoe to collect soil samples at regular intervals producing a 30x30x12-ft excavation. Chloride field tests performed on each sample yielded elevated concentrations that did not relent with depth. Organic vapors were measured using a PID which yielded low concentrations. Representative composite samples were collected from the excavation bottom and excavation walls and sent to a commercial laboratory for analysis of chloride and TPH. Approximately 204 cubic yards of excavated soil was properly disposed of at an NMOCD approved facility. The remaining excavated soil was blended with clean imported soil and a composite sample was sent to a commercial laboratory for analysis of chloride and TPH. The blended backfill was returned to the excavation to a depth of 5-ft BGS. On 8/30/2011, a 20-mil reinforced liner was installed at 5-ft. BGS and the excavation was backfilled with the remaining blended soil to ground surface and contoured to the surrounding area. On 8/31/2011, the site was seeded with a blend of native vegetation and is expected to return to a productive capacity at a normal rate. NMOCD was notified of groundwater impact on 3/13/2012.

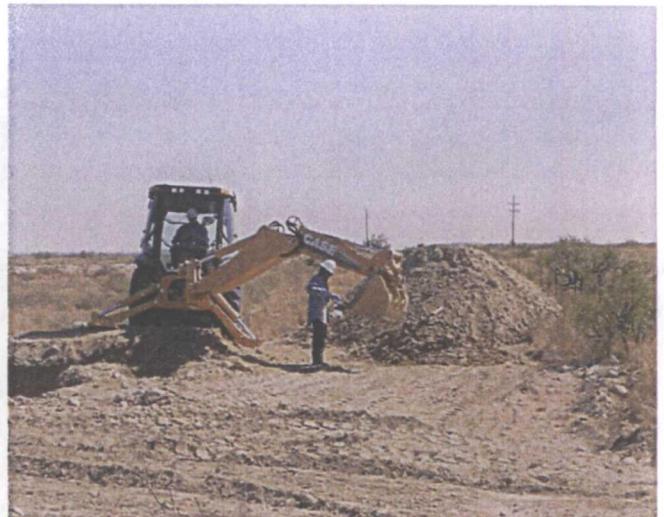
Collecting a soil sample, facing north
8.30.11

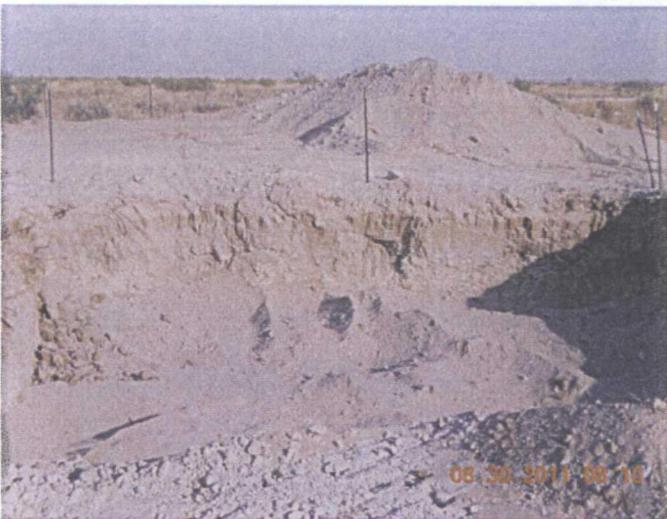
Excavation prior to installation of plastic liner up to
5-ft. BGS, facing west
8.30.11

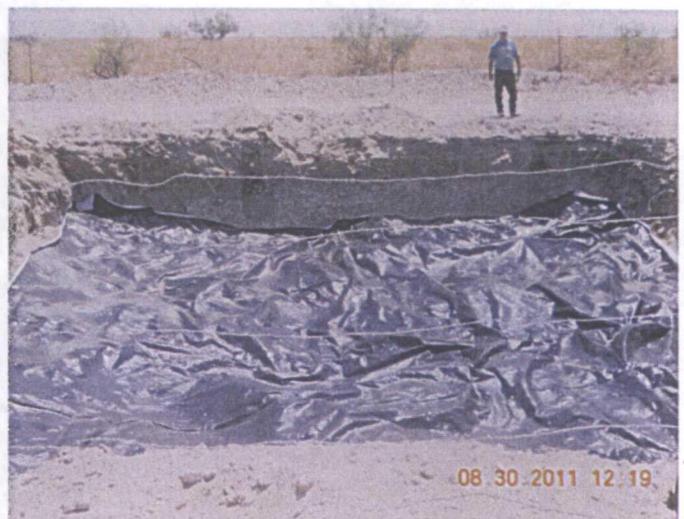
Installing a 30x30-ft., 20-mil reinforced liner at 5-ft.
BGS, facing east
8.30.11

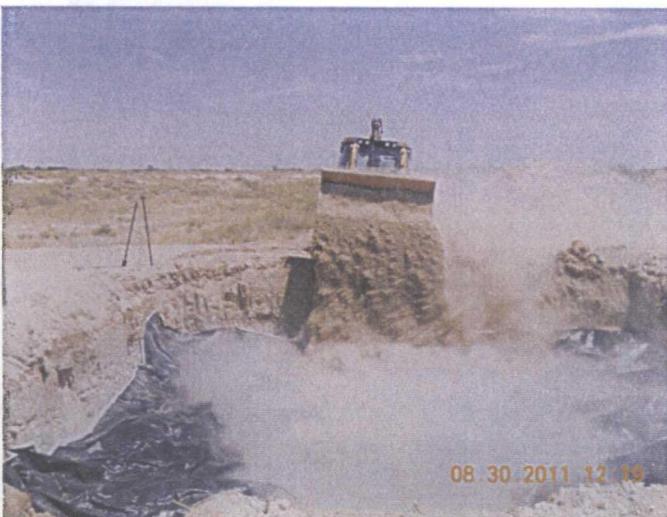
Backfilling site above liner, facing north
8.30.11

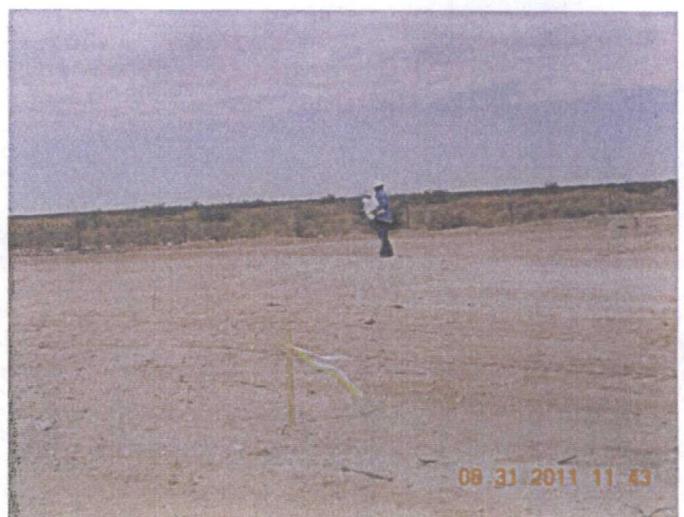
Seeding site, facing west
8.31.11

Custom seed mix <input checked="" type="checkbox"/>	Prescribed mix <input type="checkbox"/>	Seed mix name: Sandy Mix Grass Seed	Seeding date: 8/31/2011
Broadcast <input checked="" type="checkbox"/>			
Method: Hand Broadcast			
Soil conditions during seeding: Dry <input checked="" type="checkbox"/> Damp <input type="checkbox"/> Wet <input type="checkbox"/>			
Photos attached <input checked="" type="checkbox"/>	Observations: 15 lbs of sandy mix		
Number of photos: 11

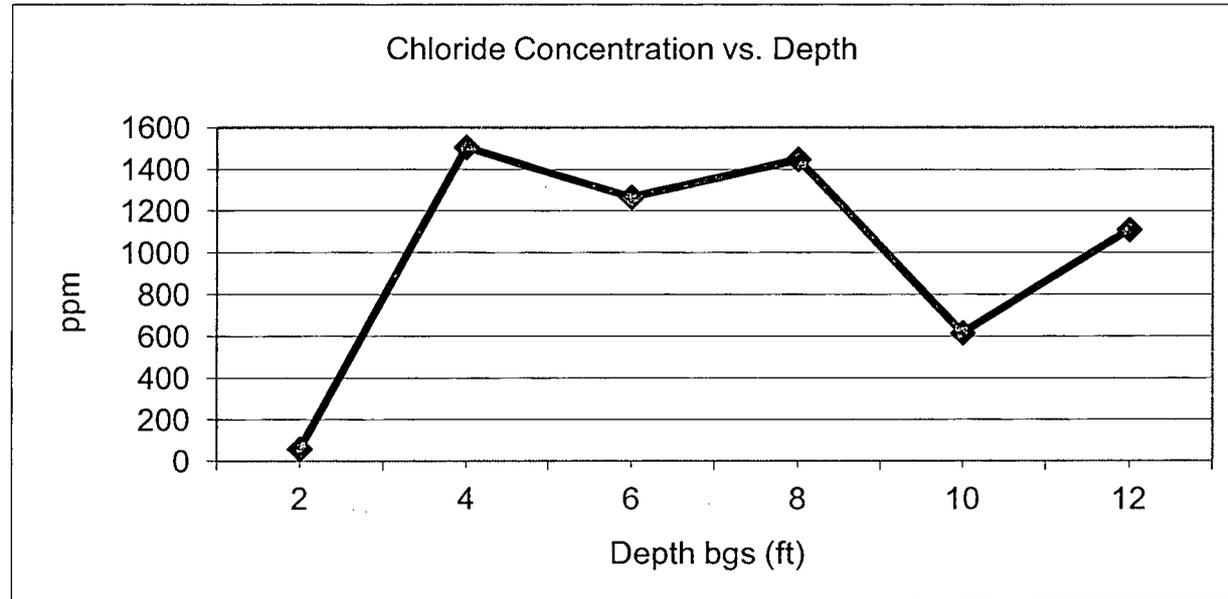
Backhoe samples at 10 ft South of the junction (source)

Depth bgs (ft)	[Cl ⁻] ppm
2	58
4	1,505
6	1,265
8	1,447
10	616
12	1,110

Groundwater = 31 ft

LOCATION	DEPTH	mg/kg
4-wall comp.	N/A	707
bottom comp.	12'	561
blended backfill	N/A	591
background	6"	56
vertical delineation trench at 10' south of source	2'	58
	4'	1,505
	6'	1,265
	8'	1,447
	10'	616
	12'	1,110
