**SITE INVESTIGATION  
REPORT**

**RE: SITE INVESTIGATION REPORT, BLACKROCK OIL STATE CY LEASE SITE, 14 MILES  
WEST OF TATUM, LEA COUNTY, NEW MEXICO**

Enclosed please find the Site Investigation Report for the Blackrock Oil State CY Lease (Blackrock Oil) site located approximately 14 miles west of Tatum, New Mexico. This report for the Blackrock Oil site is being submitted pursuant to the State of New Mexico General Services Department Purchasing Division Price agreement #10-805-00-07208 and Purchase Order (PO) #52100-0000033800 issued by the New Mexico Energy, Minerals & Natural Resources (EMNRD) Oil Conservation Division (OCD). All work was completed in accordance with the Souder, Miller & Associates (SMA) workplan dated November 29, 2011 and previously approved by OCD.

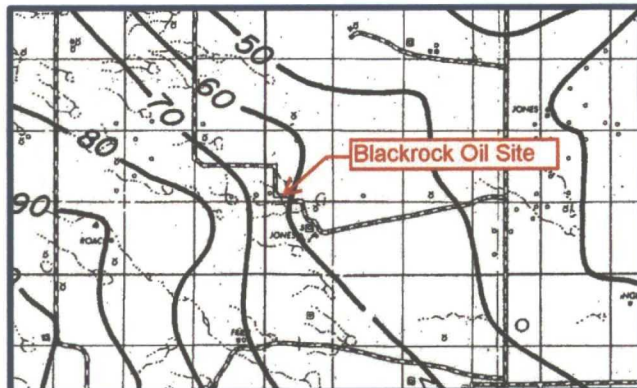
the location of the exploratory well and depth to water information. The illustration above is from the Lea County Groundwater Contour Map (1978) and locates the Blackrock Oil site near the 60 foot groundwater contour. All water well information was obtained from the New Mexico Office of the State Engineer (NMOSE) WATERS database and available literature. Based on available depth to water and groundwater contour information, it is anticipated that groundwater at the Blackrock Oil site likely occurs at a depth of approximately 70 to 80 feet below ground surface with a flow direction towards the northeast.

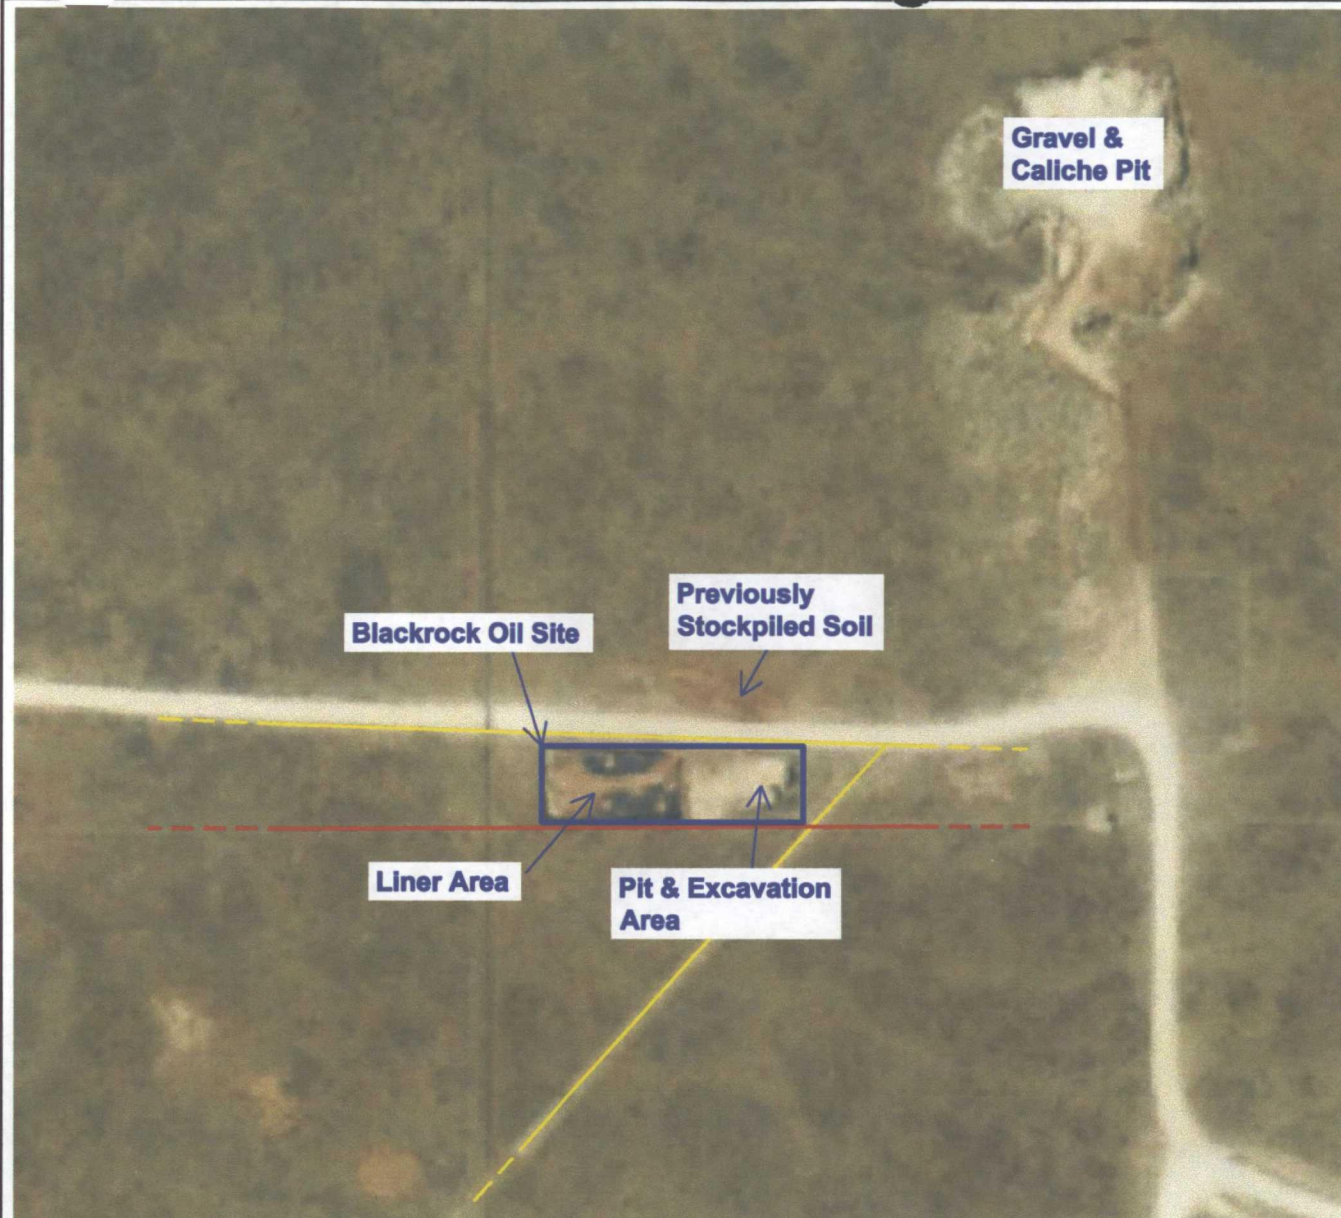
**Figure 2**

**Site Map w/ Utility Locations  
Blackrock Oil  
14 Miles West of Tatum, Lea County, New Mexico**

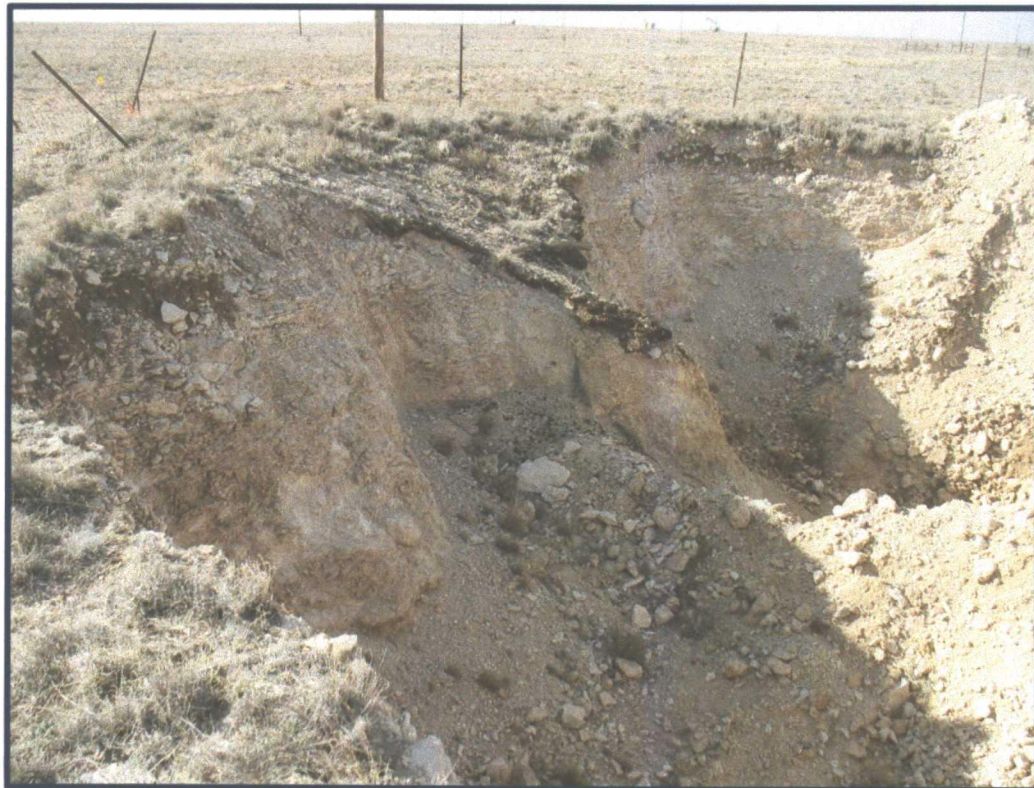
*Photograph #2: View of pit remaining from previous excavation activities prior to disturbance.*

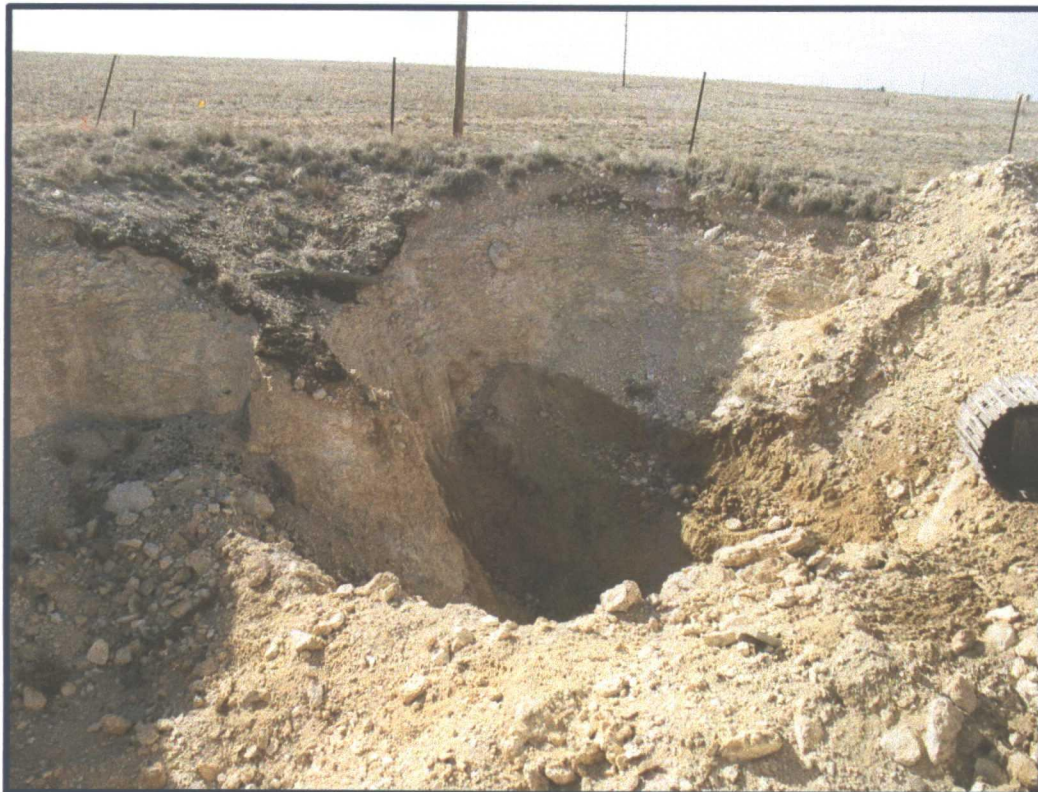
*Photograph #6: Excavation of area in southeast corner of existing pit, identified as excavation area S-1.*

The initial pot-hole area (S-1) was advanced near the southeast corner of the previous excavation area which, based on Kleinfelder's previous excavation and report, contained the highest NORM readings and seemed to follow a vertical fissure of petroleum stained soil. Additional pot-hole areas were excavated to the north (S-2), northwest (S-3) and west (S-4) of the initial S-1 pot-hole area. Several additional pot-hole areas were initially anticipated. However, the locations of oil and/or gas pipelines and an overhead electric line (Figure 2) prevented further excavation activities towards the east and south of the site. All four (4) pot-hole areas were advanced vertically as far as practical based on the lithology encountered (caliche) and the vertical reach of the excavator.

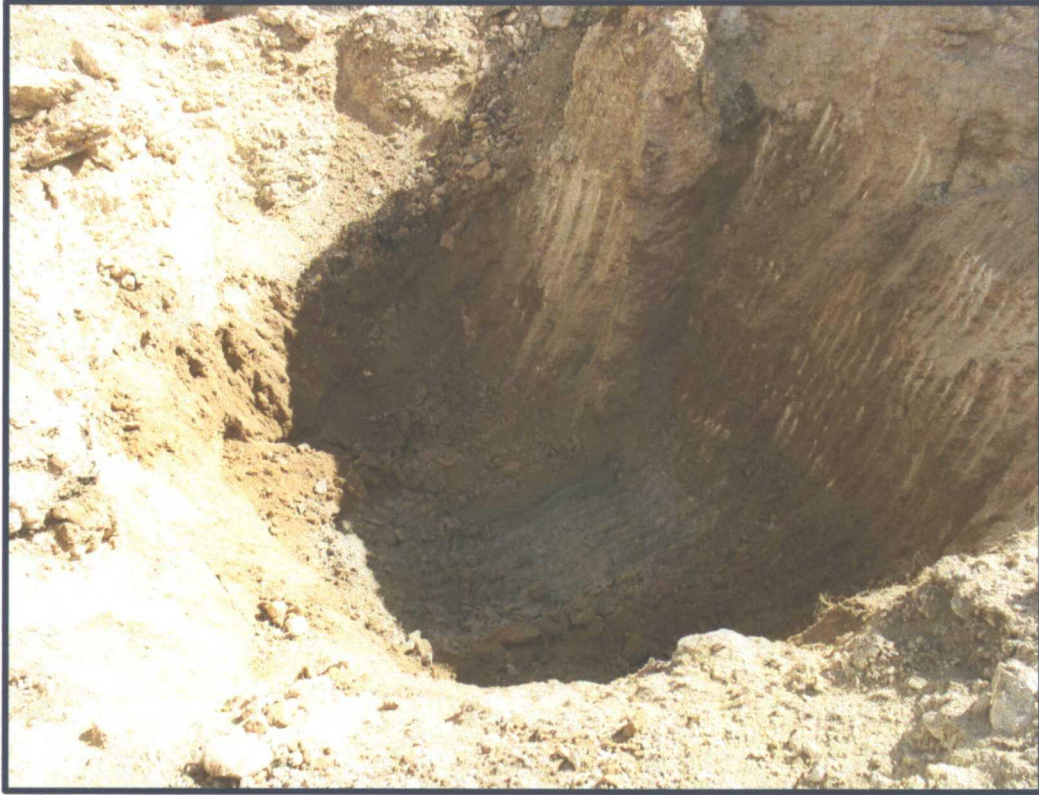
*Photograph #7: View of color change in excavation area S-1 at a depth of approximately 20 feet bgs.*

As anticipated, field soil screening results indicated the area of highest observed petroleum contamination was in the southeast corner of the former pit area (pot-hole area S-1) with a PID reading of 843 parts per million by volume (ppmv) at a total depth of approximately 20 feet bgs. The corresponding laboratory sample revealed diesel range organic (DRO) concentrations of 4,500 milligrams per kilogram (mg/Kg), motor oil range organic (MRO) concentrations of 1,500 mg/kg and gasoline range organic (GRO) concentrations of 330 mg/kg, all in excess of one or more applicable guidelines and/or standards. Ethylbenzene at a concentration of 2.2 mg/kg and total xylenes at a concentration of 5.5 mg/kg were also detected in the soil sample obtained from the total depth of S-1. DRO and MRO concentrations in excess of applicable standards were also present in the soil sample collected from S-1 at a depth of approximately 15 feet bgs. Visual documentation of soil contamination and the color change observed in S-1 with increasing depth is provided in Photographs #7, #8, #9 and #10 of Appendix A.

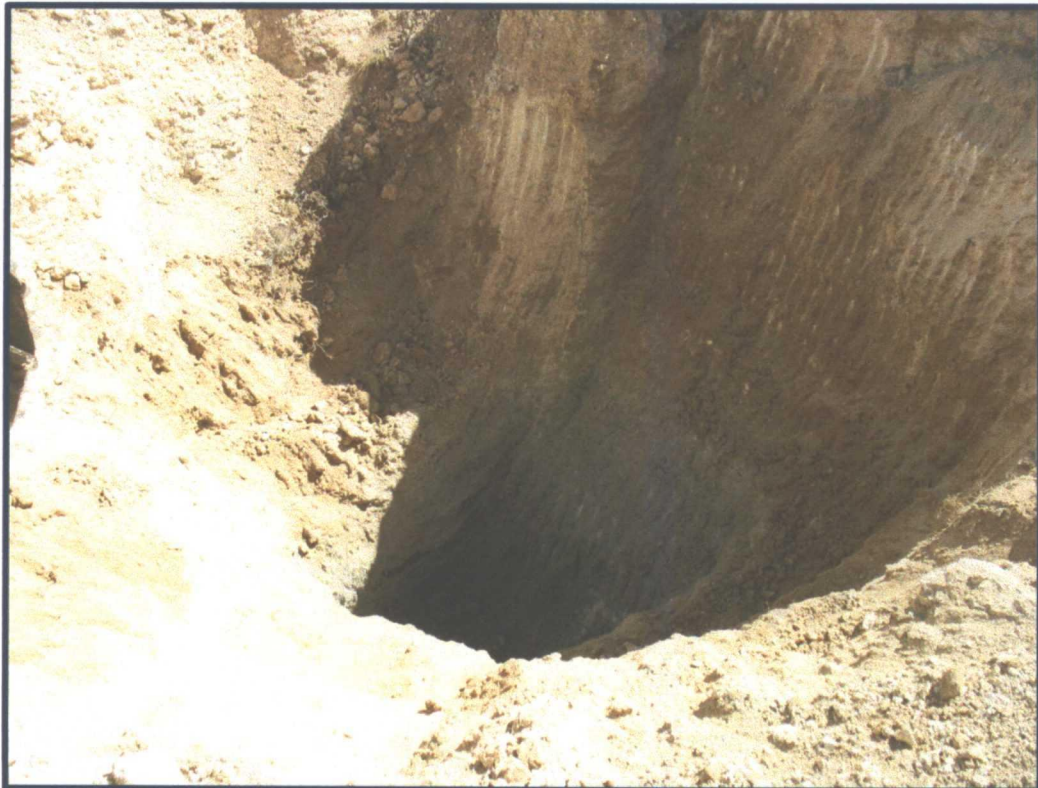
*Photograph #8: Additional view of excavation area S-1, excavator teeth having difficulty breaking up caliche*

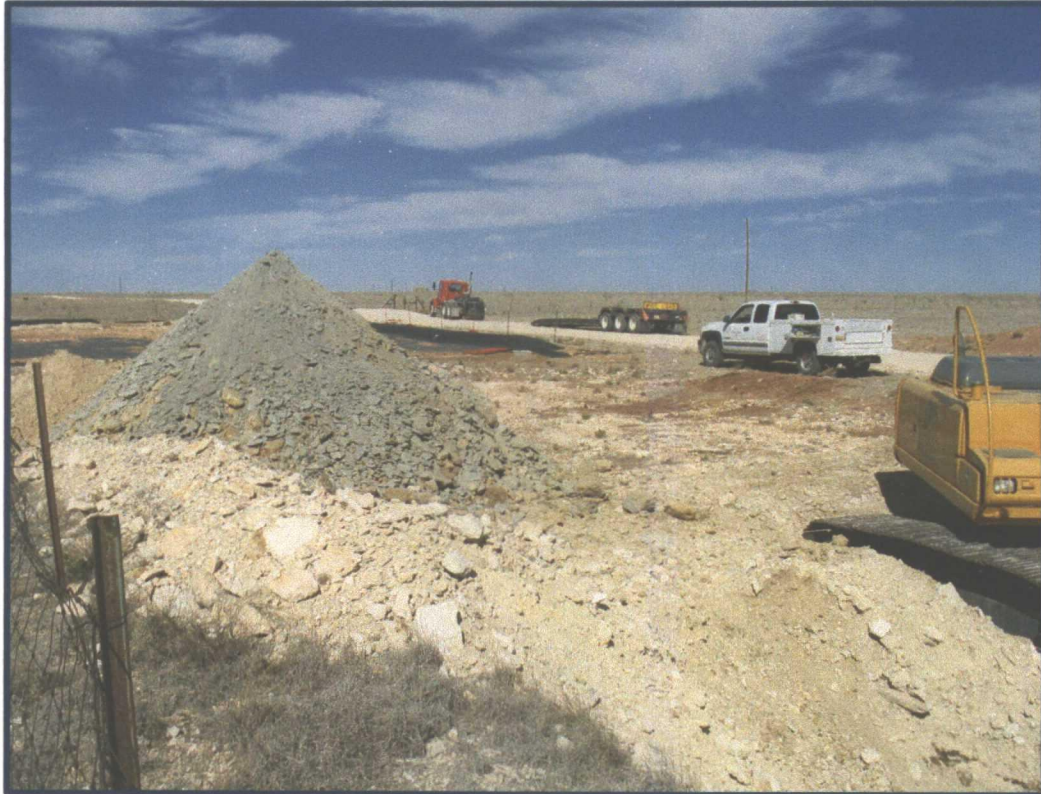
*Photograph #9: Greyish material excavated from S-1, initially thought to possibly be grout from abandoned well but determined to be stained caliche as field PID readings indicated petroleum contamination.*

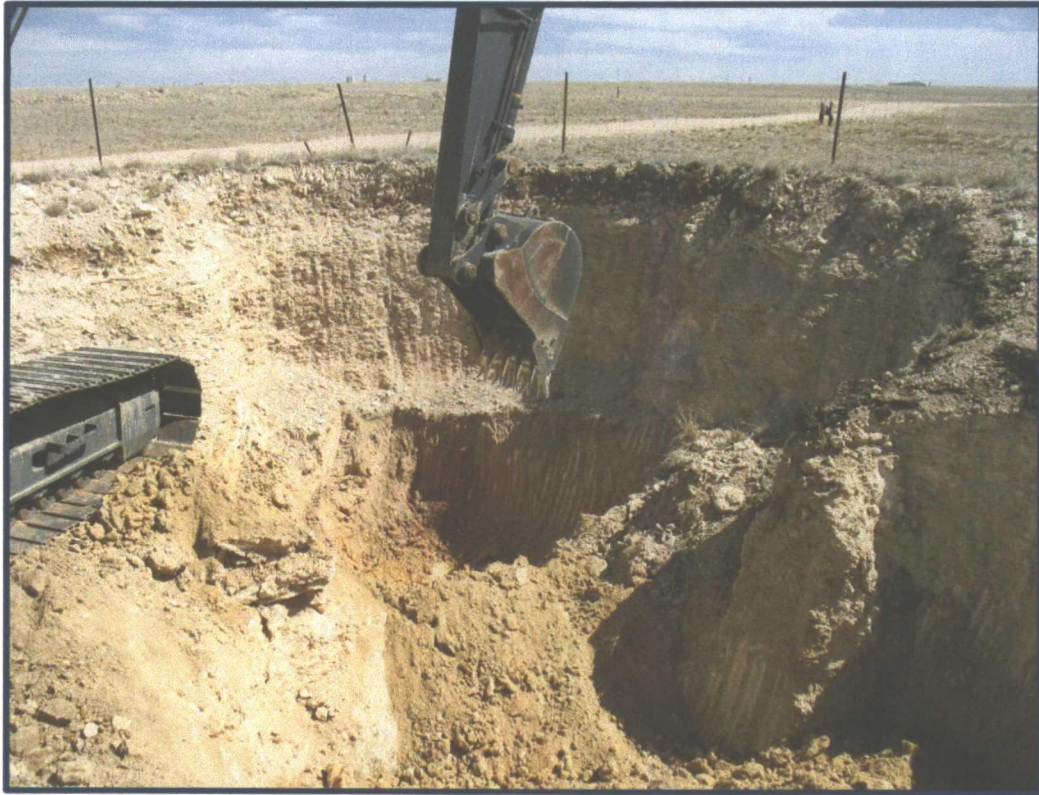
*Photograph #11: Excavation of S-2 in the northeast corner of pit.*

Pot-hole area S-2, located near the northeast corner of the former pit area, also revealed DRO and MRO concentrations in excess of applicable standards from the soil sample collected at a depth of approximately 20 feet bgs and from the soil sample collected at a total depth of approximately 25 feet bgs. The soil samples collected from pot-hole areas S-3 and S-4 were below laboratory practical quantitation (PQL) for all analyzed petroleum contaminants of concern.

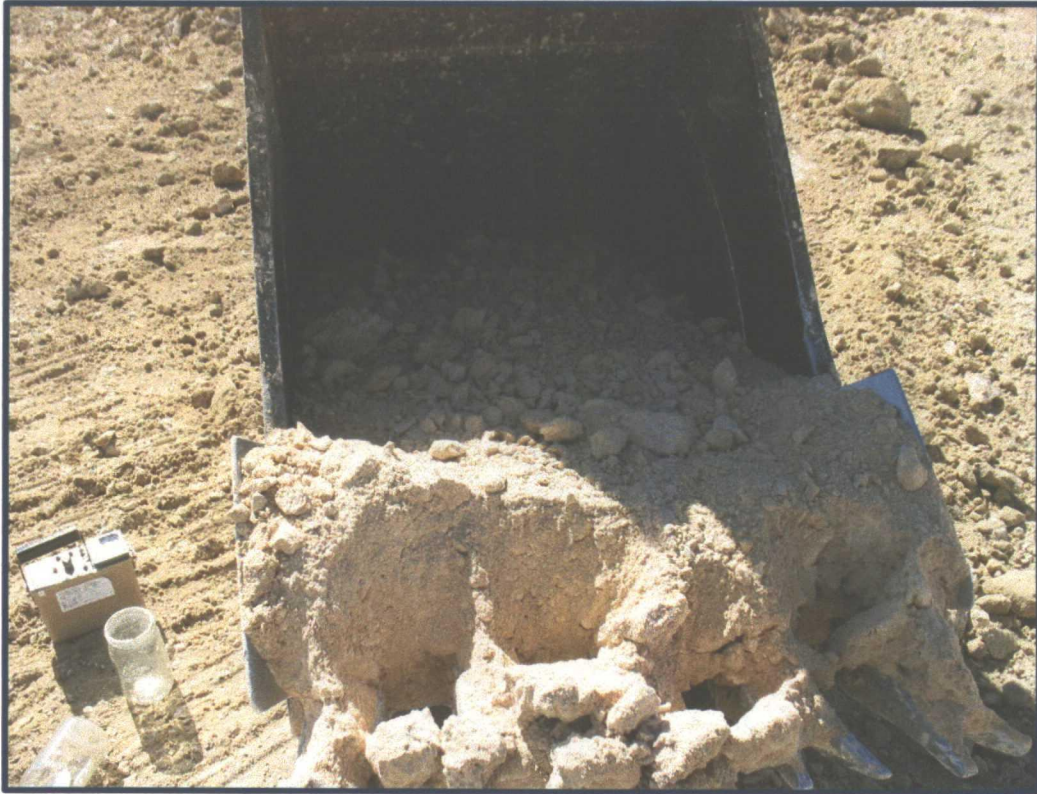
*Photograph #17: Close-up of material excavated from pot-hole area S-4 with scintillator to left of excavator bucket.*

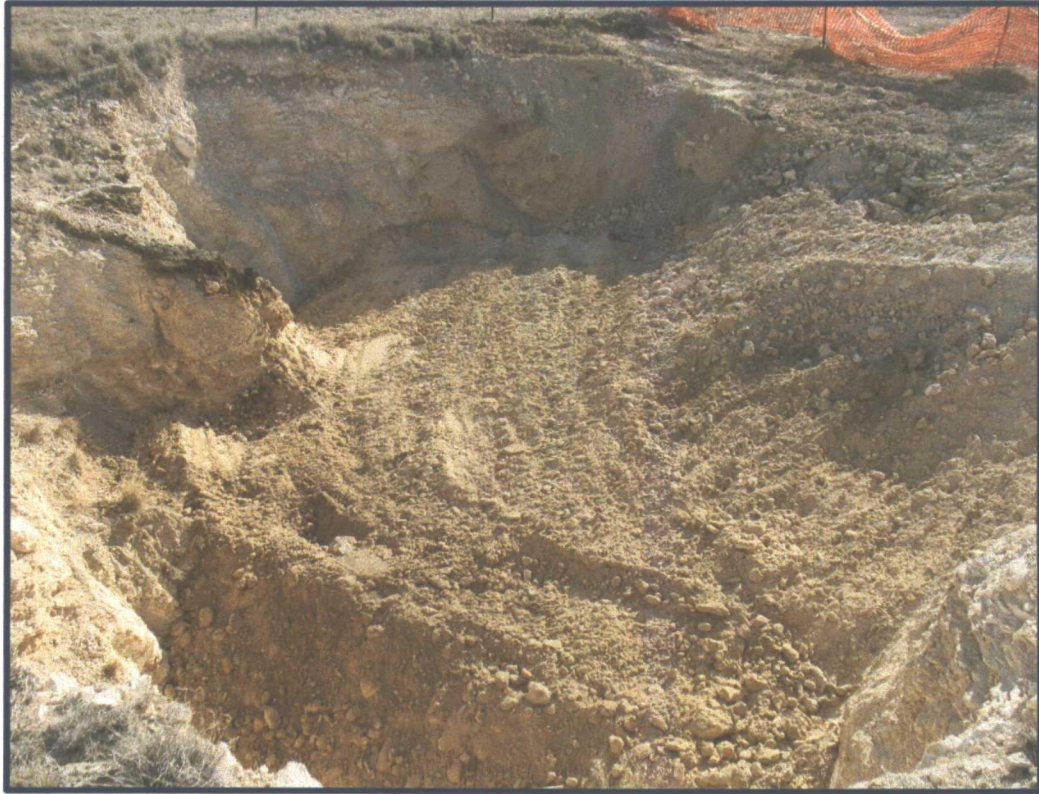
*Photograph #19: Benching and ramp construction of existing pit for added site safety and ingress/egress of any livestock that may get beyond the current fencing around the pit.*

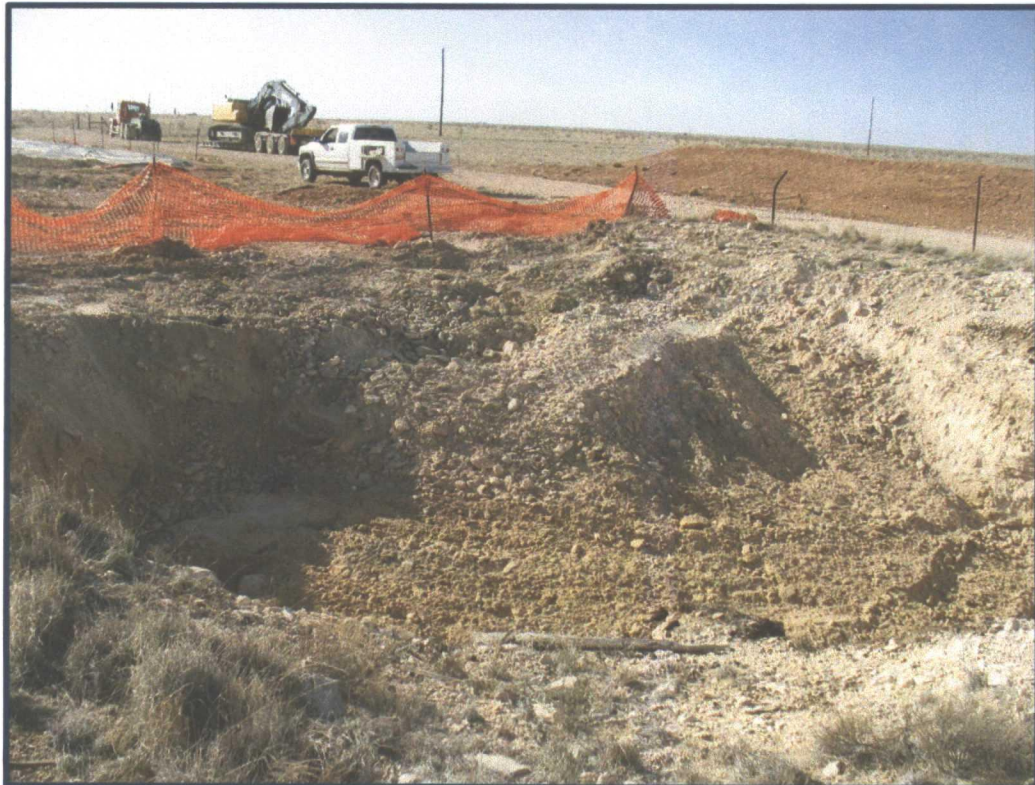
*Photograph #20: Additional view of large pit benched, ramped and with netting added for additional visibility/safety.*
