**RE: Corrective Action Plan Report and Termination Request
Rice Operating Company – EME SWD System
EME B-33 (1R427-54): UL/B sec. 33 T20S R36E
(formerly EME C-33)**

Corrective Action Plan Report

Appendix A

CAP Activities Documentation

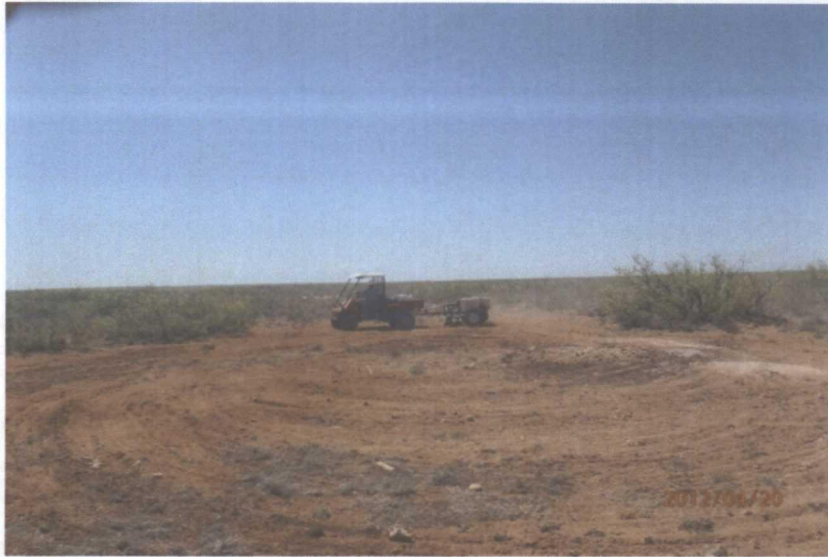
Seeding and tilling site, facing south

On April 20th, 2012, REC personnel were on site to seed the location. The site was seeded with a blend of native vegetation and the site was then watered to promote vegetative growth. Documentation for these activities can be found in Appendix A.

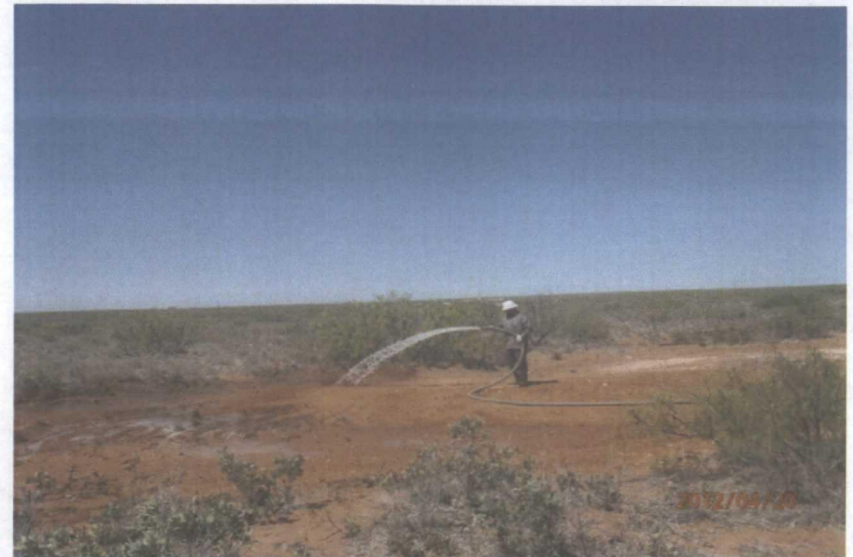
Watering seeded site, facing west

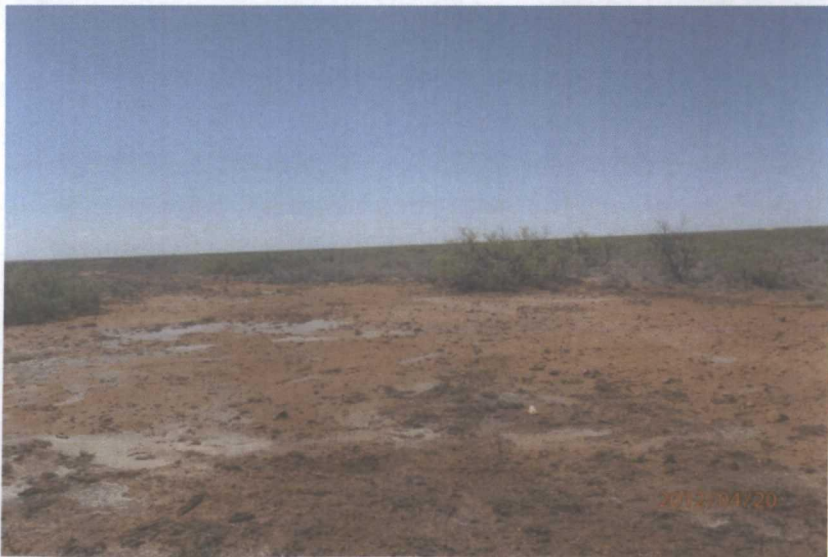
Site complete, facing south

ROC has completed the corrective actions as approved by NMOCD in the CAP by seeding the site. Therefore, ROC requests 'remediation termination' status of the regulatory file.

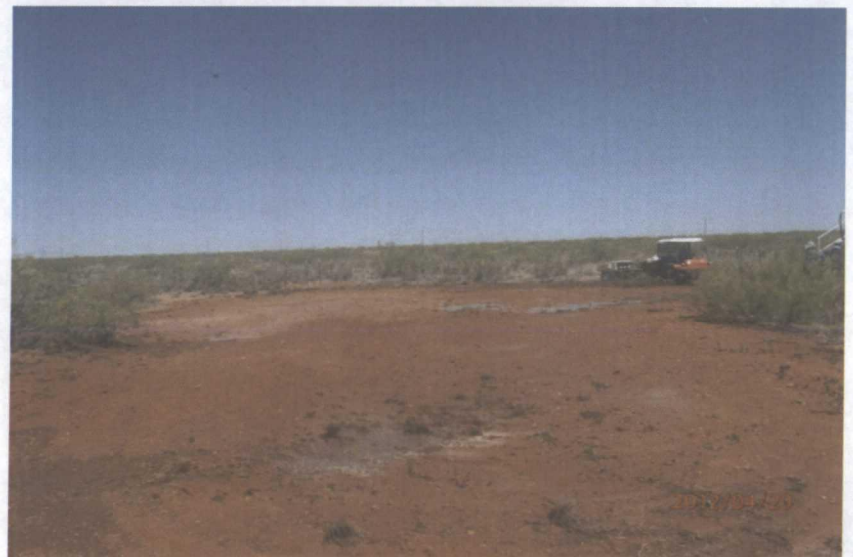
Site complete, facing north
