**RE: Termination Request  
for the Rice Operating Company's  
Vacuum B-27 Vent Site  
Unit Letter B, Section 27, T17S, R35E, NMPM, Lea County, New Mexico  
Remediation Plan (1R425-70) Termination**

RE: Termination Request  
Vacuum B-27 vent (1R425-70): UL/B, Sec. 27, T17S, R35E  
RICE Operating Company – Vacuum SWD System

# RICE OPERATING COMPANY JUNCTION BOX FINAL REPORT

## Vacuum B-27 vent

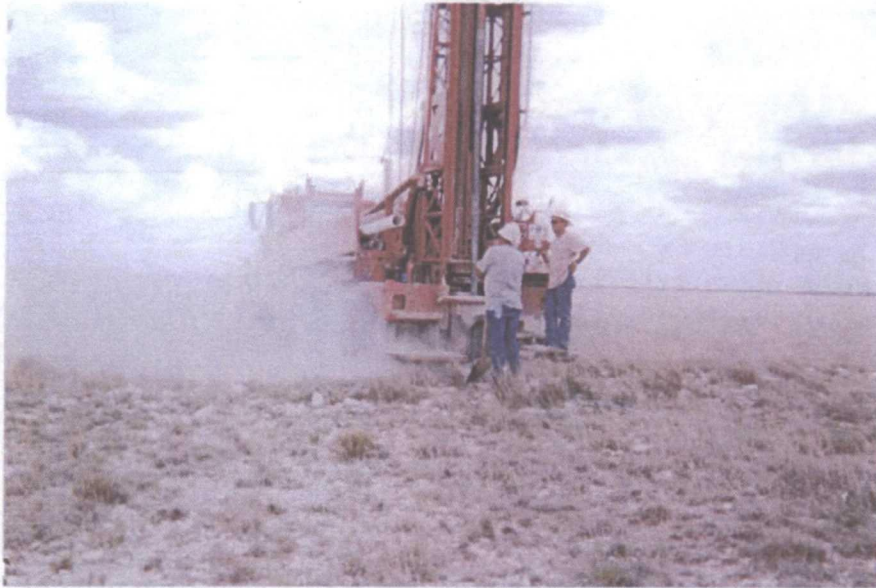
drilling SB #1 at the former junction box

6/18/2009

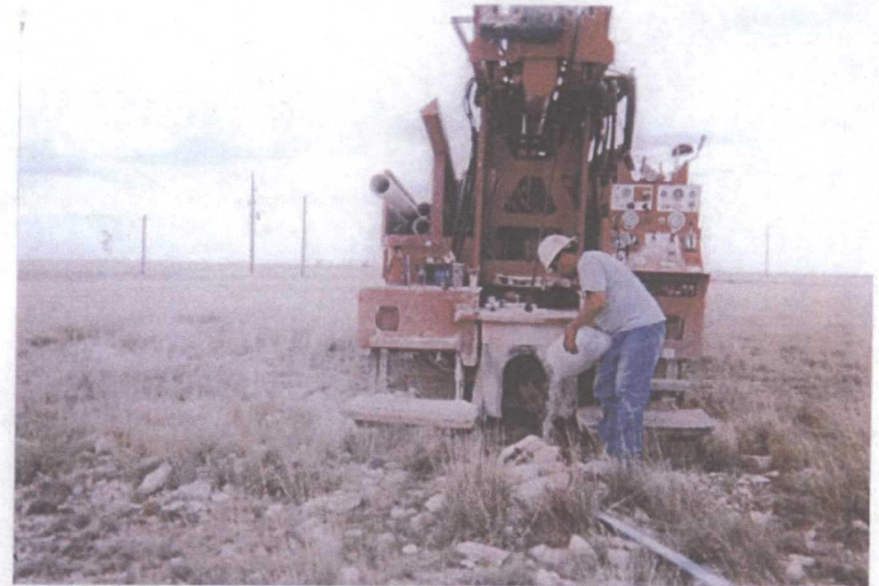
plugging SB #1 with bentonite

6/18/2009

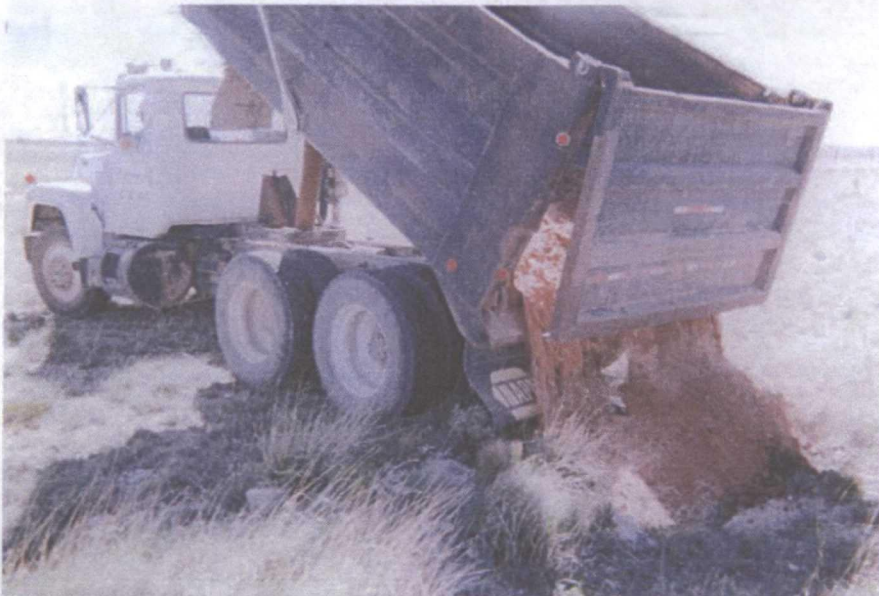
importing clean soil

6/25/2009

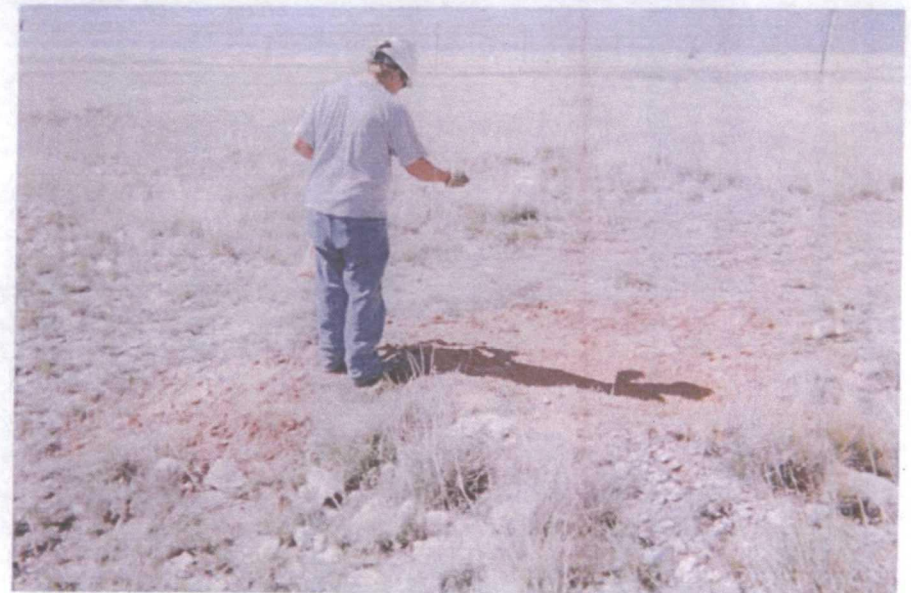
seeding backfilled site

6/25/2009
