From: Hansen, Edward J., EMNRD
Sent: Monday, June 18, 2012 4:11 PM
To: Hack Conder (hconder@riceswd.com)
Cc: Leking, Geoffrey R, EMNRD; Laura Pena (lpena@riceswd.com); Scott Curtis (scurtis@riceswd.com)
Subject: Remediation Plan (1R425-72) Termination - ROC Vacuum Jct J-7 Site

RE: Termination Request
Vacuum Jct. J-7 (1R425-72): UL/J, Sec. 7, T18S, R35E
RICE Operating Company – Vacuum SWD System

**RICE OPERATING COMPANY
JUNCTION BOX FINAL REPORT**

Vacuum Jct. J-7

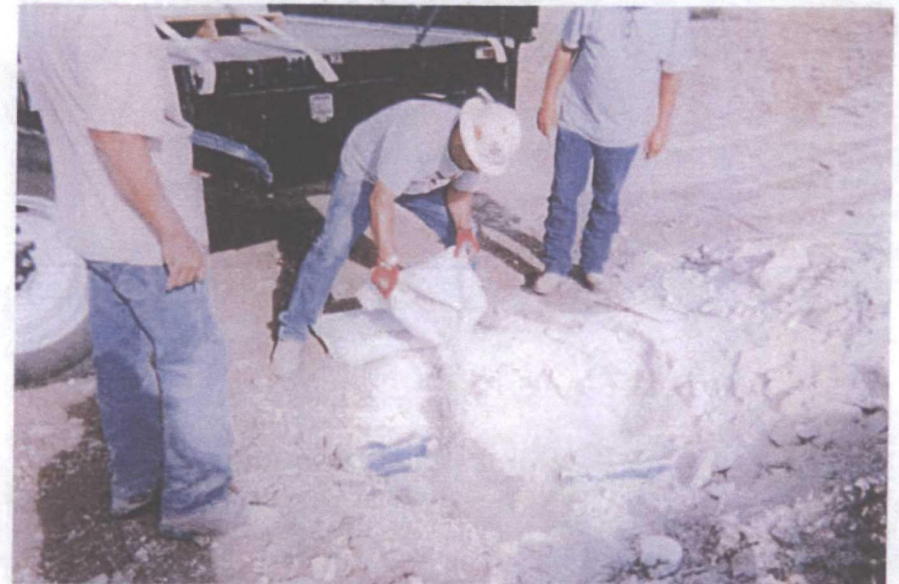
plugging SB #1 with bentonite

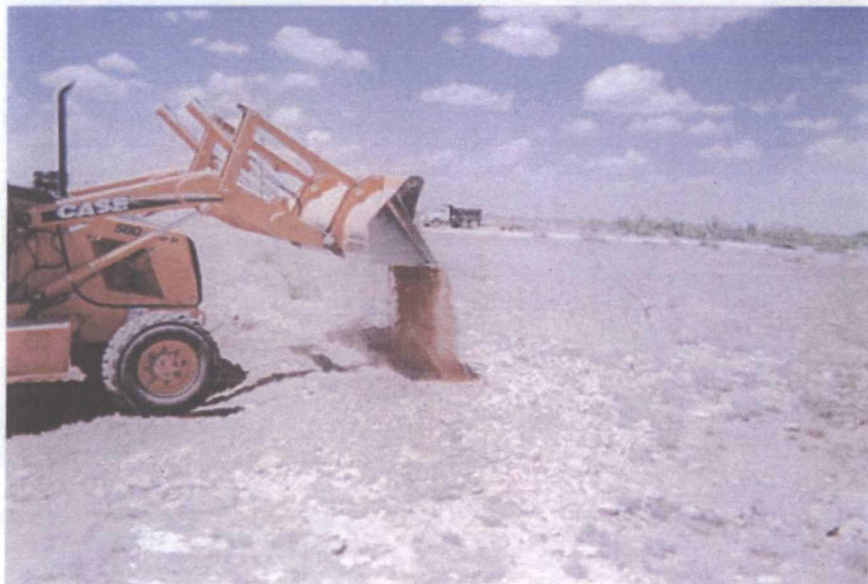
backfilling the former junction box site with clean soil

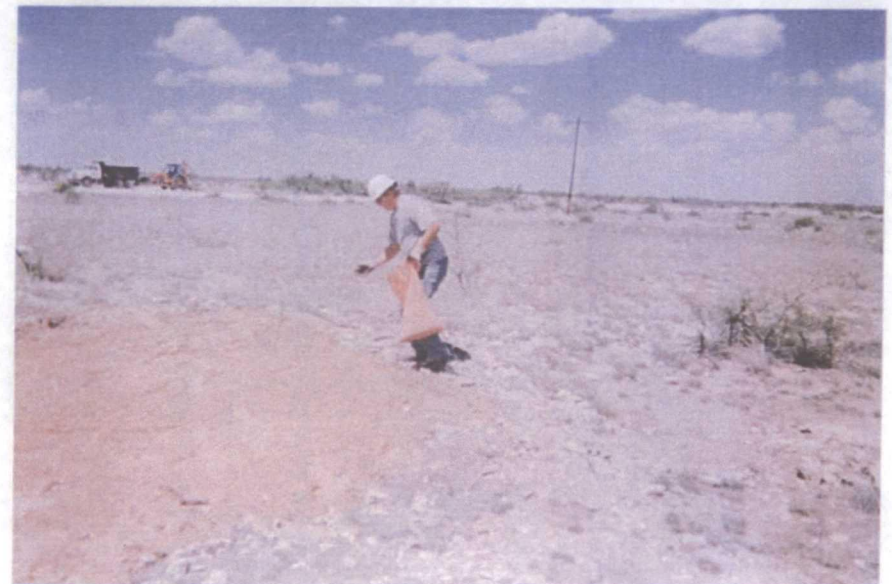
seeding backfilled site
