RE: Termination Request
Vacuum Jct. C-36-1 (1R425-74): UL/C, Sec. 36, T17S, R34E
RICE Operating Company – Vacuum SWD System

**RICE OPERATING COMPANY
JUNCTION BOX FINAL REPORT**

Vacuum Jct. C-36-1

Unit C, Section 36, T17S, R34E

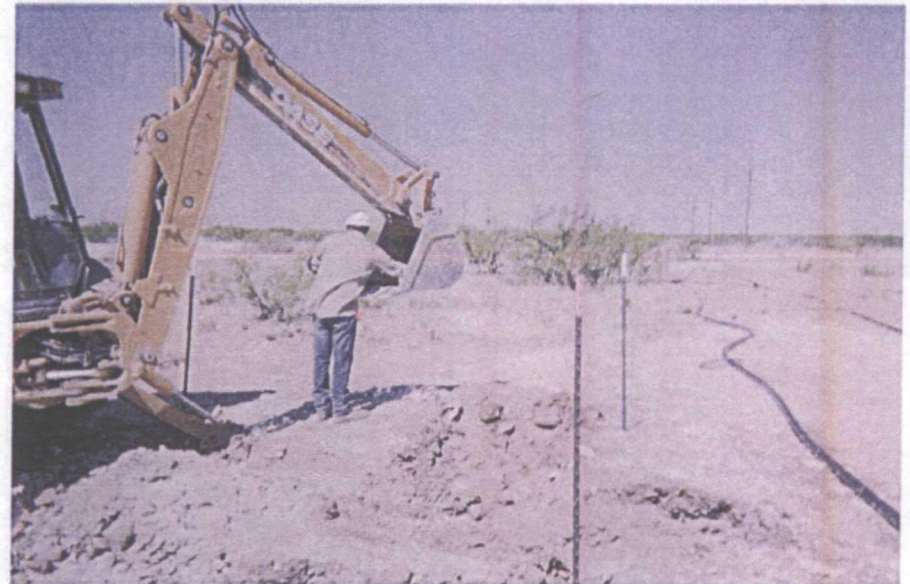
5/6/2009

collecting a sample from the source, facing west

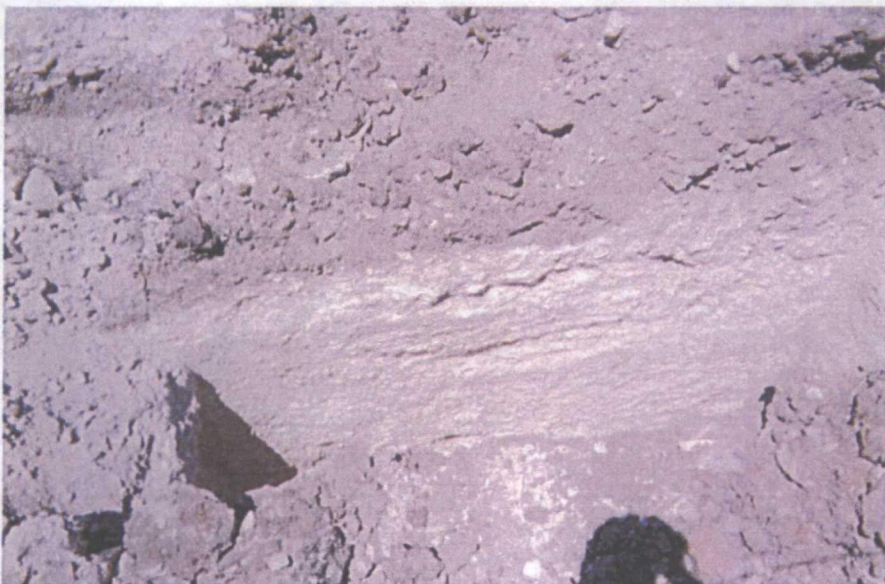
5/14/2009

final excavation, facing west

General Description of Remedial Action: This junction box was addressed during the Vacuum SWD System abandonment. After the former junction box was removed an investigation was conducted using a backhoe to collect soil sample at regular intervals creating a 5x3x7-ft deep excavation. Each sample was field tested for chlorides and organic vapors which yielded low concentrations similar to that of the background sample

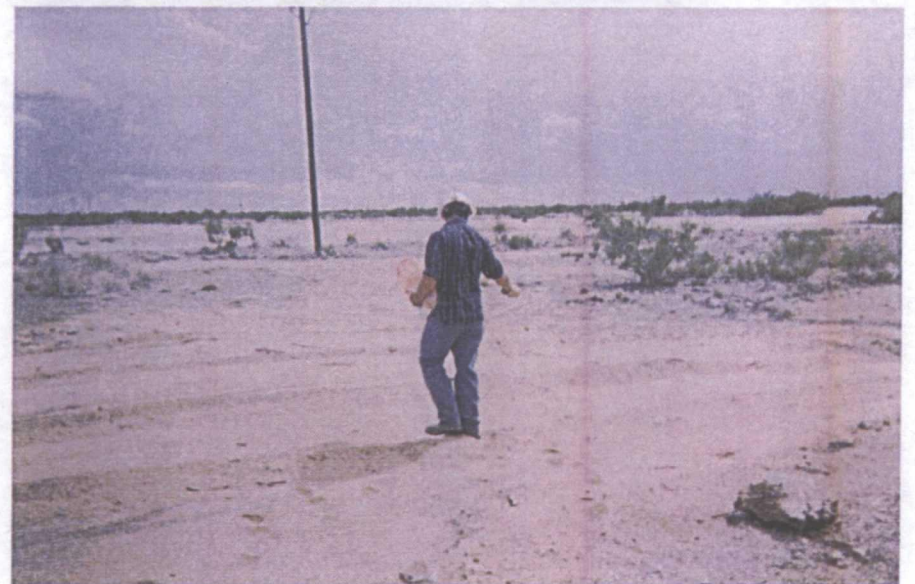
5/28/2009

seeding backfilled site, facing south

The deepest sample, 7 ft BGS, was sent to a commercial laboratory for analysis of chloride and TPH which confirmed low concentrations. The excavated soil was returned to the excavation to ground surface and contoured to the surrounding area. On 5/28/2009, the site was seeded with a blend of native vegetation and is expected to return to a productive capacity at a normal rate.
