From: Hansen, Edward J., EMNRD
Sent: Wednesday, July 18, 2012 2:05 PM
To: Hack Conder (hconder@riceswd.com)
Cc: Leking, Geoffrey R, EMNRD; Laura Pena (lpena@riceswd.com); Scott Curtis (scurtis@riceswd.com)
Subject: Remediation Plan (1R425-91) Termination - ROC Vacuum B-5-1 EOL Site

RE: Termination Request
Vacuum B-5-1 EOL (1R425-91): UL/B, Sec. 5, T18S, R35E
RICE Operating Company – Vacuum SWD System

**RICE OPERATING COMPANY
JUNCTION BOX FINAL REPORT**

Vacuum B-5-1 EOL

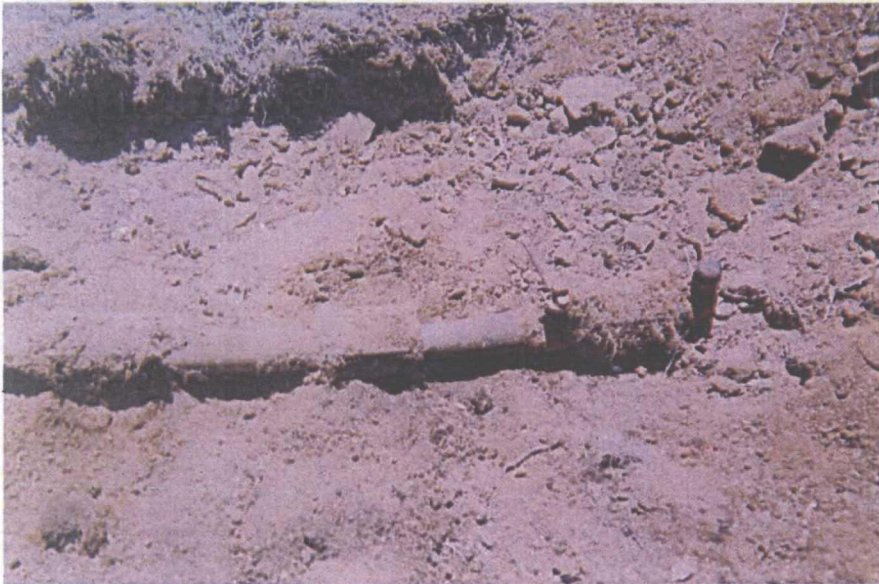
Site prior to delineation

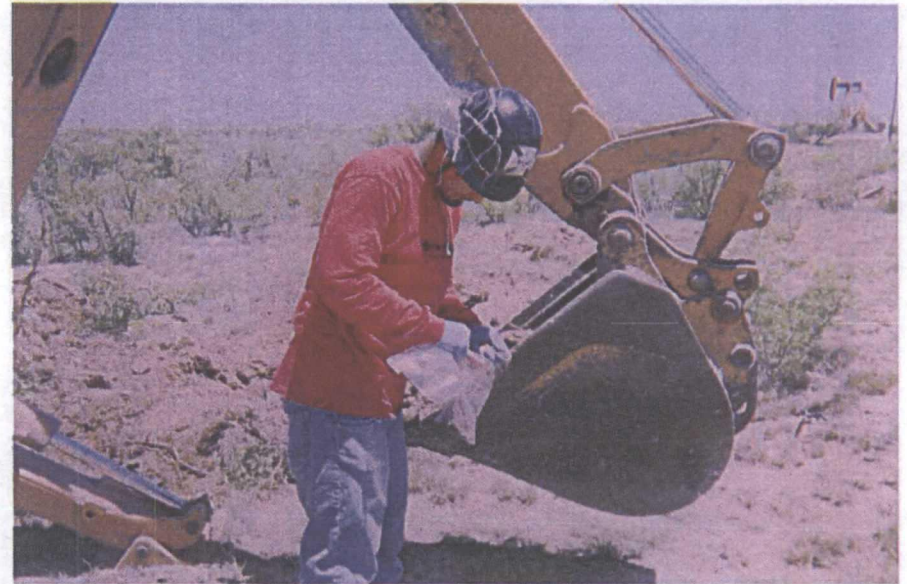
Collecting sample

General Description of Remedial Action: This junction box was addressed during the Vacuum SWD System abandonment. After the former junction box was removed an investigation was conducted using a backhoe to collect soil sample at regular intervals creating a 3x5x9-ft deep excavation. Each sample was field tested for chlorides and organic vapors which yielded low concentrations similar to that of the background sample. The deepest sample, 9 ft BGS, was sent to a commercial laboratory for analysis of chloride and TPH which confirmed low concentrations. The excavated soil was returned to the excavation to ground surface and contoured to the surrounding area. On 6/21/2010, the site was seeded with a blend of native vegetation and is expected to return to a productive capacity at a normal rate.

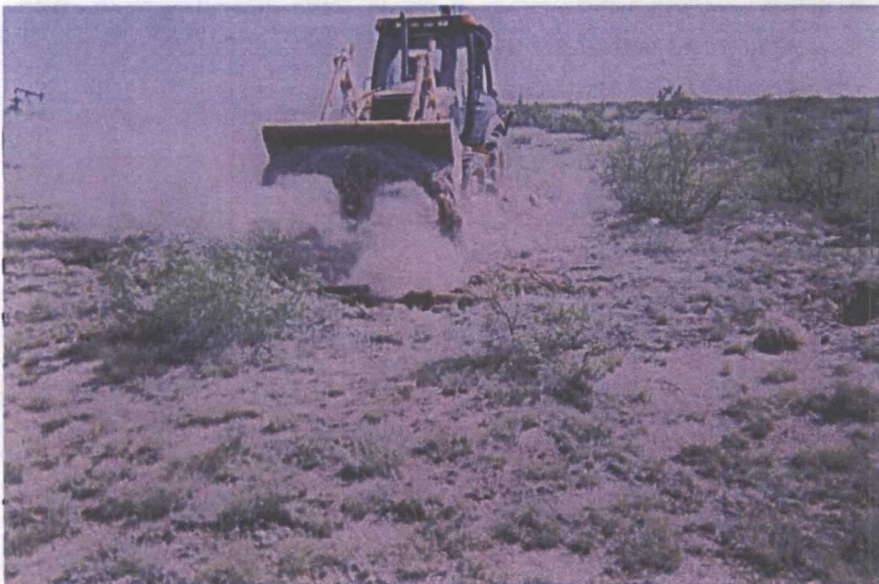
Backfilling excavation

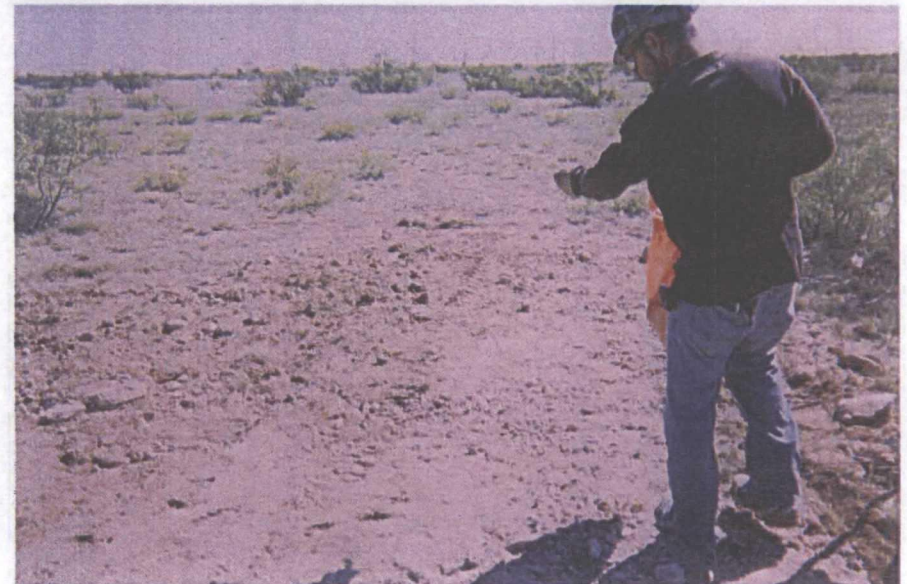
Seeding excavation
