**RE: CAP Report and Termination Request
Rice Operating Company – BD SWD System
BD B-29 (1R426-169): UL/B&C sec. 29 T21S R37E**

CAP Activities Documentation

BD B-29 leak (1R426-259)
Unit B, Section 29, T22S, R37E

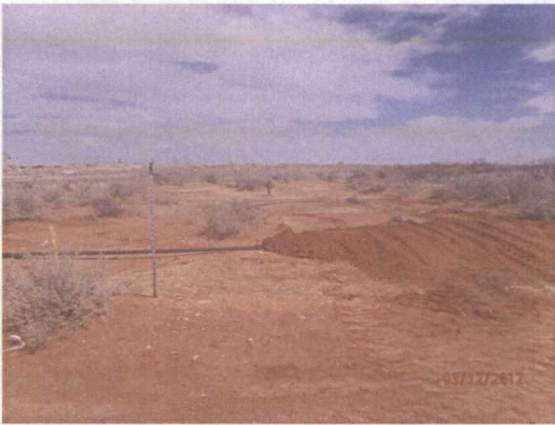
Southeast excavation prior to excavation,
facing east
3/12/12

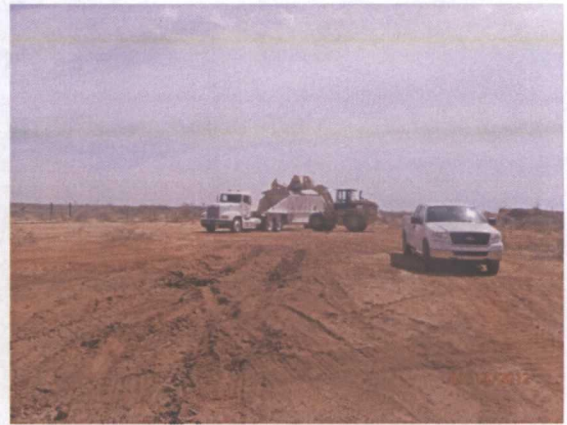
Exporting soil, facing west
3/14/12

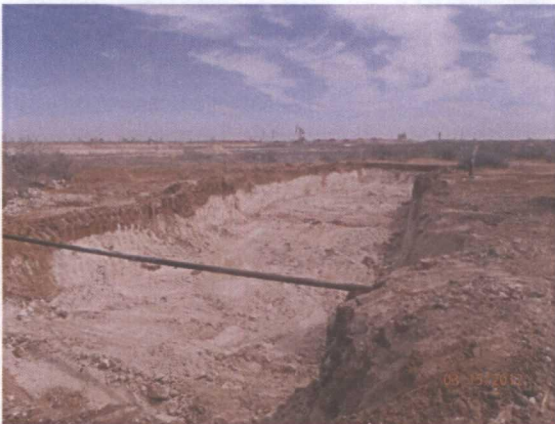
Southeast excavation completed, facing east
3/15/12

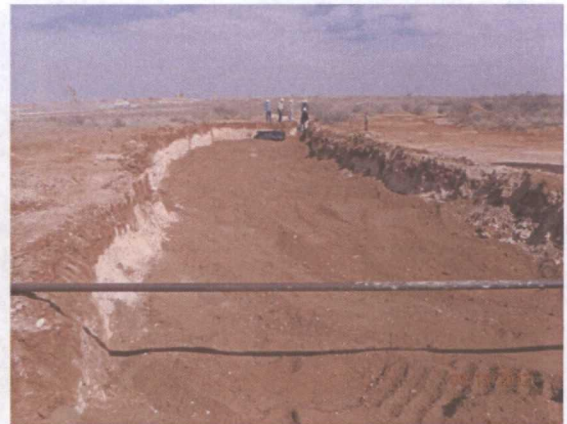
Installed bottom 6" sand pad, facing east
3/15/12

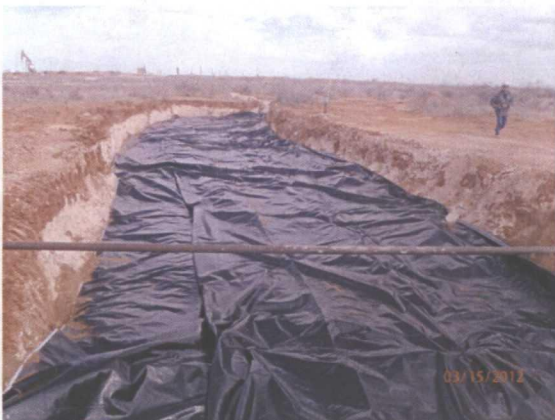
Installed 115' x 25', 20-mil reinforced
plastic liner, facing east
3/15/12

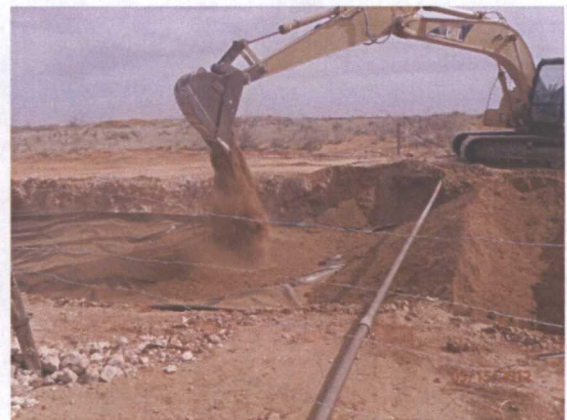
Installing 6" sand pad above liner, facing
east
3/15/12

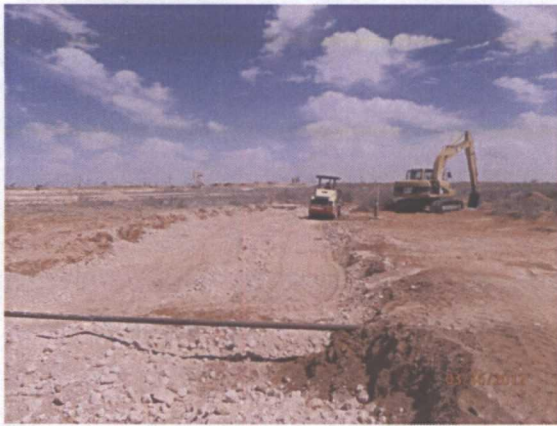
Roller packing caliche in backfilled excavation, facing east 3/16/12

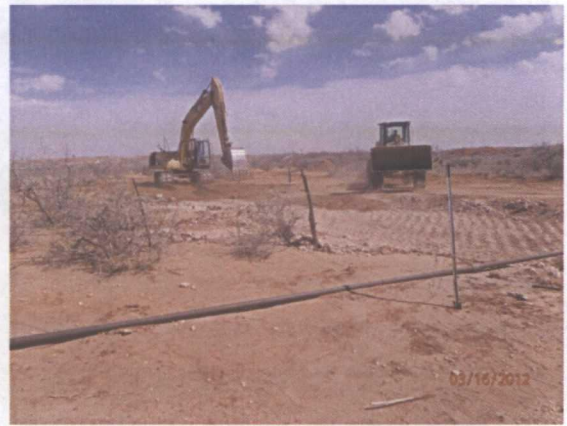
Backfilling 2' deep excavation with sand to ground surface, facing southeast 3/16/12

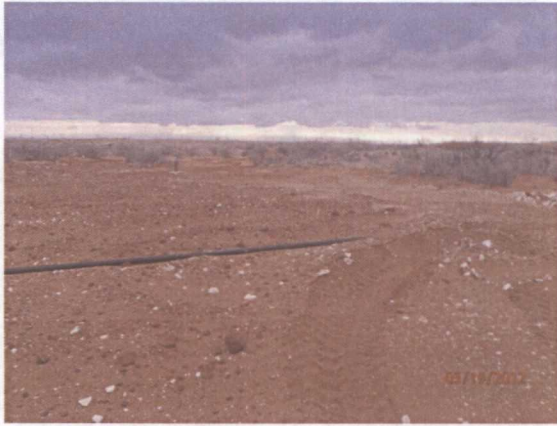
Excavation completed, facing east 3/19/12

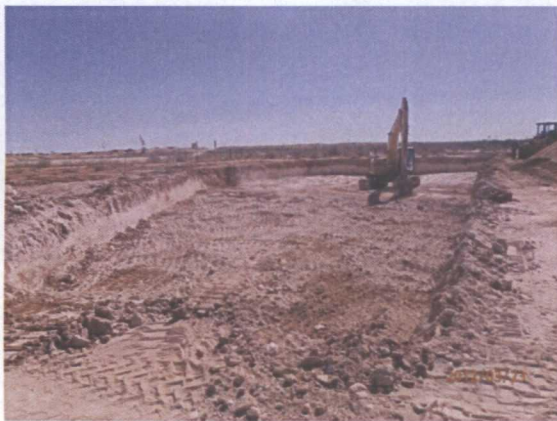
Center excavation, facing northeast 3/23/12

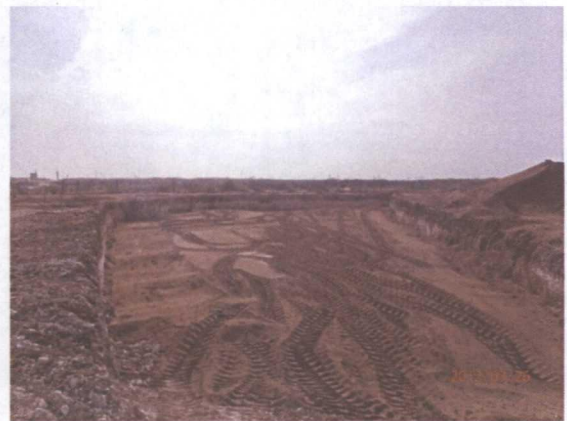
Installed bottom 6" sand pad, facing east 3/26/12

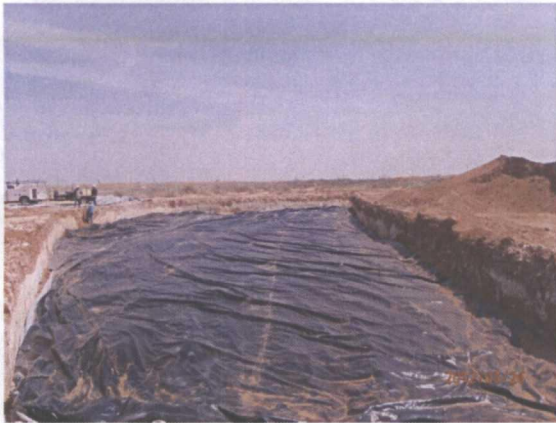
Installed south portion of 85' x 180', 20-mil reinforced plastic liner, facing east 3/26/12

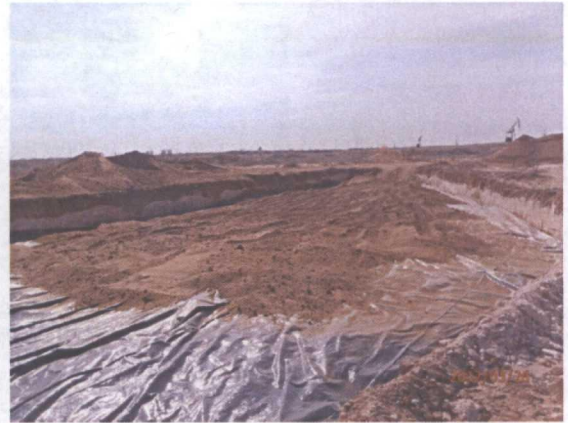
Installing 6" sand pad above liner, facing west 3/26/12

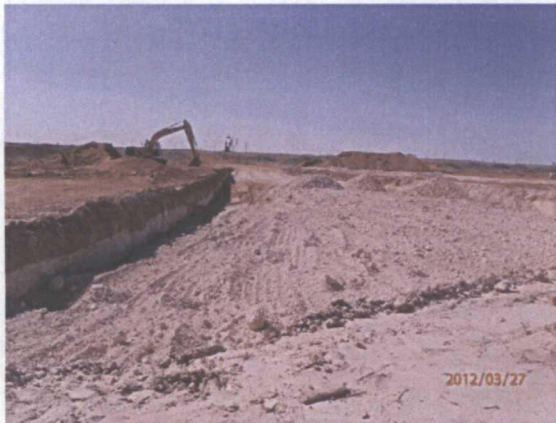
Backfilling site with caliche, facing west 3/27/12

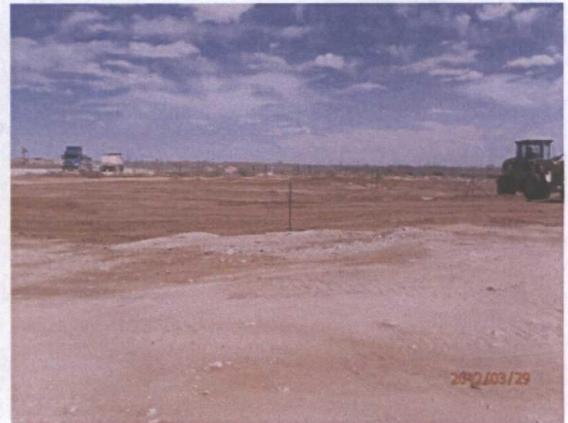
Center excavation (north of line) prior to excavation, facing east 3/29/12

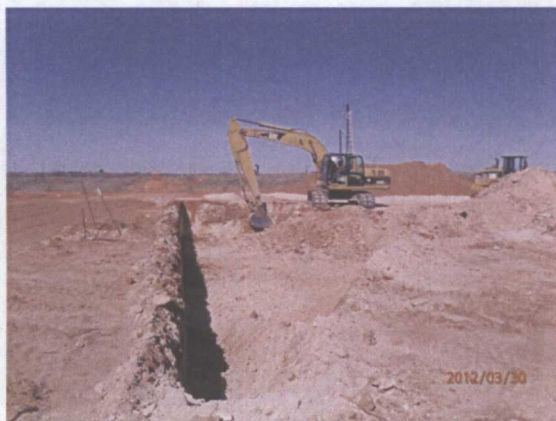
Excavating site, facing west 3/30/12

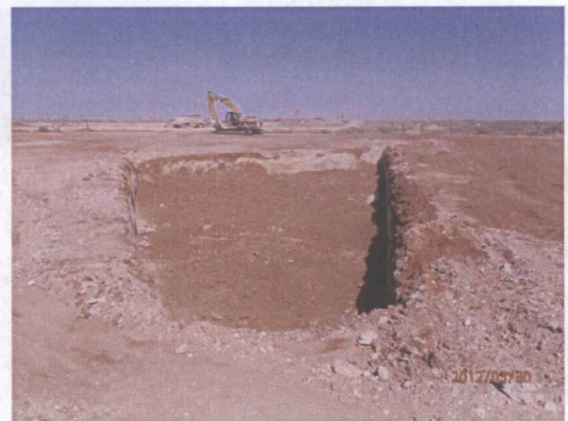
Installed bottom 6" sand pad, facing east 3/30/12

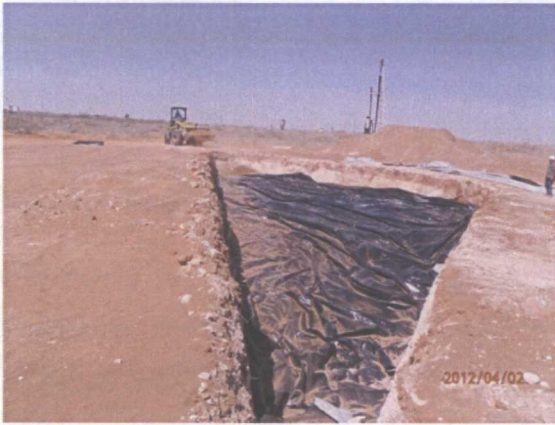
Installed north portion of 20-mil reinforced plastic liner, facing east 4/2/12

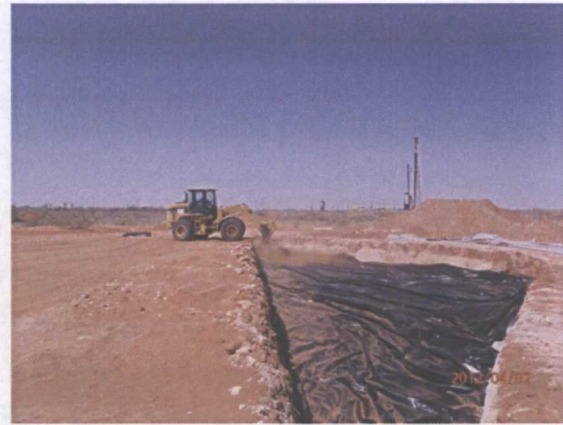
Backfilling excavation with imported sand, facing west 4/2/12

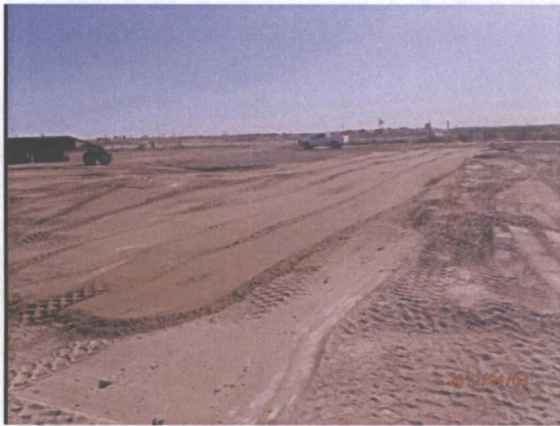
Excavation completed, facing northeast 4/3/12

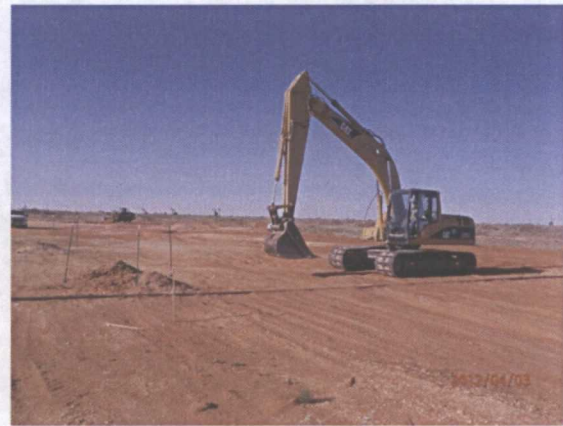
North excavation prior to excavating, facing southwest 4/3/12

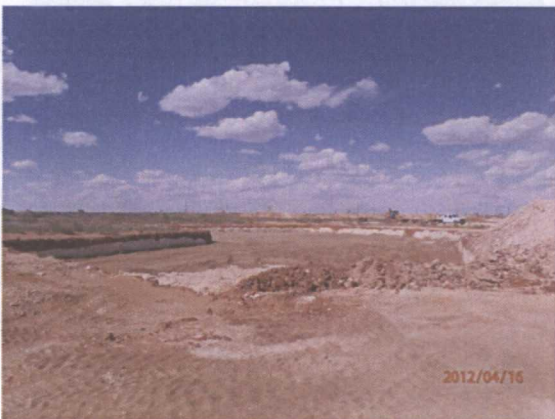
Excavating site, facing east 4/16/12

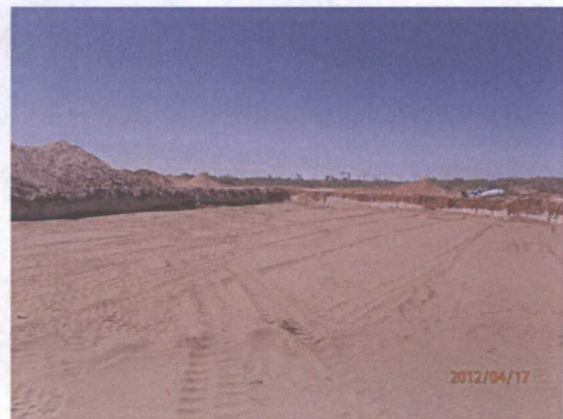
Installed bottom 6" sand pad, facing southwest 4/17/12

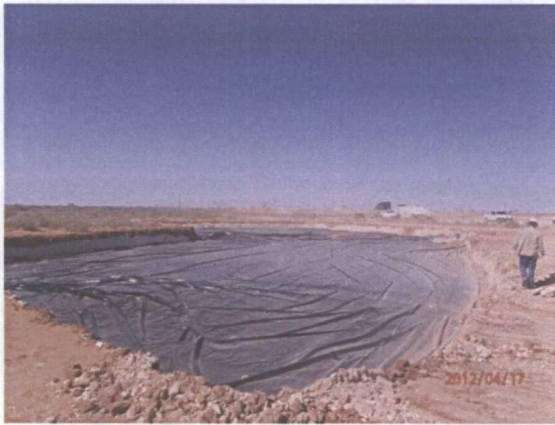
Installed 190' x 130', 20-mil reinforced L-shaped plastic liner, facing northeast 4/17/12

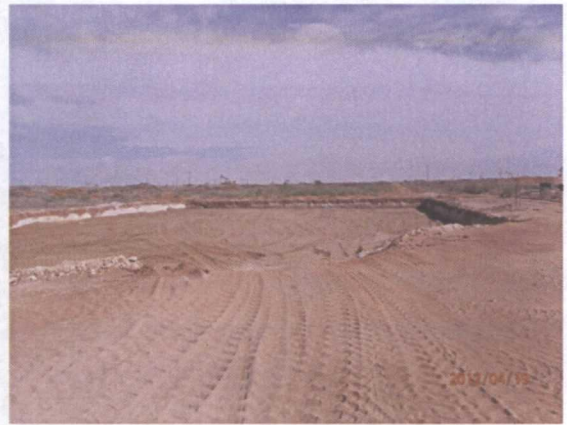
Installed 6" sand pad above liner, facing north 4/19/12

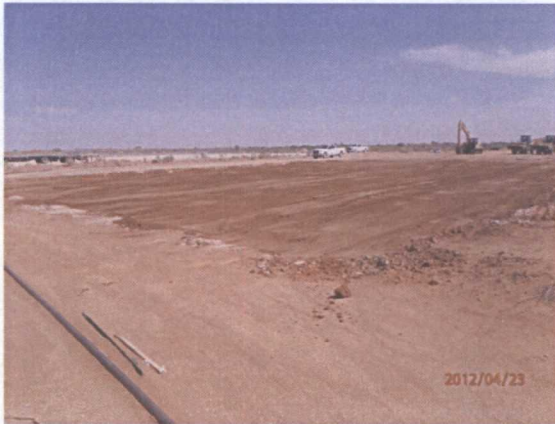
Backfilled north excavation, facing southeast 4/23/12

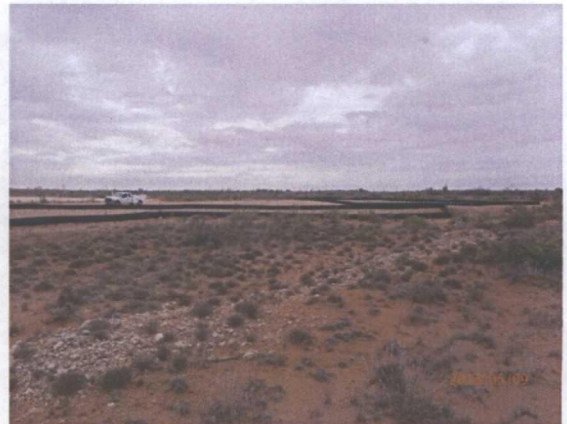
Sites completed, facing southeast 5/9/12

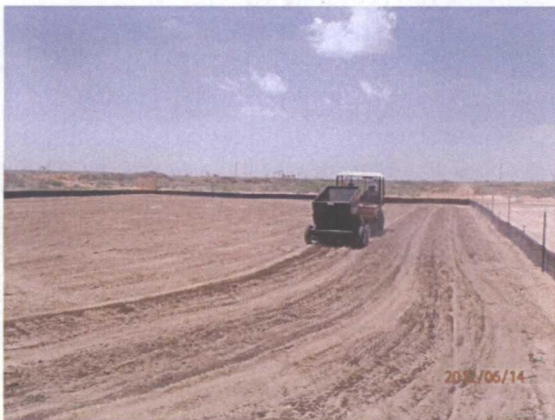
Spreading amendments, facing north 6/14/12

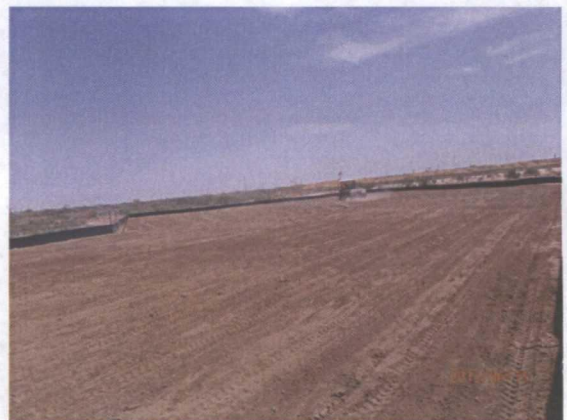
Seeding sites, facing east 6/15/12

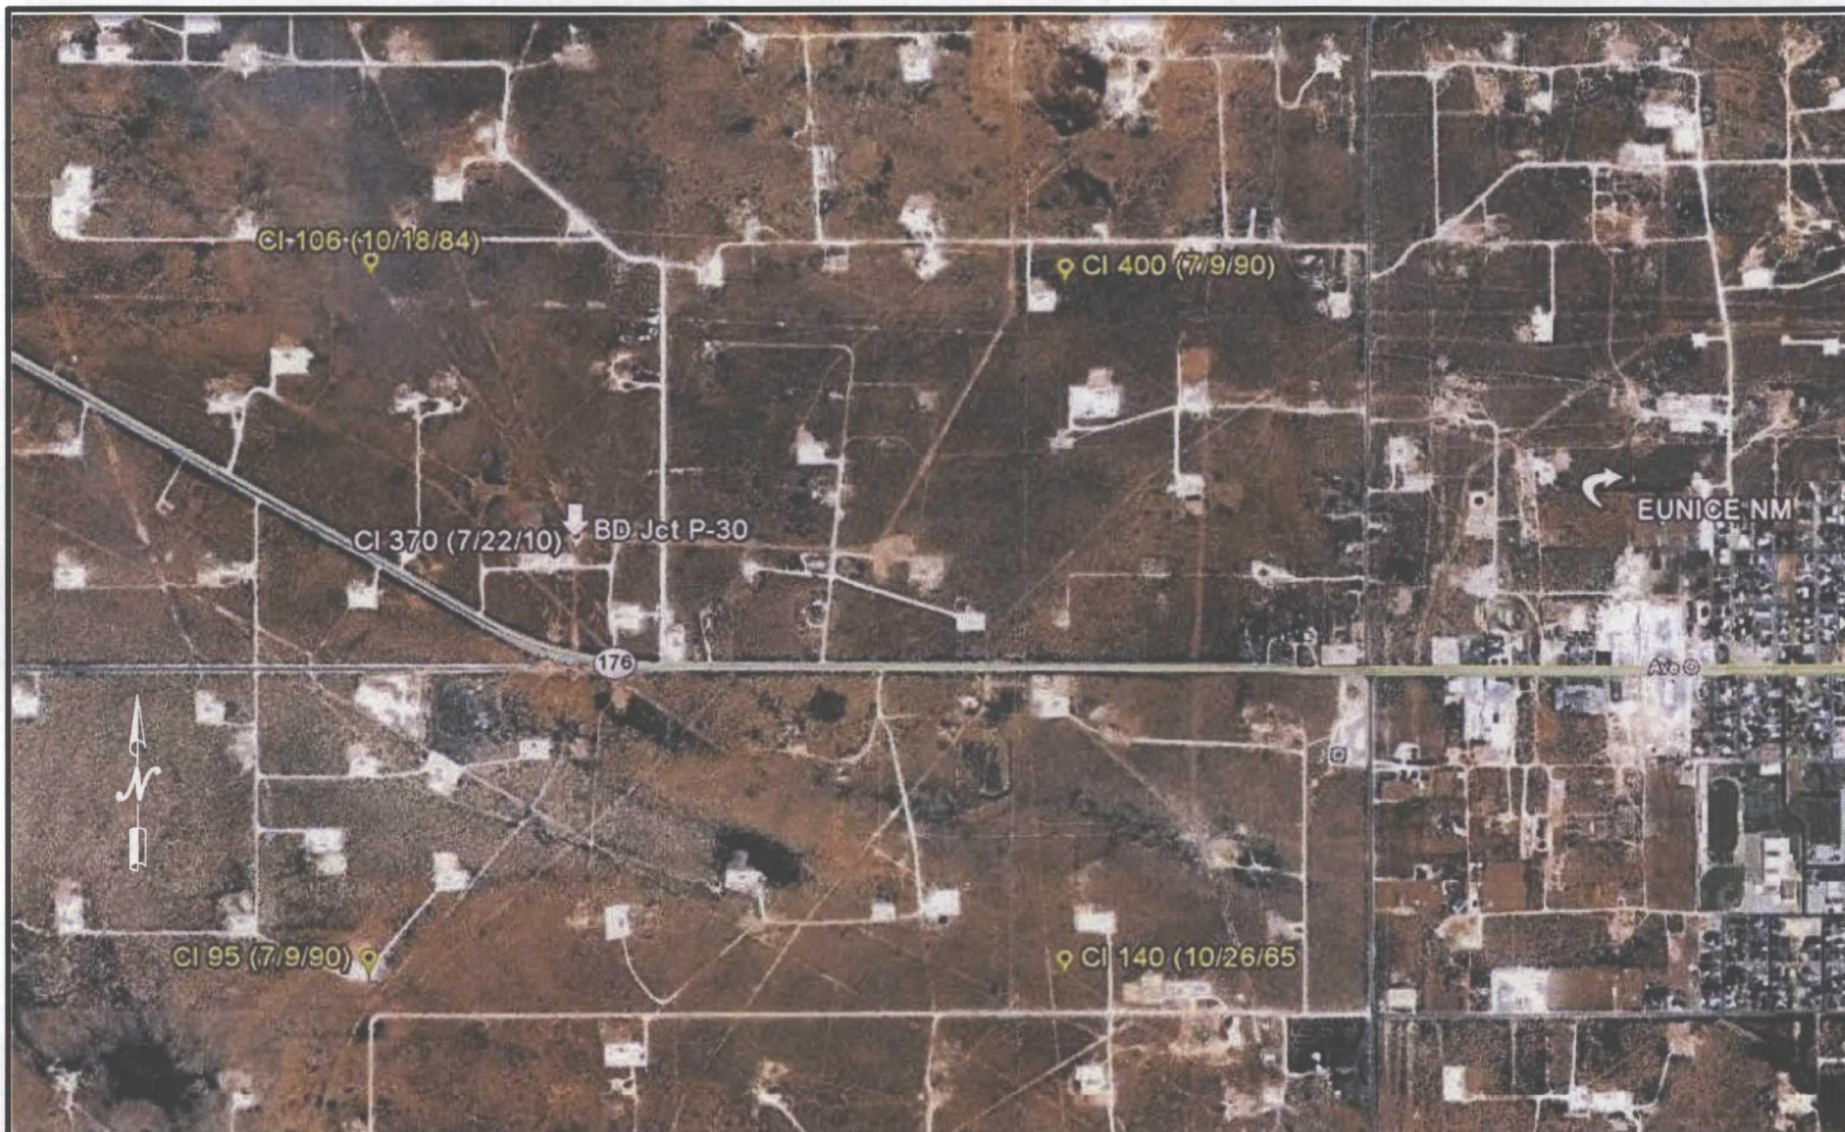
BD Jct. P-30 Site
T21S - R37E - Section 30, Unit P
RICE *Operating Company*

Chloride concentrations in each well identified in Table 3 above and in Figure 1 are representative of background conditions. The nearest water well is located approximately 2,500 ft northwest of the site and is not a concern due to its upgradient location. The closest downgradient well from the site is located almost a mile (5,000 ft) southeast and is not a concern due to its long distance from the site. The remaining wells can not be affected by any activity at the site due to their distant cross-gradient locations and the prevailing southeast trending groundwater gradient direction.
