From: Hansen, Edward J., EMNRD
Sent: Monday, July 30, 2012 4:49 PM
To: Hack Conder (hconder@riceswd.com)
Cc: Leking, Geoffrey R, EMNRD; Laura Pena (lpena@riceswd.com); Scott Curtis (scurtis@riceswd.com)
Subject: Remediation Plan (1R425-94) Termination - ROC Vacuum E-31 EOL Site

RE: Termination Request
Vacuum E-31 EOL (1R425-94): UL/E, Sec. 31, T17S, R35E
RICE Operating Company – Vacuum SWD System

RICE OPERATING COMPANY
JUNCTION BOX FINAL REPORT

Vacuum E-31 EOL

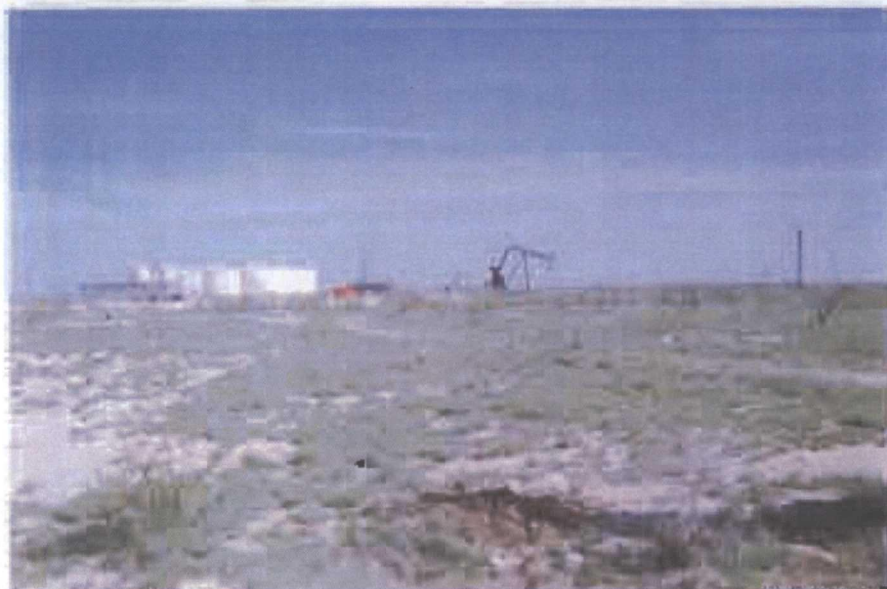
Site prior to delineation

4/27/2010

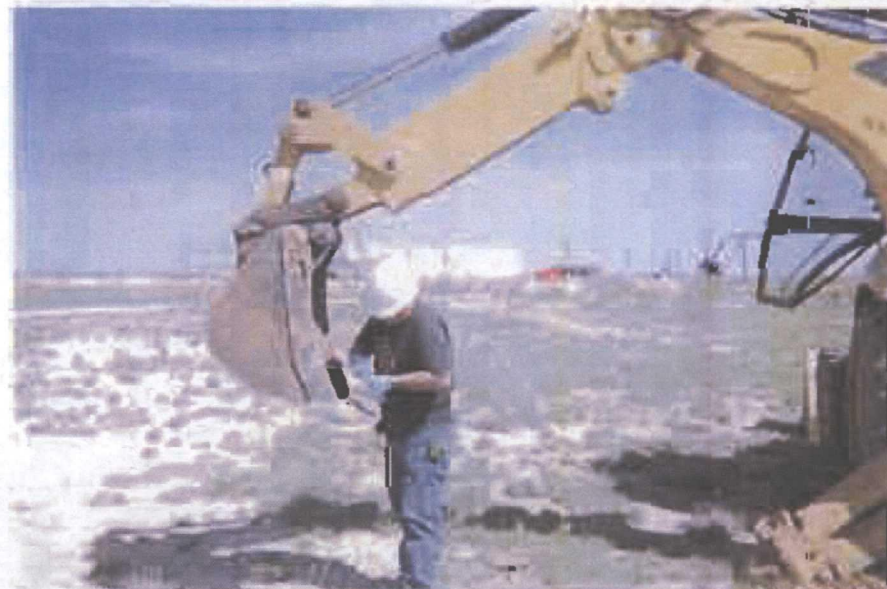
Collecting Sample

4/27/2010

investigation was conducted using a backhoe to collect soil sample at regular intervals

creating a 7x3x5-ft deep excavation. Each sample was field tested for chlorides and

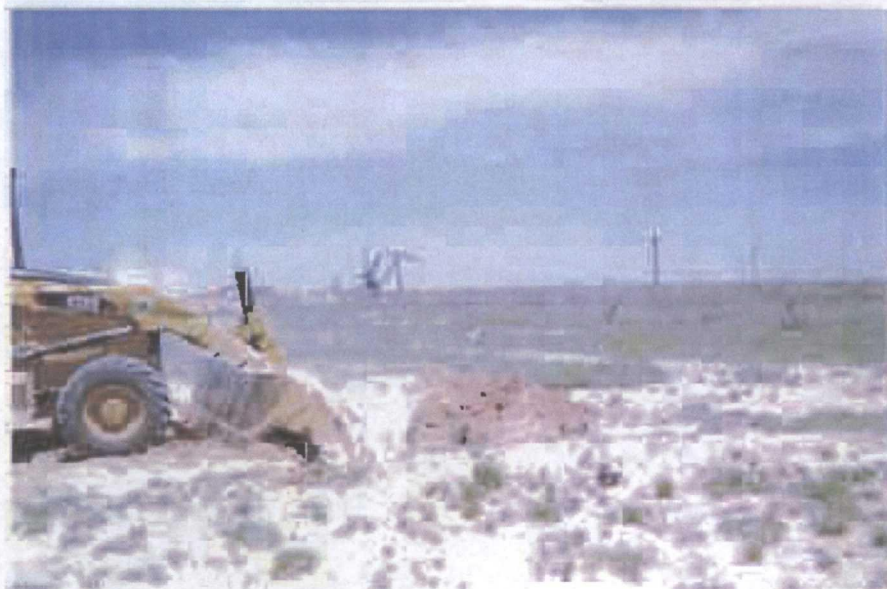
Backfilling excavation

4/27/2010

The excavated soil was return to the excavation to ground surface and contoured to the surrounding area. On 5/21/2010, the site was

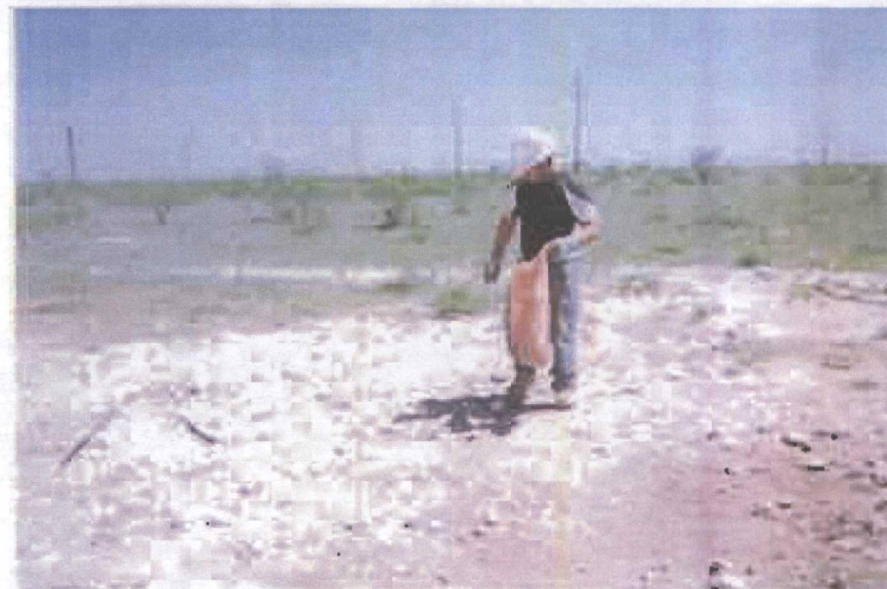
Seeding excavation

5/21/2010

seeded with a blend of native vegetation and is expected to return to a productive capacity at a normal rate.
