REPORTS

**RE: CAP Report for Groundwater and Termination Request
Rice Operating Company – EME SWD System
EME Jct. K-8-1 (1R427-316): UL/K sec. 8 T20S R37E
(formerly EME Jct. N-8-1)**

Plugging Report

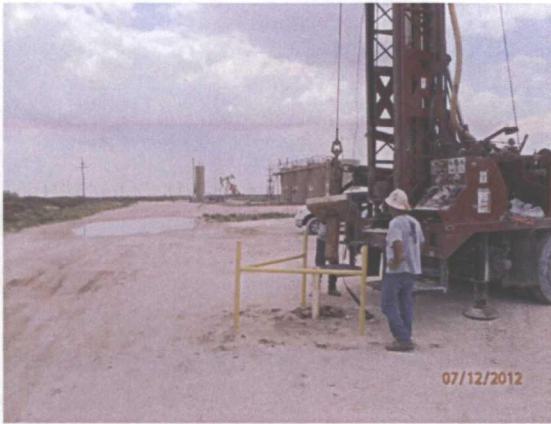
Pulling MW-1, facing south

MW-1, the near source well, was plugged and abandoned with a 1-3% bentonite/concrete slurry and a three foot concrete cap on July 12th, 2012 (Appendix C). MW-2, the up gradient monitor well, remains in place to monitor the regional impact and will be sampled on a yearly basis.

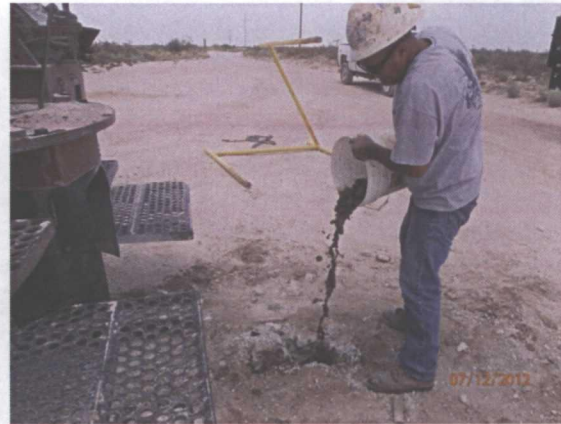
Pouring the 1-3% bentonite/concrete slurry into
bore hole, facing north

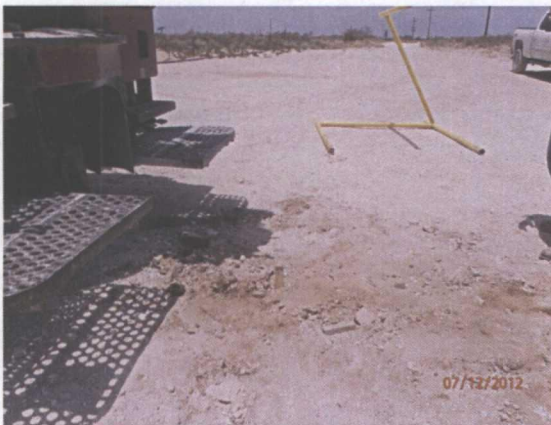
Completed P&A of MW-1, facing north

Client	Rice Operating
Contractor	Harrison & Cooper
Date Completed	7/12/2012
Site	EME Jct. K-8-1
Well ID	MW-1
Casing Diameter	4"
Well Depth	64'
Casing Material	PVC
Plugging Material	Portland/Bentonite Slurry
Slurry Interval	3'-64'
Cement Interval	0'-3'
