**RE: ICP Report and Termination Request**

**Rice Operating Company – EME SWD System**

**EME Jct. P-24 (1R427-287): UL/P sec. 24 T19S R36E**

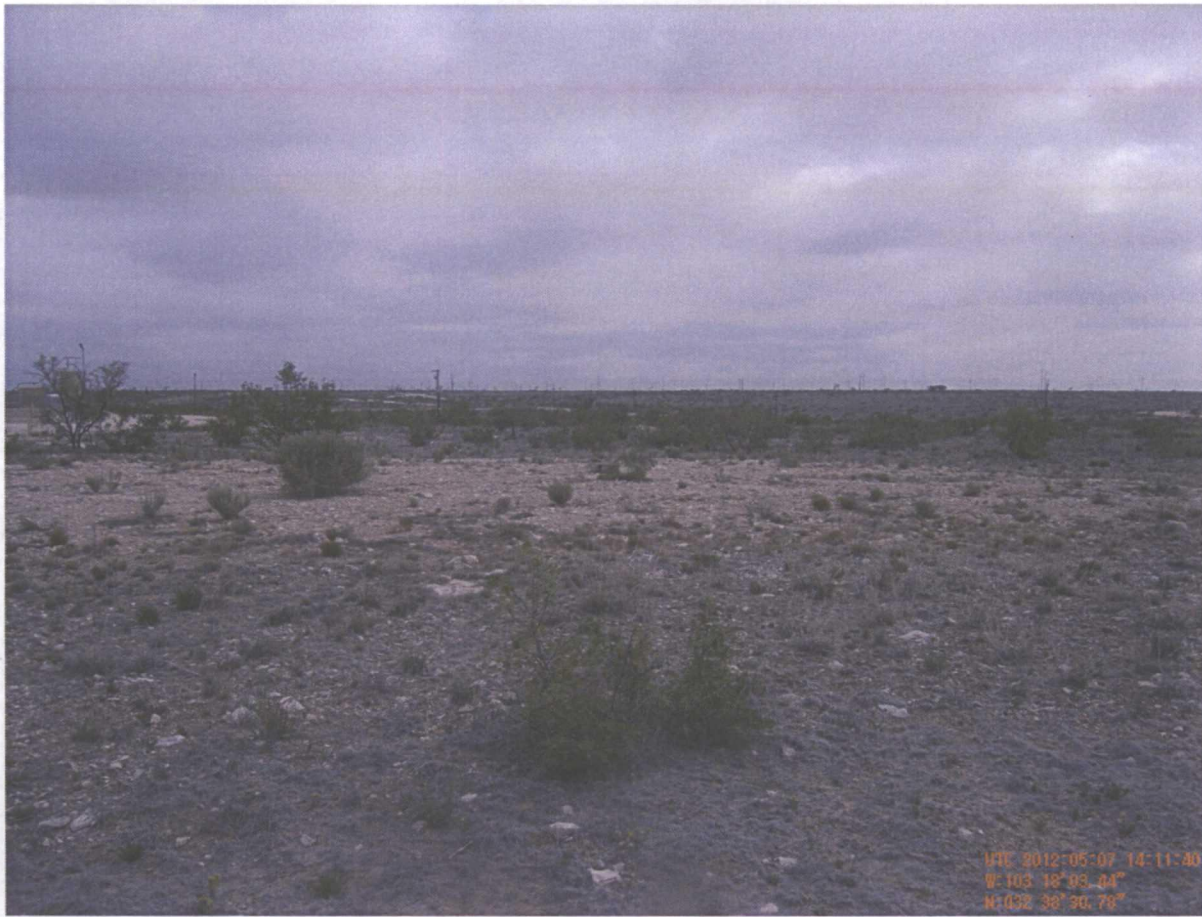
Site investigation activities proved that chlorides and hydrocarbons are not constituents of concern at the site and will in no way affect groundwater beneath the site. As observed in the site photos (Appendix B), the site has returned to normal vegetative capacity. Since the soil investigation showed low levels of chlorides and hydrocarbons at the site and the site has returned to normal vegetative capacity, RECS requests 'remediation termination' status of the regulatory file.

Site photo toward center, facing north
