. . 2RP-616 SITE INFORMATION Report Type: CLOSURE General Site Information: Site: Birch Keely Unit #196 Well Site COG Operating LLC Company: Section, Township and Range Sec 25 T17S R29E Unit P Lease Number: API-30-015-24976 County: **Eddy County** GPS: 32.80003° N 104.02646° W Surface Owner: Federal Mineral Owner: From the intersection of CR 217 and Hwy 82 travel west of Hwy 82 for 1.8 miles, turn left onto Directions: lease road and travel 1.3 miles, turn right and travel 0.3 miles to site. Release Data: Date Released: 2/6/2011 Type Release: Produced Water Source of Contamination: Steel Flowline Fluid Released: 20 bbls Fluids Recovered: 18 bbls Official Communication: Name: Pat Ellis Ike Tavarez Company: COG Operating, LLC Tetra Tech Address: 550 W. Texas Ave. Ste. 1300 1910 N. Big Spring P.O. Box City: Midland Texas, 79701 Midland, Texas Phone number: (432) 686-3023 (432) 682-4559 Fax: (432) 684-7137 pellis@conchoresources.com Email: ike.tavarez@tetratech.com

Re: Closure Report for the COG Operating LLC., Birch Keely Unit #196 Well Site, Unit P, Section 25, Township 17 South, Range 29 East, Eddy County, New Mexico.

Table 1
COG Operating LLC.
BIRCH KEELY UNIT #196
EDDY COUNTY, N

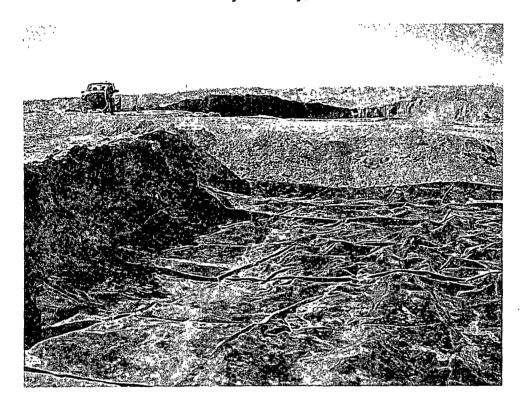
1. View of Excavation and liner Installation

As requested by the BLM, confirmation samples were collected from the excavation bottom holes and sidewalls. During the excavation, the area of AH-3 (SB-3) was not sampled due to a plastic liner noted on the north wall of the excavation, which appeared to be the edge of a closed reserve pit. The confirmation samples results are shown in Table 1. Once excavated to the appropriate depths, the excavations were backfilled with clean soil to grade.

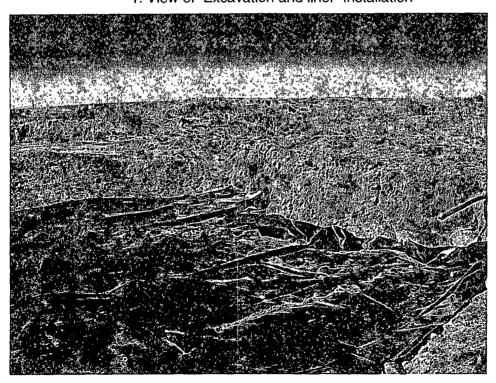
2. View of Excavation and Liner installation
