**RE: CAP Report and Termination Request  
Rice Operating Company – BD SWD System  
BD Jct. G-23 (1R426-286): UL/G sec. 23 T22S R37E**

## **Corrective Action Plan Report**

## BD Jct. G-23 (1R426-286)

Unit G, Section 23, T22S, R37E

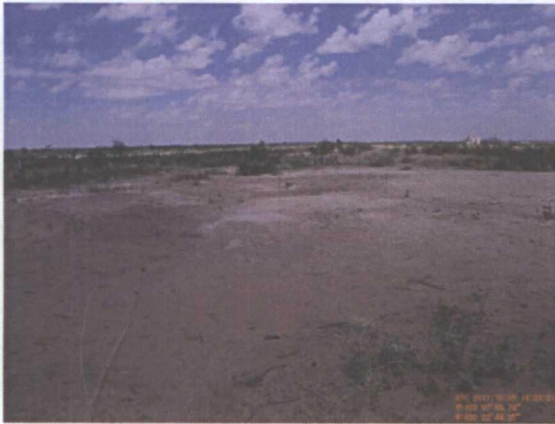
Site prior to scraping, facing north 10/5/2011

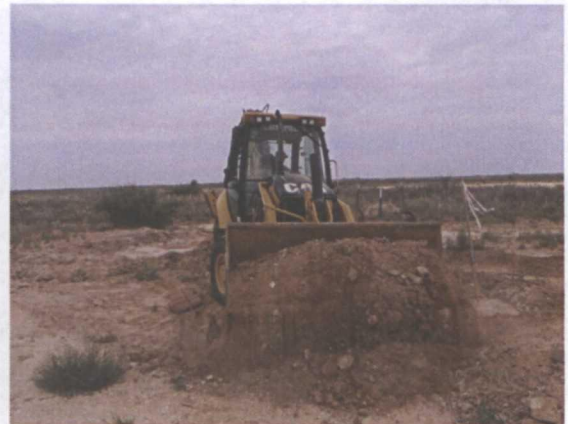
Scraping site, facing south 7/16/2012

On July 16<sup>th</sup>, 2012, RECS personnel were on site to begin scraping the site down 1 foot deep to remove all rock and break up the soil for seeding. A total of 288 yards of scraped soil was disposed of at a NMOCD approved facility. A total of 300 yards of clean soil was imported to the site to serve as backfill material. The site was backfilled, contoured to the surrounding location, and seeded with a blend of native vegetation (Appendix A).

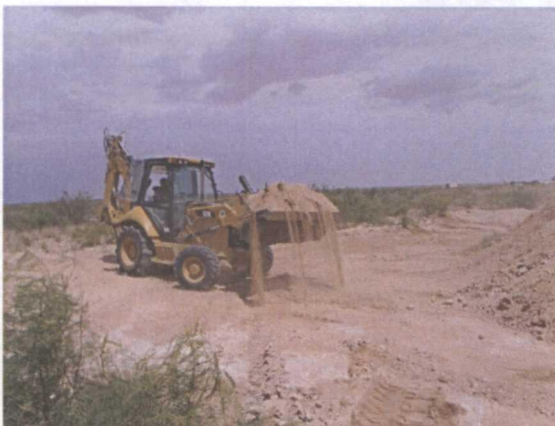
Exporting soil, facing east 7/16/2012

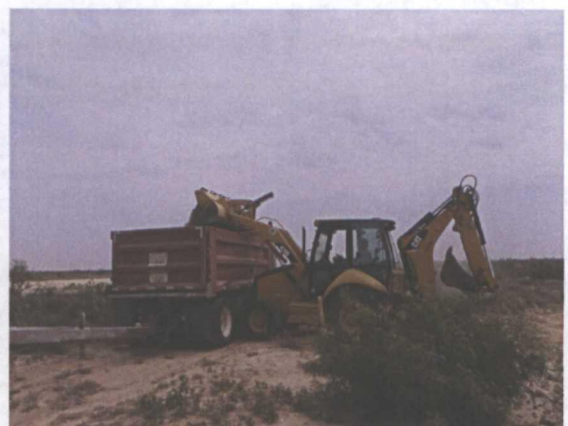
Exporting soil, facing north 7/16/2012

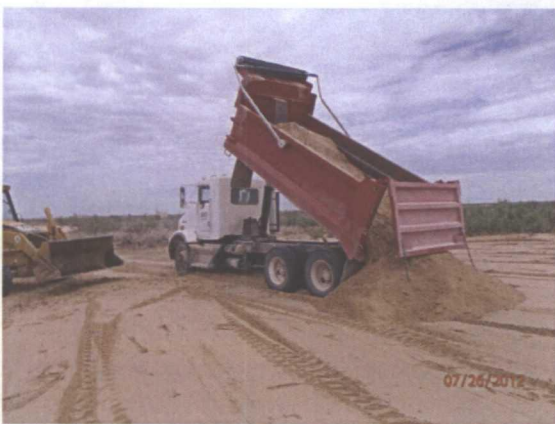
Importing soil, facing north 7/26/2012

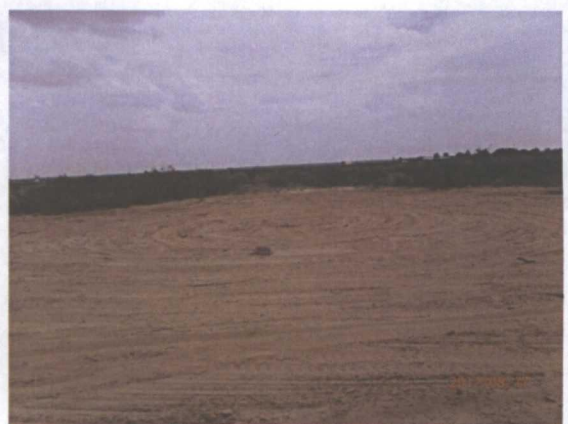
Site seeded and tilled, facing east 8/17/2012

The site has been scraped and seeded and is expected to return to normal vegetative capacity. Since ROC has completed the corrective actions as approved by NMOCD in the CAP, ROC requests 'remediation termination' status of the regulatory file.
