**Excavation Summary and Soil Closure Request  
Blinebry-Drinkard (BD) N-32 vent  
Unit N, SEC. 32, T21S, R37E, Eunice, Lea County, New Mexico  
NMOCD CASE # 1R426-153**

# Installed Infiltration Barrier

BD N-32 Vent (1R426-153)  
Unit Letter N, Section 32, T21S, R37E

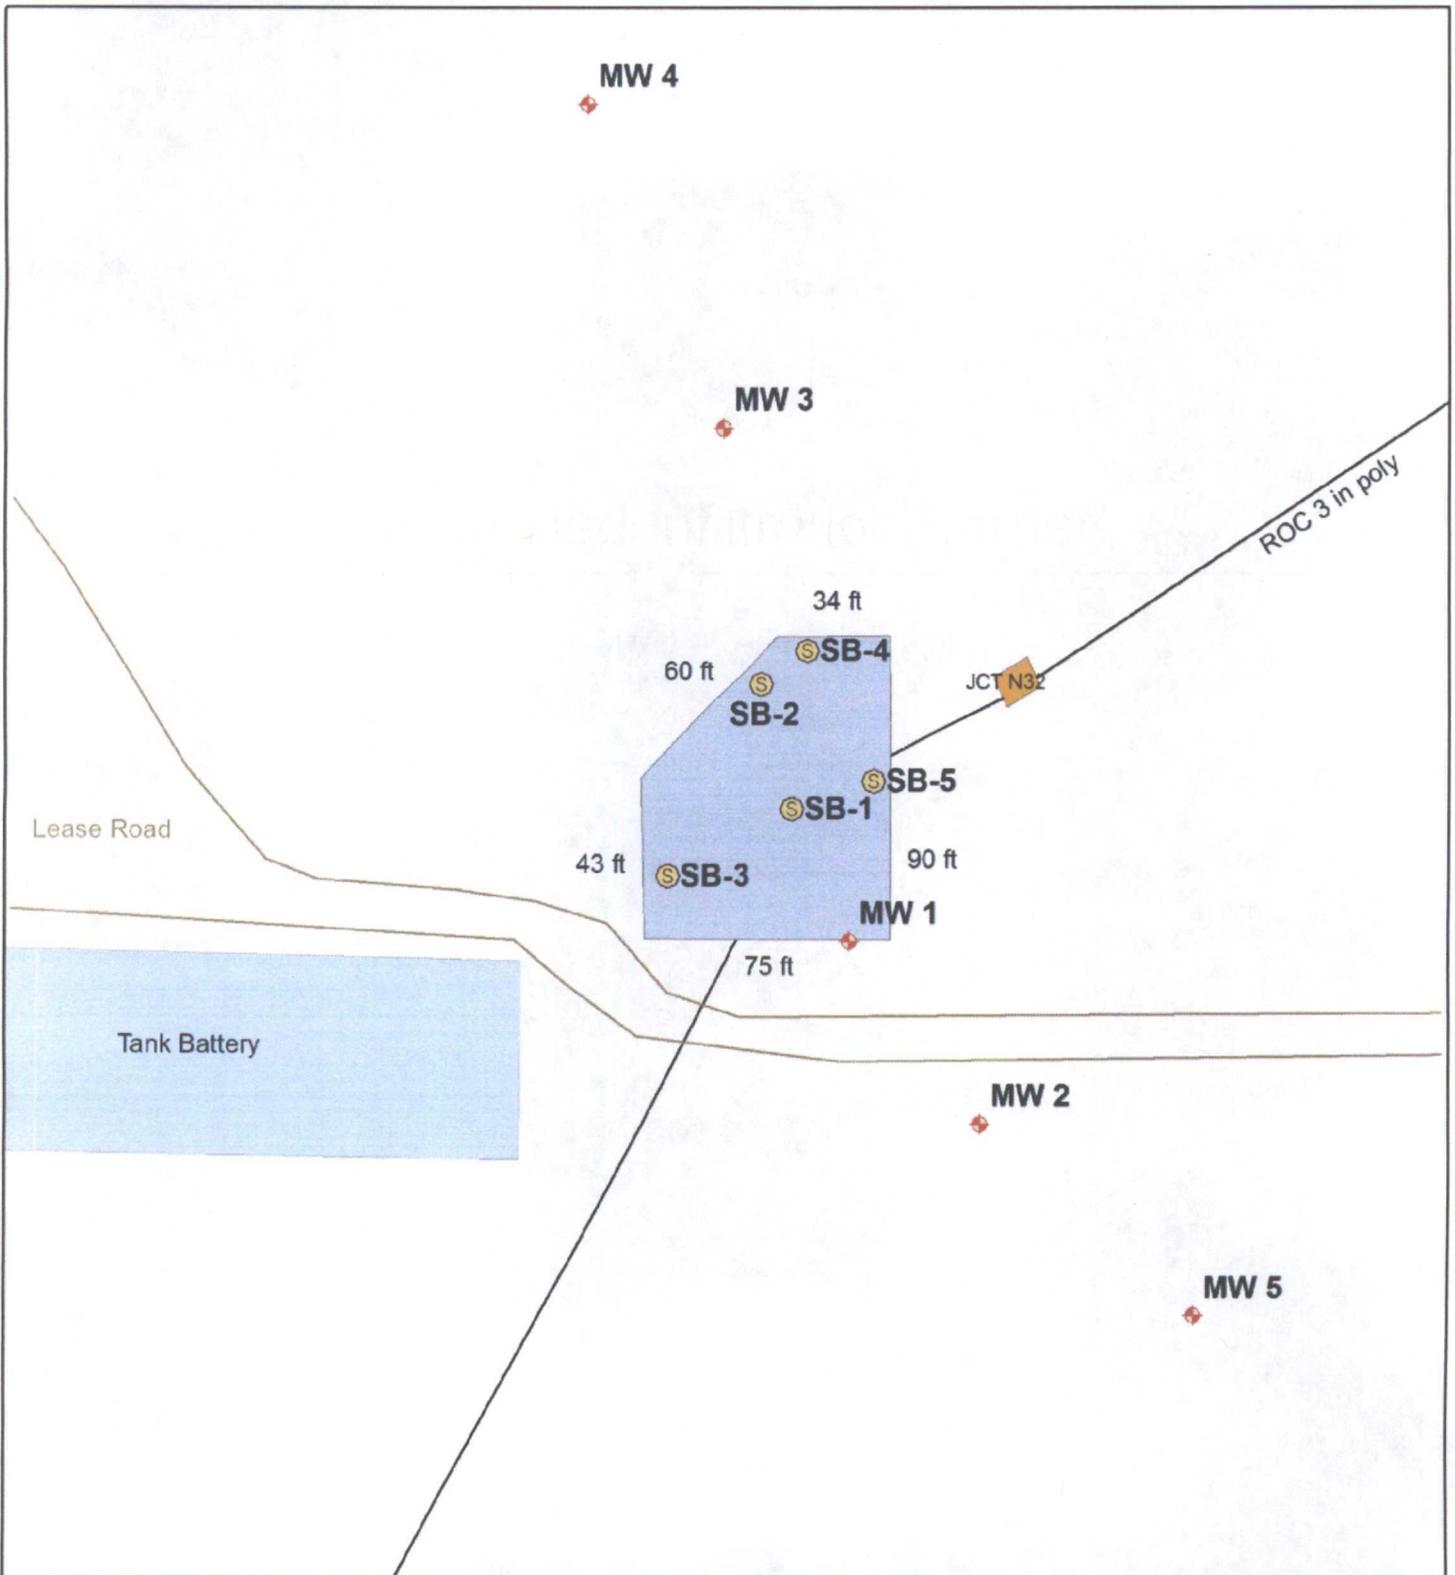
***BD N-32 vent***

Legals: UL/N sec. 32  
 T21S R37E  
 NMOCD Case #: 1R426-153

Beginning May 18, 2012, the site was excavated to dimensions of 75 ft x 90 ft x 25 ft bgs. Approximately 6,680 yards of the excavated soil was disposed of at a NMOCD approved facility. Soil was scraped from the surface of the site location to use as a sand pad below and above the liner to protect it from punctures. The blowsand was field tested with a PID meter and returned a result of 0.1 ppm. The sample was then sent to a commercial laboratory for analysis of chloride, which resulted in a concentration of 32 mg/kg. The excavation was padded with six inches of the blowsand and the 20-mil reinforced poly liner was installed and properly seated in the bottom of the excavation on July 2, 2012. Clean soil was imported and used to pad

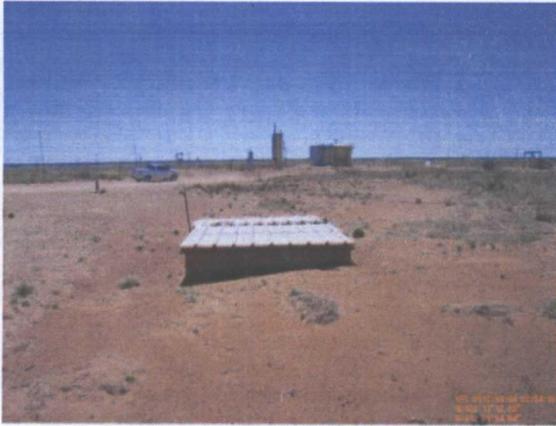
Site prior to excavation, facing southwest  
4/4/2012

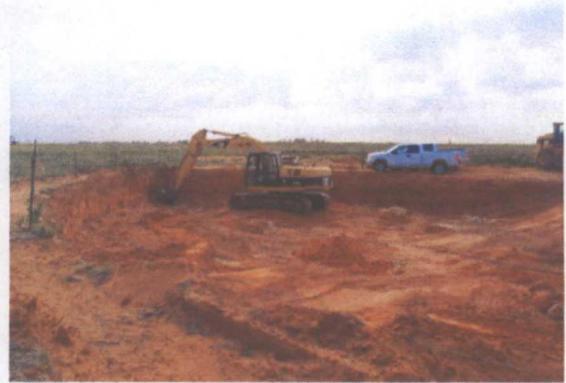
Excavating site, facing northeast 6/5/2012

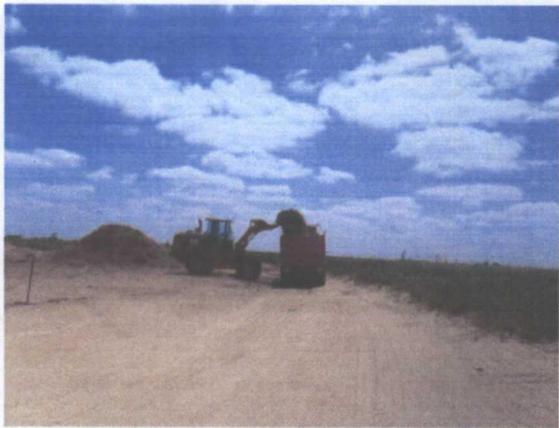
Exporting soil, facing east 6/8/2012

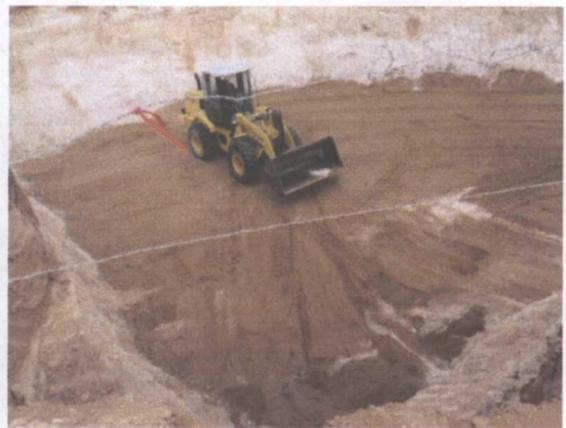
Installing 6" bottom sand pad, facing west  
7/2/2012

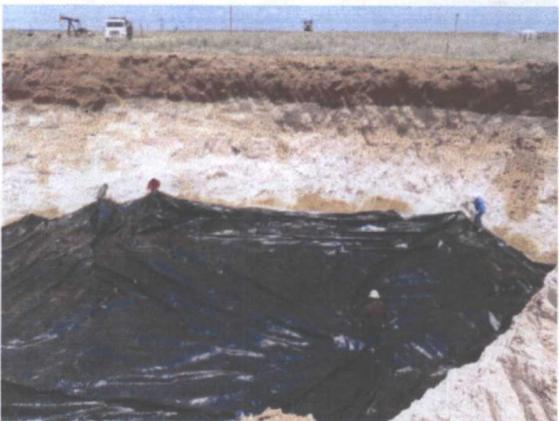
Installing 75' x 90' 20-mil reinforced liner  
at 25' bgs, facing west 7/2/2012

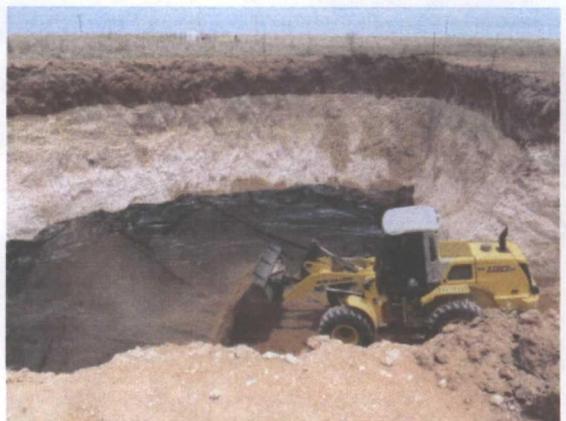
Installing 6" sand pad above liner, facing  
north 7/2/2012

six inches above the liner and to backfill the excavation up to 20 ft bgs. The imported topsoil was field tested with a PID meter, resulting in a concentration 0.3 ppm. The sample was then sent to a commercial laboratory for analysis of chloride, resulting in a chloride concentration below detectable limits (<16 mg/kg). The excavation was backfilled with caliche from 20 ft bgs to 5 ft bgs. The remaining 5 ft of the excavation was backfilled with imported topsoil. A sample was sent to a commercial laboratory for analysis of chlorides, yielding a chloride concentration below detectable limits (<16 mg/kg). The area was contoured to the surrounding area and seeded with a blend of native vegetative and is expected to return to a normal vegetative capacity. Silt net fencing was installed around the excavation to help keep the seed in place. Photo documentation and laboratory analysis of these activities are attached.

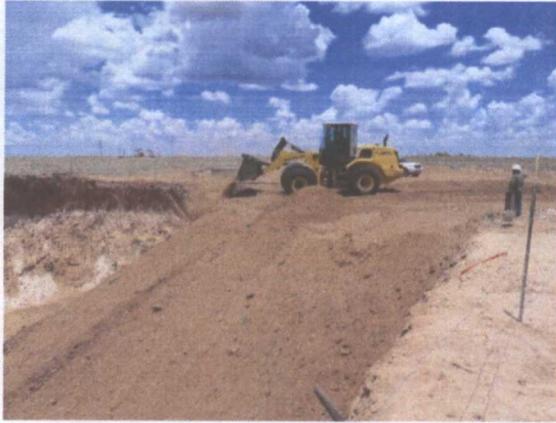
Backfilling with imported topsoil, facing east  
7/5/2012

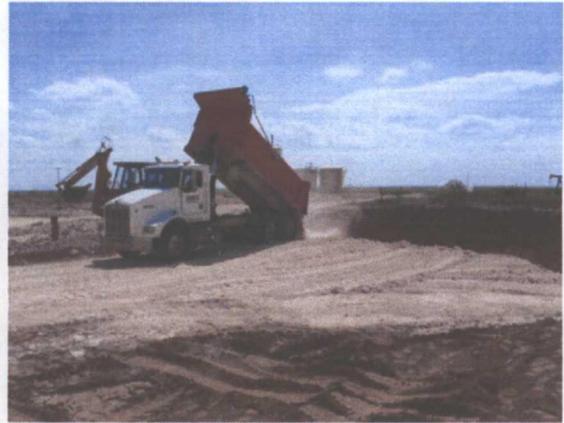
Backfilling with caliche, facing south  
7/9/2012

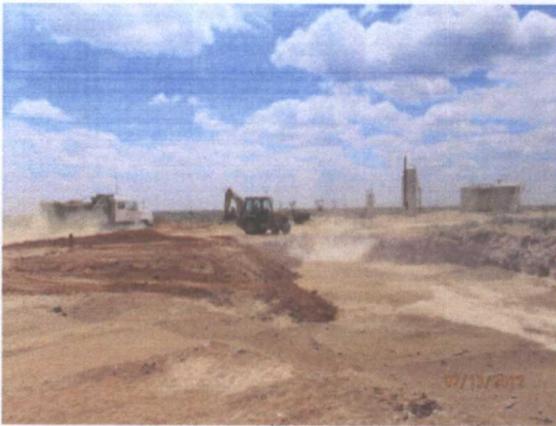
Installing topsoil above caliche, facing southwest  
7/13/2012

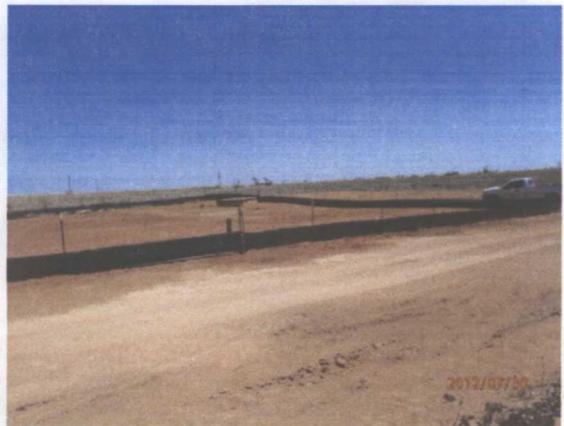
Silt net fence installed, facing north  
7/30/2012

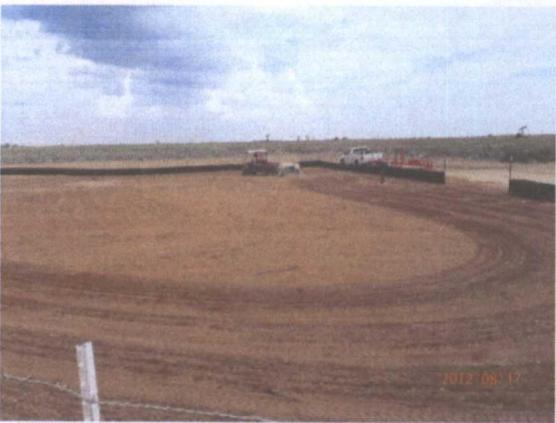
Tilling and seeding, facing east  
8/17/2012

Custom seed mix <input checked="" type="checkbox"/>	Prescribed mix <input type="checkbox"/>	Seed mix name: 2.5 lbs side oats 2.5 lbs blue grama	Seeding date: 8/17/12
Broadcast <input checked="" type="checkbox"/>			
Method: Mechanical Spreader			
Soil conditions during seeding: Dry <input checked="" type="checkbox"/> Damp <input type="checkbox"/> Wet <input type="checkbox"/>			
Photos attached <input type="checkbox"/>	Observations: Seed was tilled into the soil.		
Number of photos:

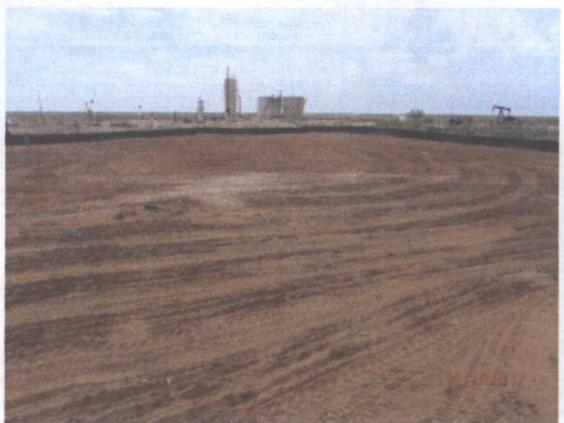
Site complete, facing southwest  
8/17/2012
