STAGE 2 REPORT

Re: Stage 2 Abatement Plan Completion and Termination Request, Rice Operating Company, Justis Saltwater Disposal System (SWD) L-1 Boot, Unit L, Section 1, T-25-S, R-37-E, Lea County, New Mexico, NMOCD CASE #1R0423-0 (AP-48)

**Justis L-1 boot (AP-48)
Unit L, Section 1, T25S, R37E**

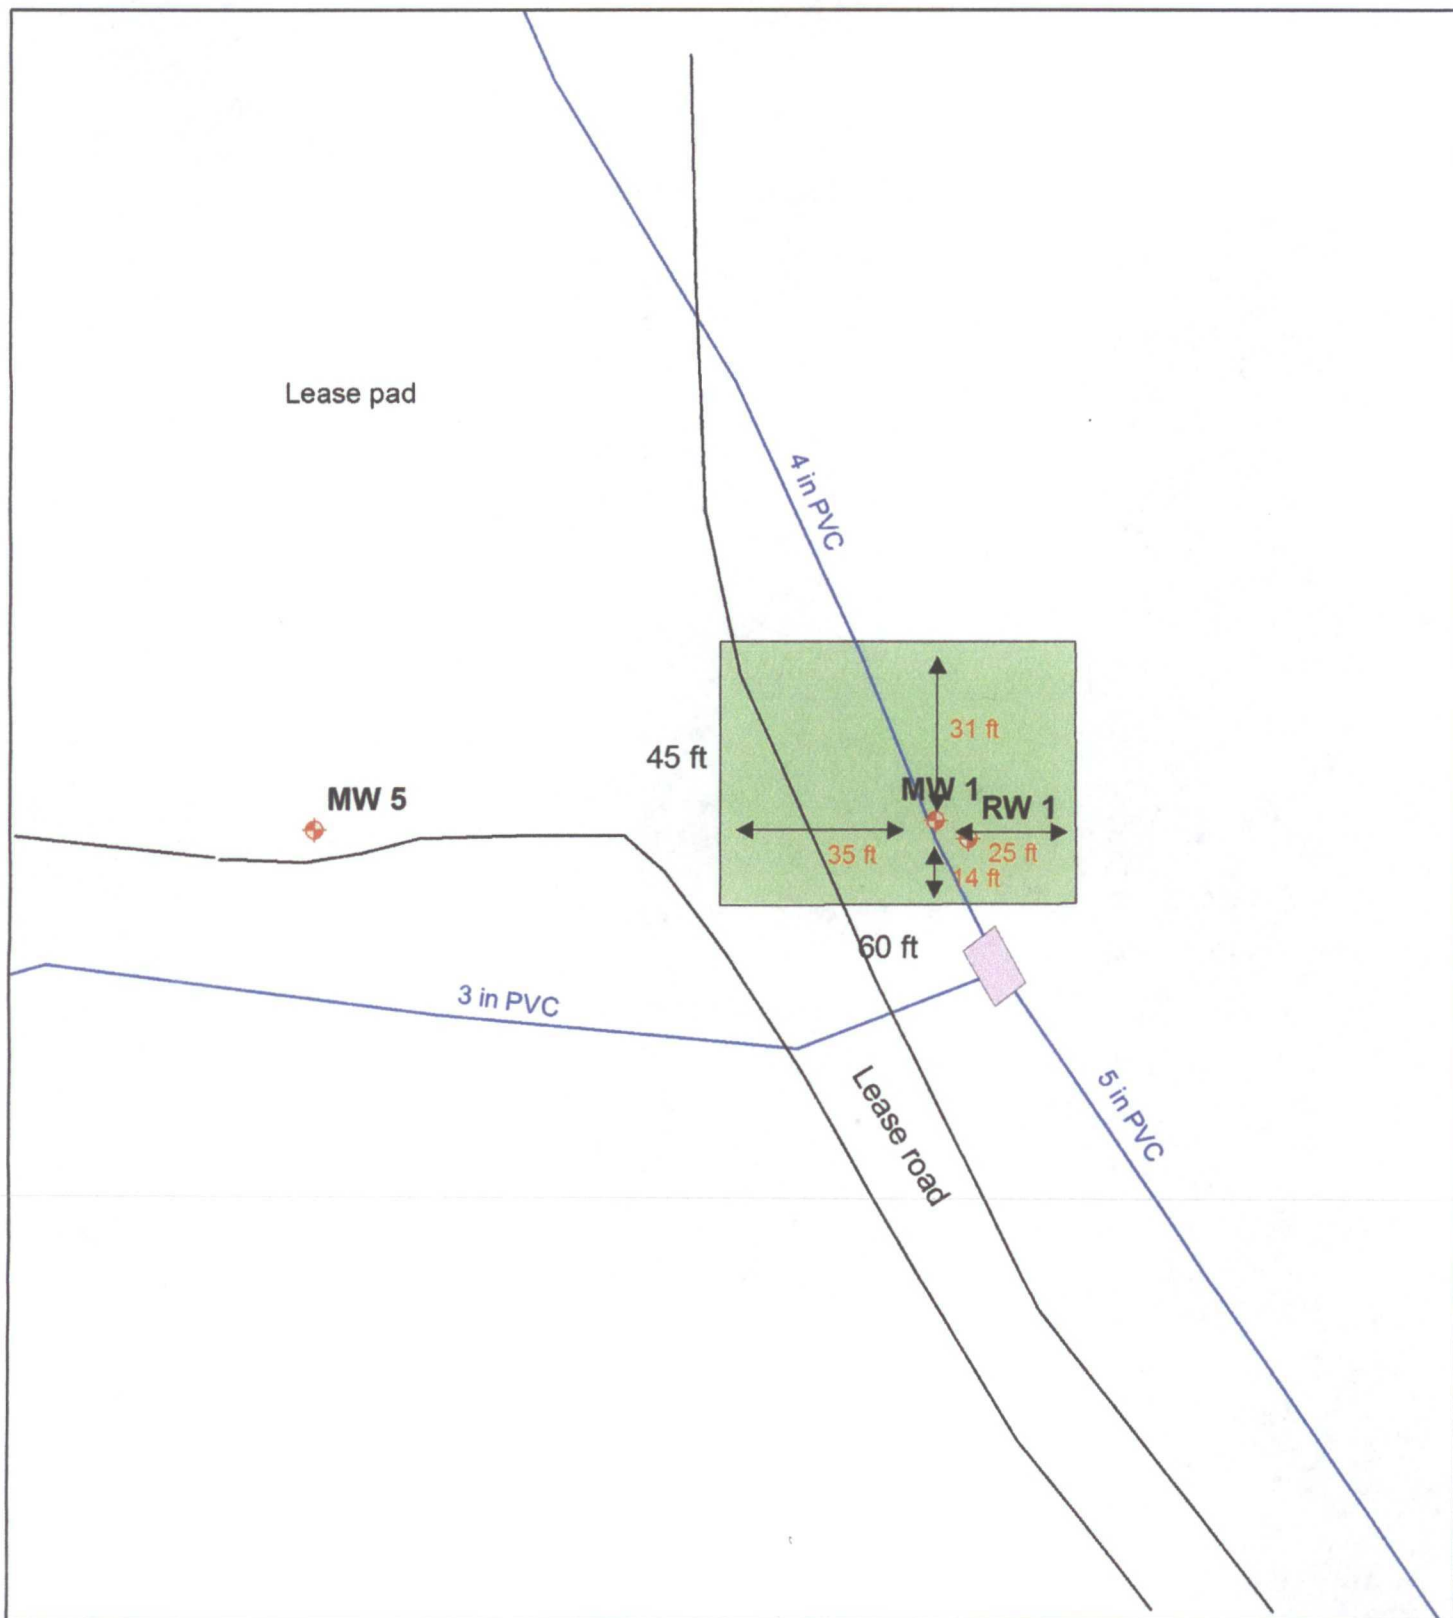
Figure 4

Installed Liner

Between August 1 and August 27, 2011, the site was excavated to dimensions of 45 feet by 60 feet by 5 feet deep. See attached photographs. Clean, imported soil was used as a 6 inch pad in the bottom of the excavation. Laboratory analysis of the imported soil resulted in a chloride concentration below detectable limits (<16 mg/kg) and a field PID measurement of 0.2 ppm. The 20-mil polyethylene liner was properly seated in the bottom of the excavation and a 6 inch pad was placed above the liner. Laboratory analysis of the imported soil resulted in a chloride concentration below

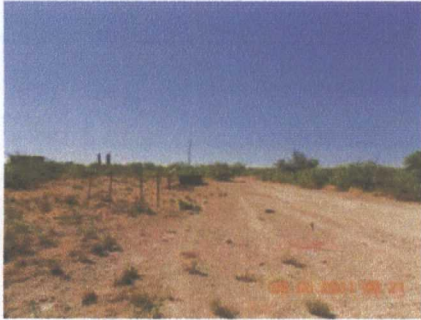
site prior to excavating, facing south 8.5.11

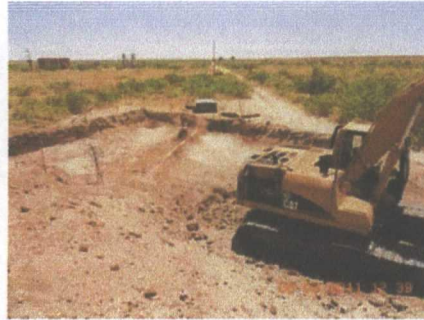
excavating the site, facing southeast 8.9.11

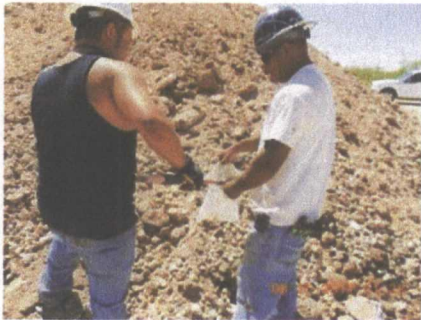
collecting a soil sample 8.15.11

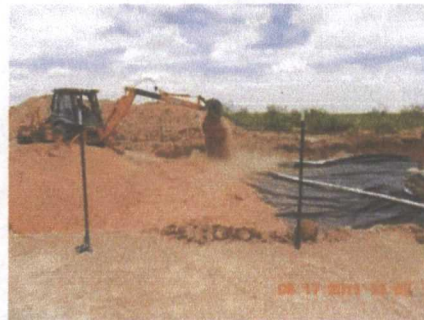
importing sand for 6" pad above liner, facing west 8.17.11

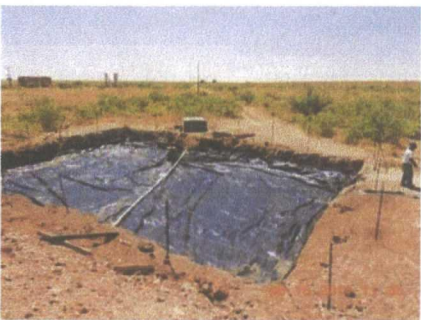
20-mil reinforced liner installed, facing southeast 8.15.11

On October 4, 2010, ROC submitted a Stage 2 Abatement Plan Addendum to the NMOCD. The addendum proposed installing a 20-mil polyethylene liner in order to impede vertical migration of chlorides in the soil near the initial junction box. In addition, the addendum included the installation of a recovery well with plans to remove 434 kilograms (kg) of chloride mass or approximately 60,385 gallons of chloride impacted groundwater from the well. Removed groundwater would be utilized for pipeline and well maintenance. A subsequent Addendum proposing a 45 foot by 60 foot, 20-mil polyethylene liner be installed at 4 feet bgs was submitted to the NMOCD on December 22, 2010. See Figure 4 for liner dimensions. The NMOCD approved the Stage 2 Abatement Plan Addendum and subsequent Addendum in an email dated December 27, 2010.

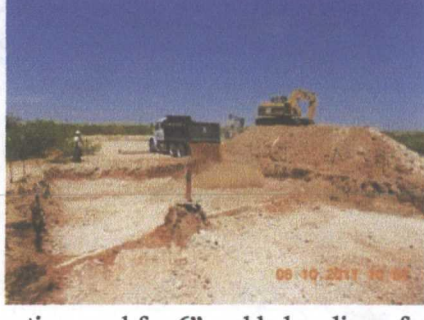
importing sand for 6" pad below liner, facing northwest 8.10.11

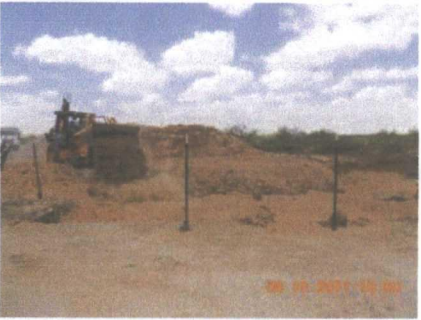
backfilling site with blended backfill, facing north 8.18.11

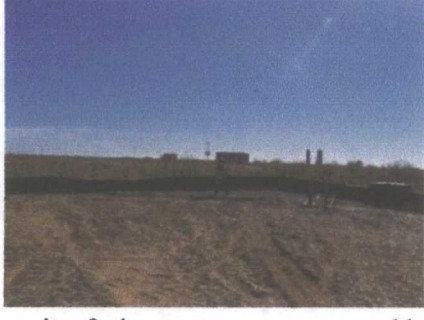
seeding site, facing east 11.18.11
