RE: **Corrective Action Plan (CAP) Report & Termination Request**
Rice Operating Company – Vacuum SWD System
Vacuum Jct N-28-1: UL/N, Sec. 28, T17S, R35E (formerly Vacuum Jct K-28-1)
NMOCD Case Number: 1R425-87

Vacuum N-28 Vent (1R425-85) and Vacuum Jct. N-28-1 (1R425-87)
Unit Letter N, Section 28, T17S, R35E

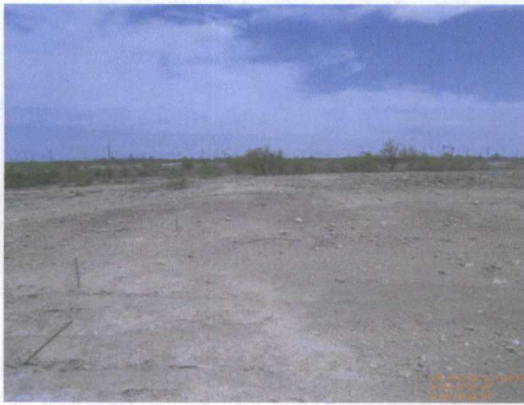
Sites prior to excavation, facing south-southwest
7/31/2012

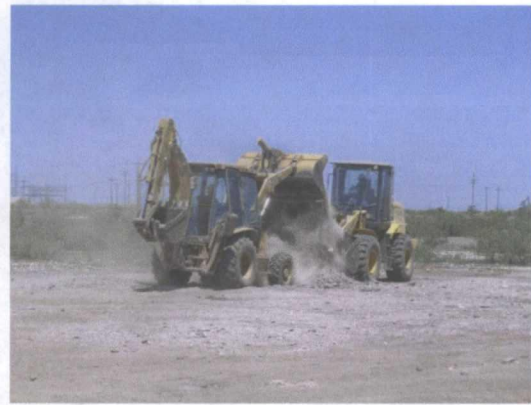
Screening rock, facing northeast 8/10/2012

- The excavated soil was screened to remove large rocks and the soil was properly disposed of at a NMOCD approved facility.
- The large rocks were returned to the excavation and the site was then backfilled and contoured to the surrounding area with clean, imported soil. The site was then seeded with a blend of native vegetation.

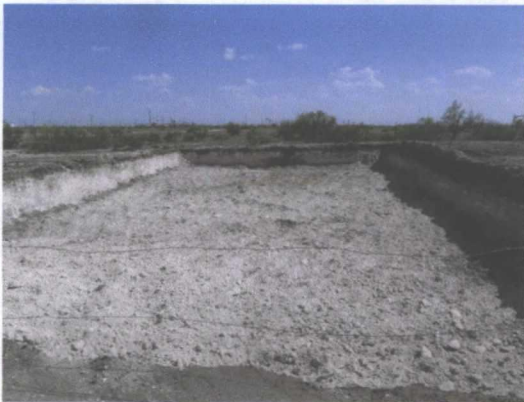
Completed excavation, facing south 8/10/2012

- Excavated the area encompassed by the soil borings (48 ft by 96 ft) to a depth of approximately 5 ft bgs. Due to the close proximity between this and the ROC Vacuum N-28 vent junction box, the excavation and liner encompassed the affected areas of both former boxes (See attached plat).

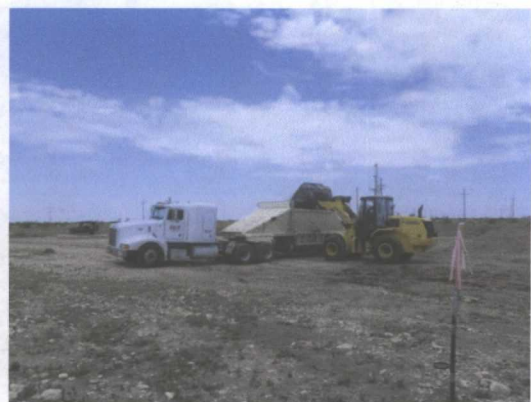
Exporting spoil pile, facing west 8/13/2012

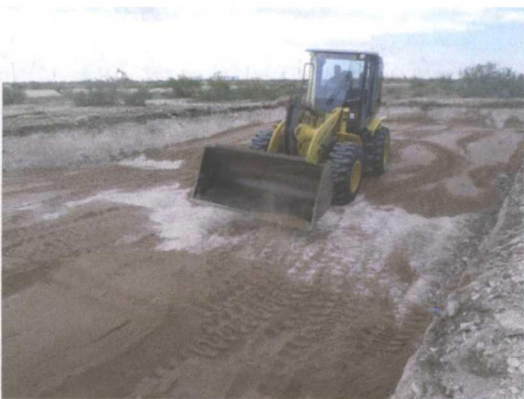
Installing 6" bottom sand pad, facing south
8/15/2012

- Clean blow sand was imported placed in the bottom of the excavation creating a 6 inch blow sand layer. The imported blow sand was utilized for the three N-28 sites (N-28 vent, Jct. N-28-1, and N-28-2 vent). A sample of the imported soil returned a field PID result of 1.4 ppm, a laboratory chloride result below detectable limit (<16 mg/kg) and a laboratory TPH result below detectable limit (<10 mg/kg DRO and GRO). A 48 ft by 96 ft, 20-mil, reinforced poly liner was installed and properly seated above a 6 inch pad, and a 6 inch layer of blow sand was placed above the liner.

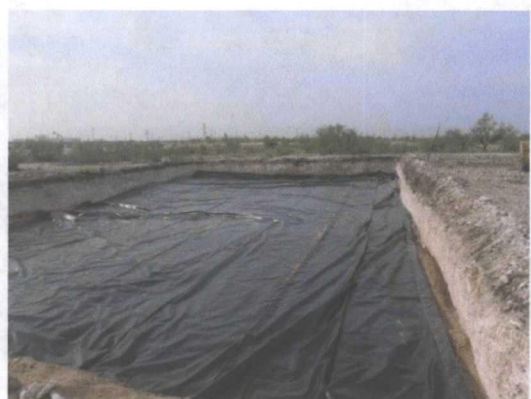
Installed 48' x 96', 20-mil reinforced plastic
liner at 5' bgs, facing south 8/17/2012

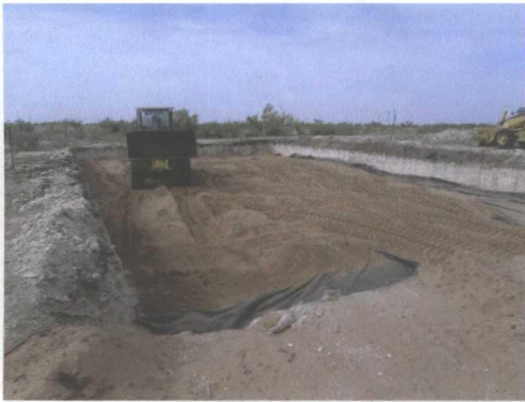
Installing 1' sand lift above liner, facing south
8/17/2012

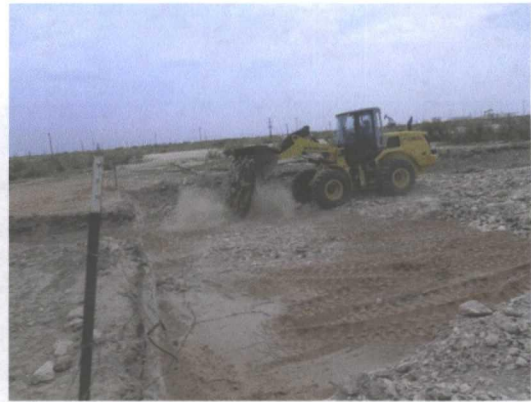
Returning rock to 2' bgs, facing east 8/17/2012

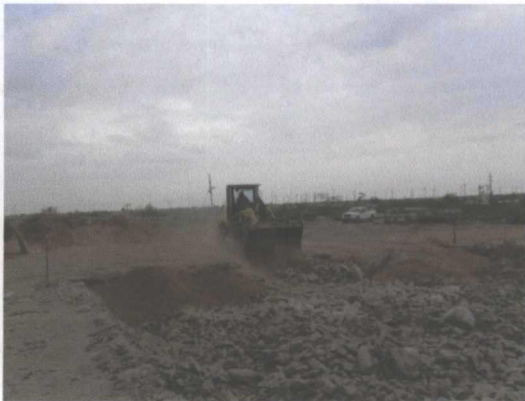
Backfilling with topsoil from 2' bgs, facing
north 8/17/2012

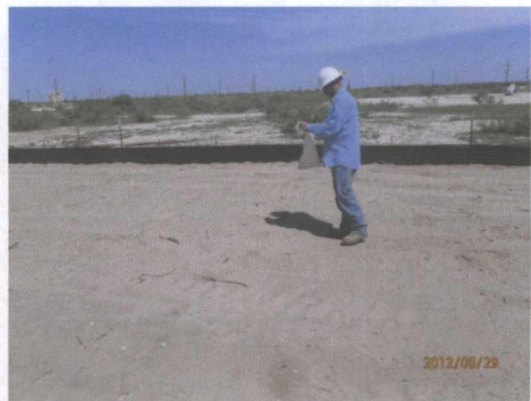
Seeding site, facing east 8/29/2012

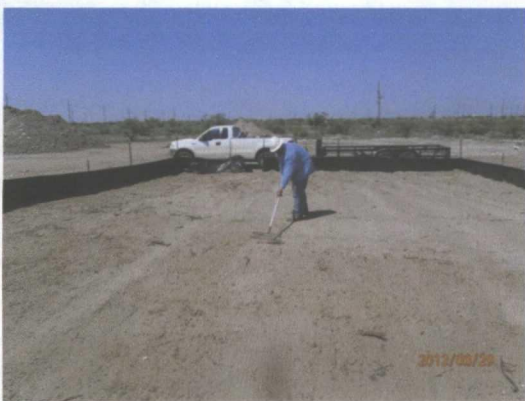
Raking seed, facing north 8/29/2012

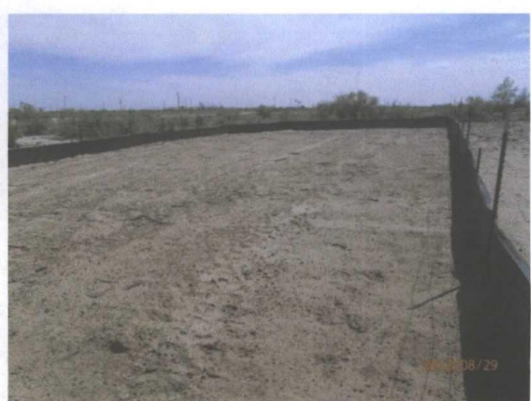
Site complete, facing south 8/29/2012
