RE: Corrective Action Plan (CAP) Report & Termination Request
Rice Operating Company – Vacuum SWD System
Vacuum N-28-2 vent (Formerly Vacuum K-28-2 vent)
NMOCD Case Number: 1R425-86. UL/N, Sec. 28, T17S, R35E

Rice Operating Company - Vacuum N-28-2 Vent

Figure 6

**Vacuum N-28-2 vent
Unit N, Section 28, T17S, R35E**

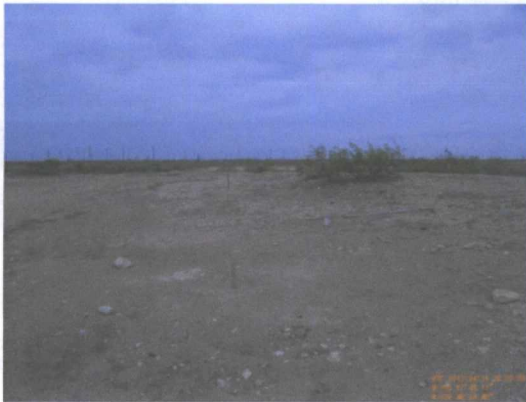
site prior to excavation, facing east
4/19/2012

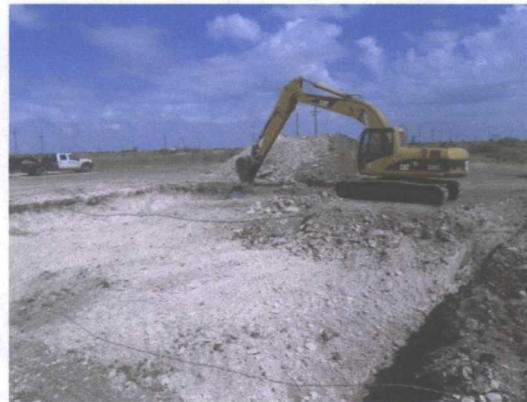
excavating the site, facing northwest
8/27/2012

- Excavated the area encompassed by the soil borings (55 ft by 61 ft) to a depth of approximately 5 ft bgs (See attached plat).
- Clean blow sand was imported placed in the bottom of the excavation creating a 6 inch blow sand layer. A sample of the imported soil returned a field PID result of 1.4 ppm, a laboratory chloride result below detectable limit (<16 mg/kg) and a laboratory TPH result below detectable limit (<10 mg/kg DRO and GRO). A 55 ft by 61 ft, 20-mil, reinforced poly liner was installed and properly seated above a 6 inch pad, and a 1 foot layer of blow sand was placed above the liner .

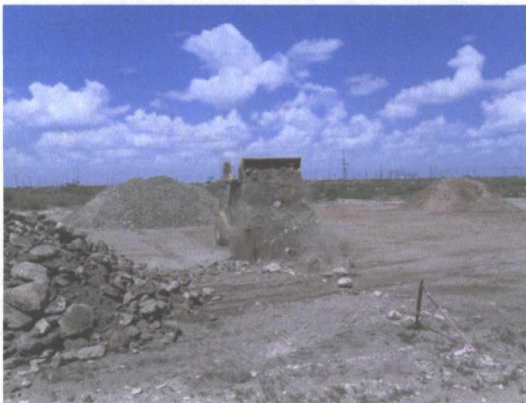
screening rock from the excavated soil,
facing north 8/27/2012

- The excavated soil was screened to remove large rocks and the soil was properly disposed of at a NMOCD approved facility.
- The large rocks were returned to the excavation and the site was then backfilled and contoured to the surrounding area with clean, imported soil.

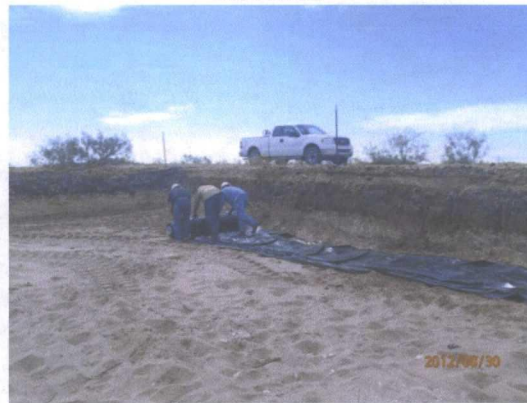
installing the 20-mil, reinforced liner above the
6 inch blow sand pad, facing north 8/30/2012

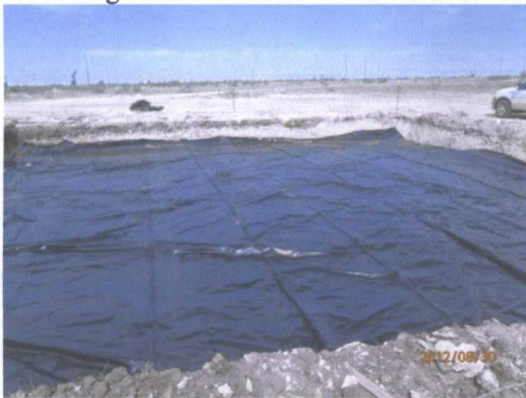
20-mil, reinforced liner installed,
facing west 8/30/2012

due to activities not directly caused by ROC operations. Nevertheless, in order to protect groundwater quality from the potential migration of residual soil chlorides and hydrocarbons, ROC submitted a CAP on April 16th, 2012. The report proposed installing a 20-mil reinforced liner at 3 ft bgs (limited by the presence of hard rock), backfilling with clean soil, and seeding of the surface. NMOCD approved the report on June 25th, 2012.

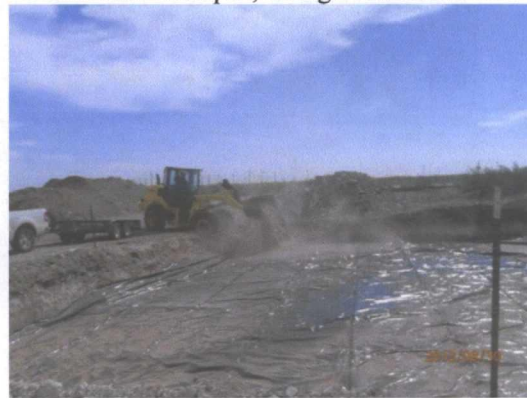
padding above the liner with 6 inches of blow
sand, facing west 8/30/2012

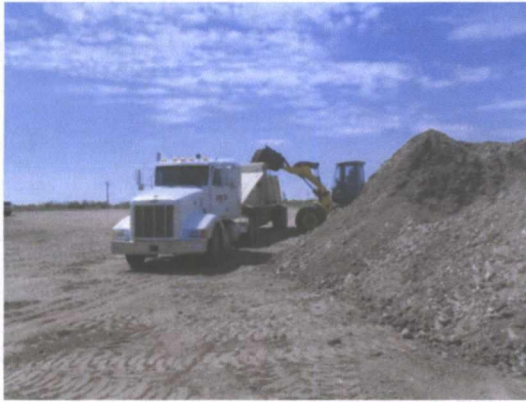
Exporting excavated soil, facing west
9/10/2012

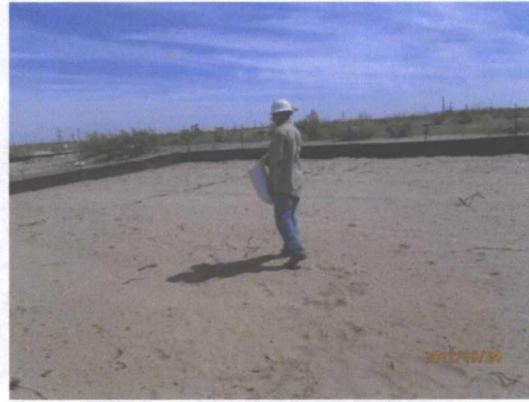
seeding the backfilled site, facing south
9/24/2012

- On September 24th, 2012, the site was seeded with a blend of native vegetation.

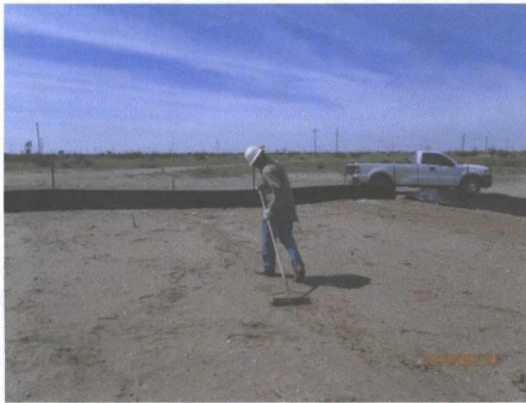
raking in the seed, facing north 9/24/2012

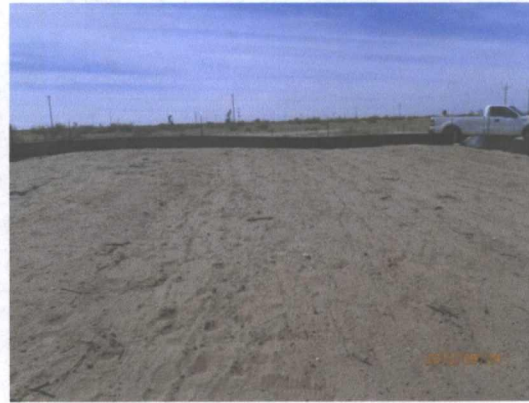
site complete, facing west 9/24/2012
