**From:** Hansen, Edward J., EMNRD  
**Sent:** Thursday, January 17, 2013 12:44 PM  
**To:** Hack Conder (hconder@riceswd.com)  
**Cc:** Leking, Geoffrey R, EMNRD; Laura Pena (lpena@riceswd.com); Katie Jones <kjones@riceswd.com> (kjones@riceswd.com); Scott Curtis (scurtis@riceswd.com)  
**Subject:** Remediation Plan (1R427-18) Termination - ROC EME A-8 Boot Site

RE: Termination Request  
EME A-8 boot (1R427-18): UL/A Sec. 8, T21S, R36E  
RICE Operating Company – Eunice Monument Eumont SWD System

**RICE OPERATING COMPANY  
JUNCTION BOX FINAL REPORT**

EME A-8 Boot (1R427-18)  
Unit Letter A, Section 8, T21S, R36E

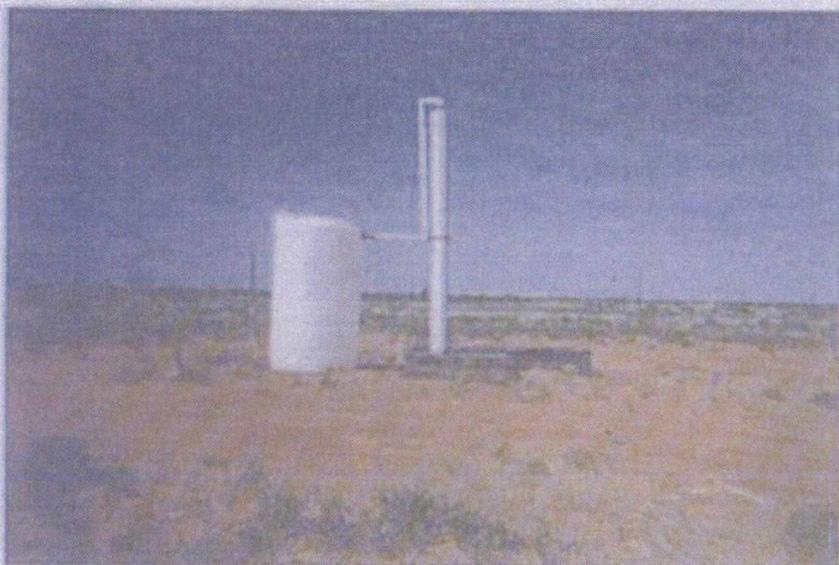
Undisturbed Box & Boot Before NORM Removal (2/18/2003)

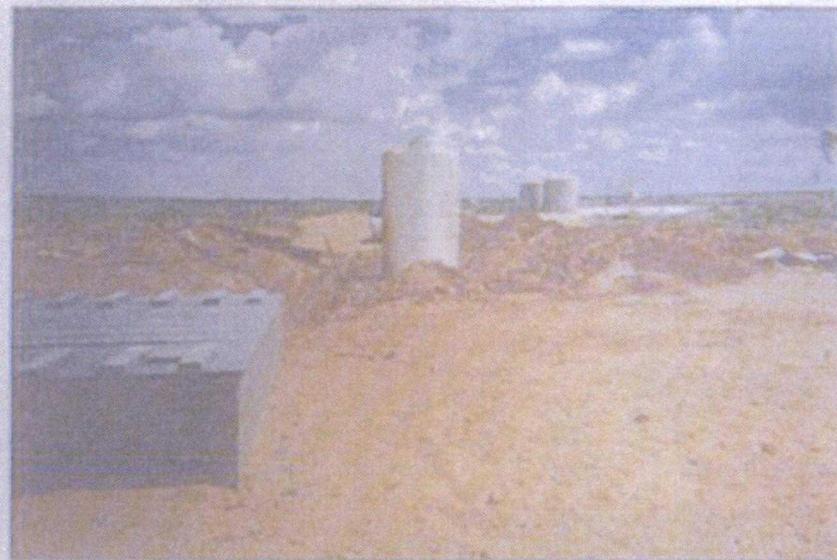
New Junction Box in Foreground, Moved 60 ft West (Aug. 2003)

SWD SYSTEM	JUNCTION	UNIT	SECTION	TOWNSHIP	RANGE	COUNTY	BOX DIMENSIONS - FEET		
							Length	Width	Depth
EME	A-8 boot	A	8	21S	36E	Lea	moved 60 ft west

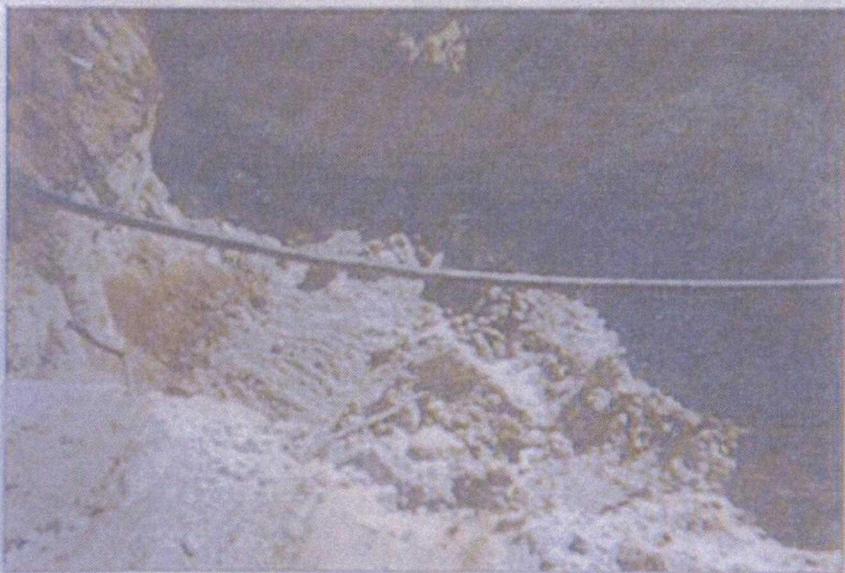
30 x 30 x 11-ft-deep Excavation (Sept. 2003)

Soil Excavated 367 cubic yards Excavation Length 30 Width 30 Depth 11 feet

General Description of Remedial Action: The site was delineated vertically and laterally with a backhoe while chloride tests and PID readings were performed at regular intervals. Chloride concentrations exhibited a vertical and lateral decline. TPH concentrations were well below NMOCD guidelines. Bottom composite and 4-wall composite samples were taken for closure from the final 30 x 30 x 11 ft deep excavation. The excavated soil was blended at the location and then backfilled into the excavation. The disturbed surface area was re-seeded with native vegetation on 10/15/2003 and will be monitored for growth.

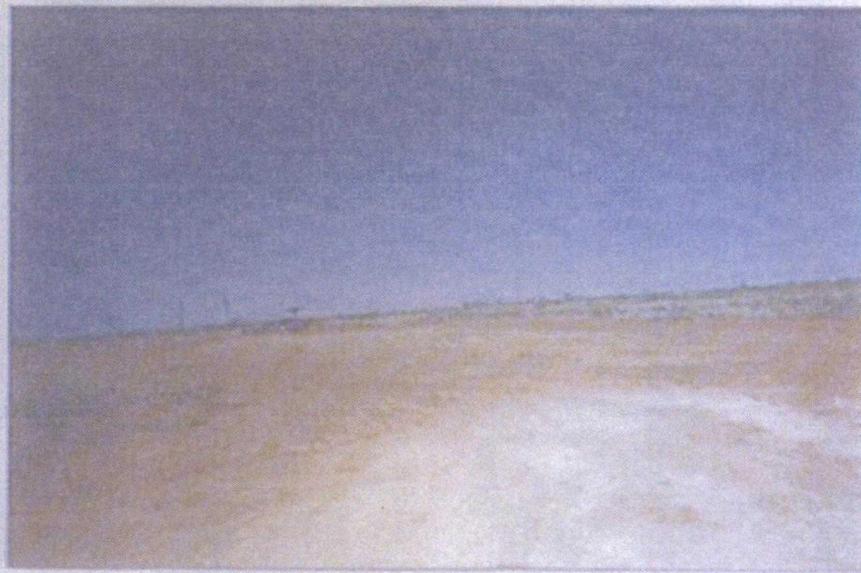
Seeding Disturbed Surface (10/15/2003)

contoured to the surrounding area. On 10/15/2003, the site was seeded with a blend of native vegetation and is expected to return to a productive capacity at a normal rate.

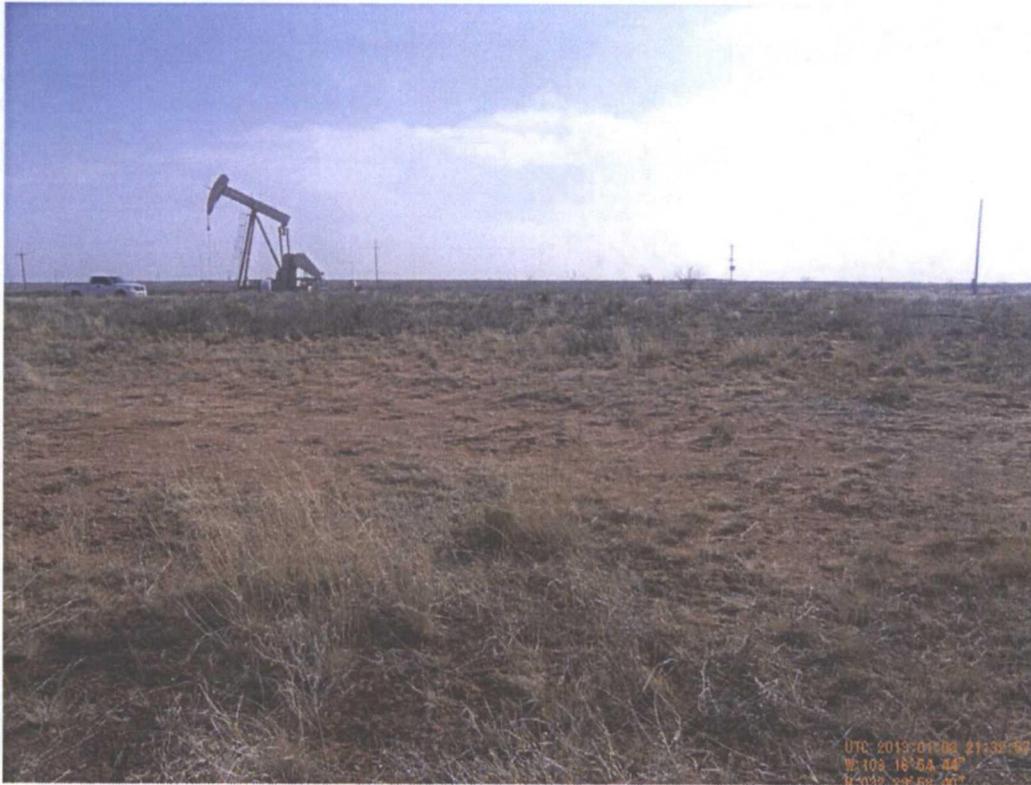
1/8/2013

Facing South

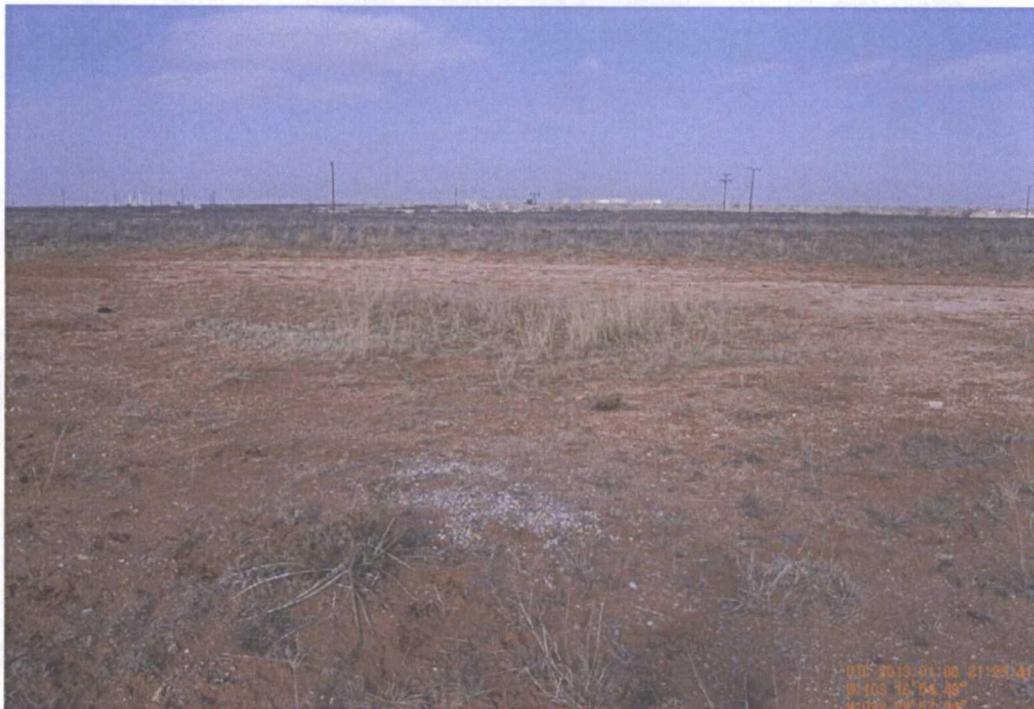
1/8/2013

Facing North
