**Annual GW  
Mon. Report**

**2011 ANNUAL MONITORING REPORT** APR 2 2012

**SOIL CLOSURE REQUEST**

**14-INCH VAC TO JAL LEGACY**

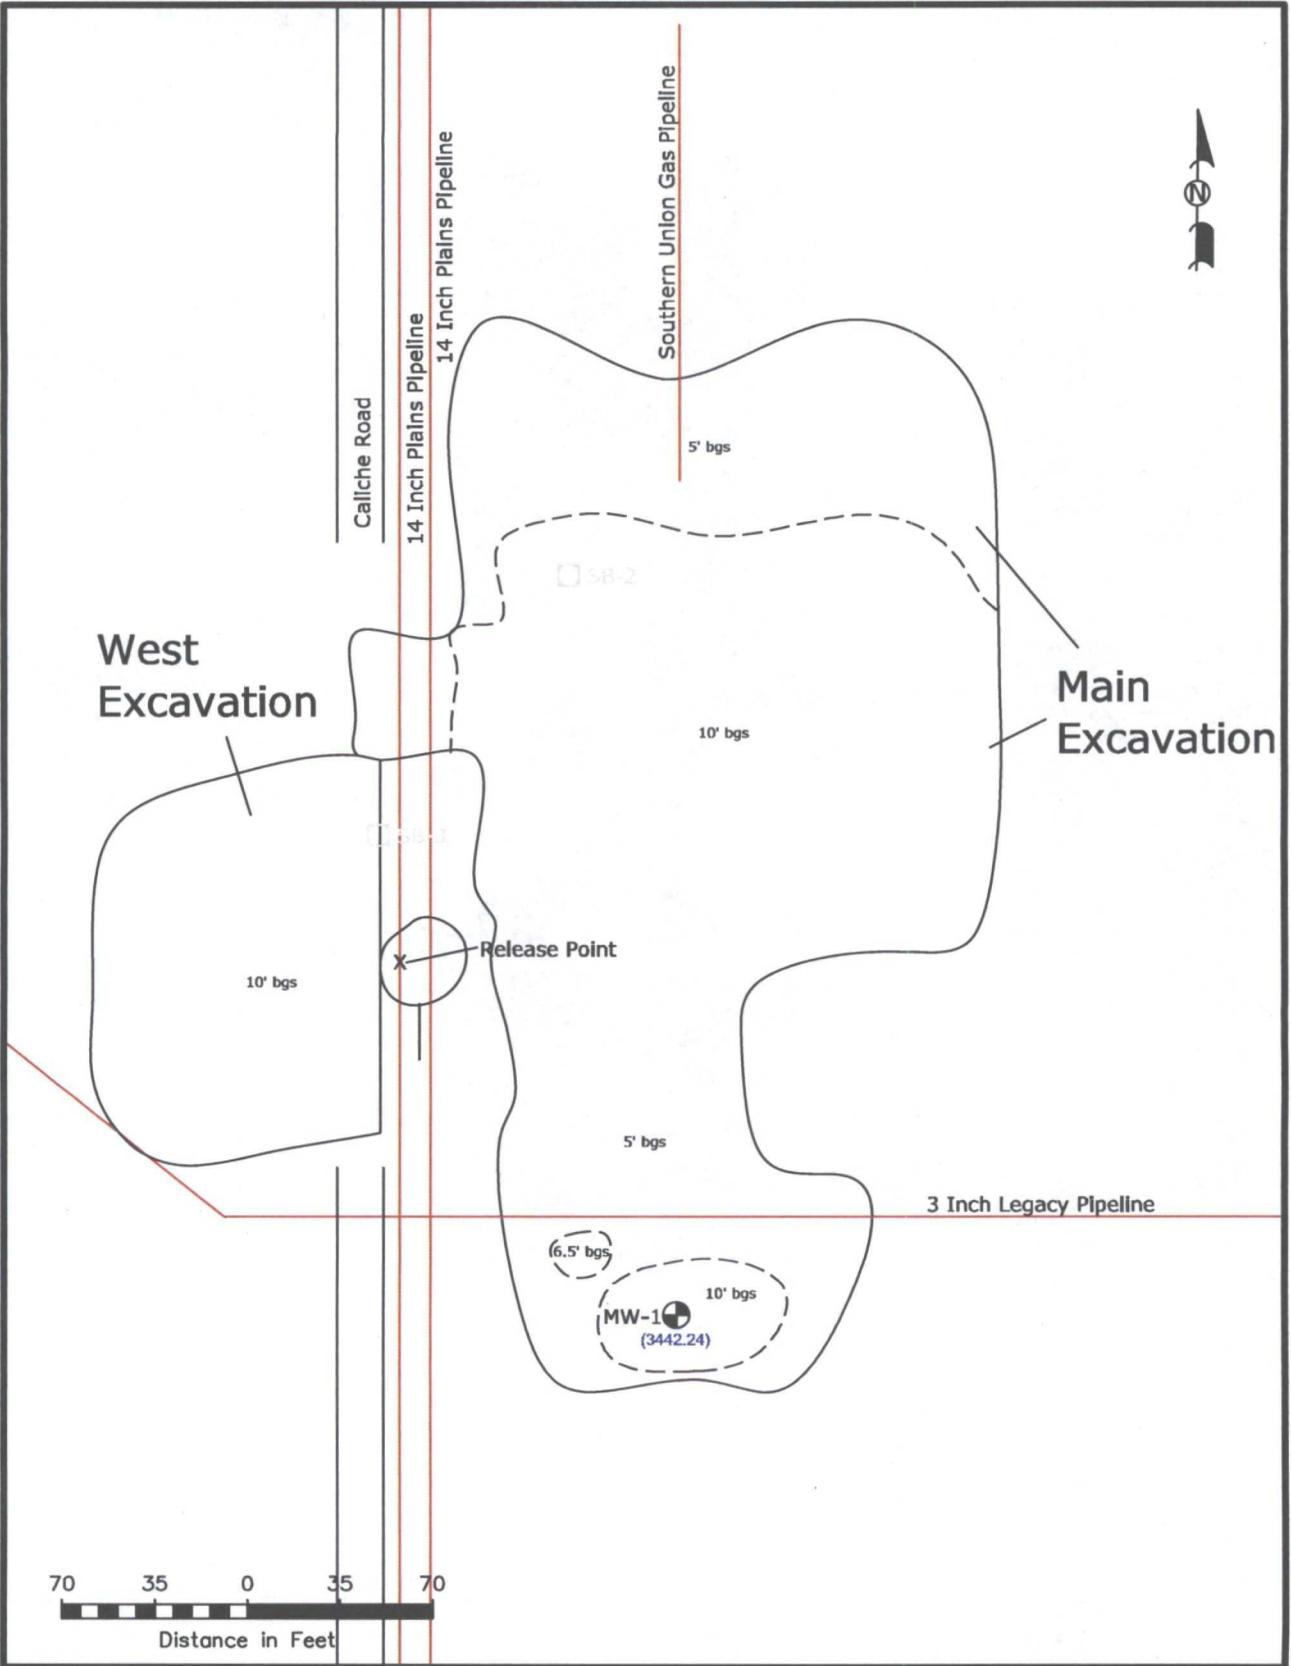
Figure 2A  
Groundwater Elevation  
Map (2/28/2011)  
Plains Pipeline, L.P.  
14-Inch Vac to Jal - Legacy  
Lea County, NM  
SRS # 2009-092  
1RP-2162

Locations of the groundwater monitoring well and the inferred groundwater elevation were constructed from measurements collected during the quarterly monitoring events and are depicted on Figures 2A through 2C. The groundwater elevation data is provided in Table 1, "Groundwater Elevation Data". An inferred groundwater gradient map cannot be constructed from the observed groundwater elevation data derived from the one (1) on-site monitor well. An inferred groundwater gradient map requires a minimum of three (3) monitor wells to calculate an accurate groundwater gradient direction and magnitude. Review of NMOSE records indicate a general southeast groundwater gradient in this area of Lea County, New Mexico. The corrected

groundwater elevation in monitor well MW-1 ranged from 3,442.15 to 3,442.24 feet above mean sea level on November 7 and February 28, 2011, respectively.

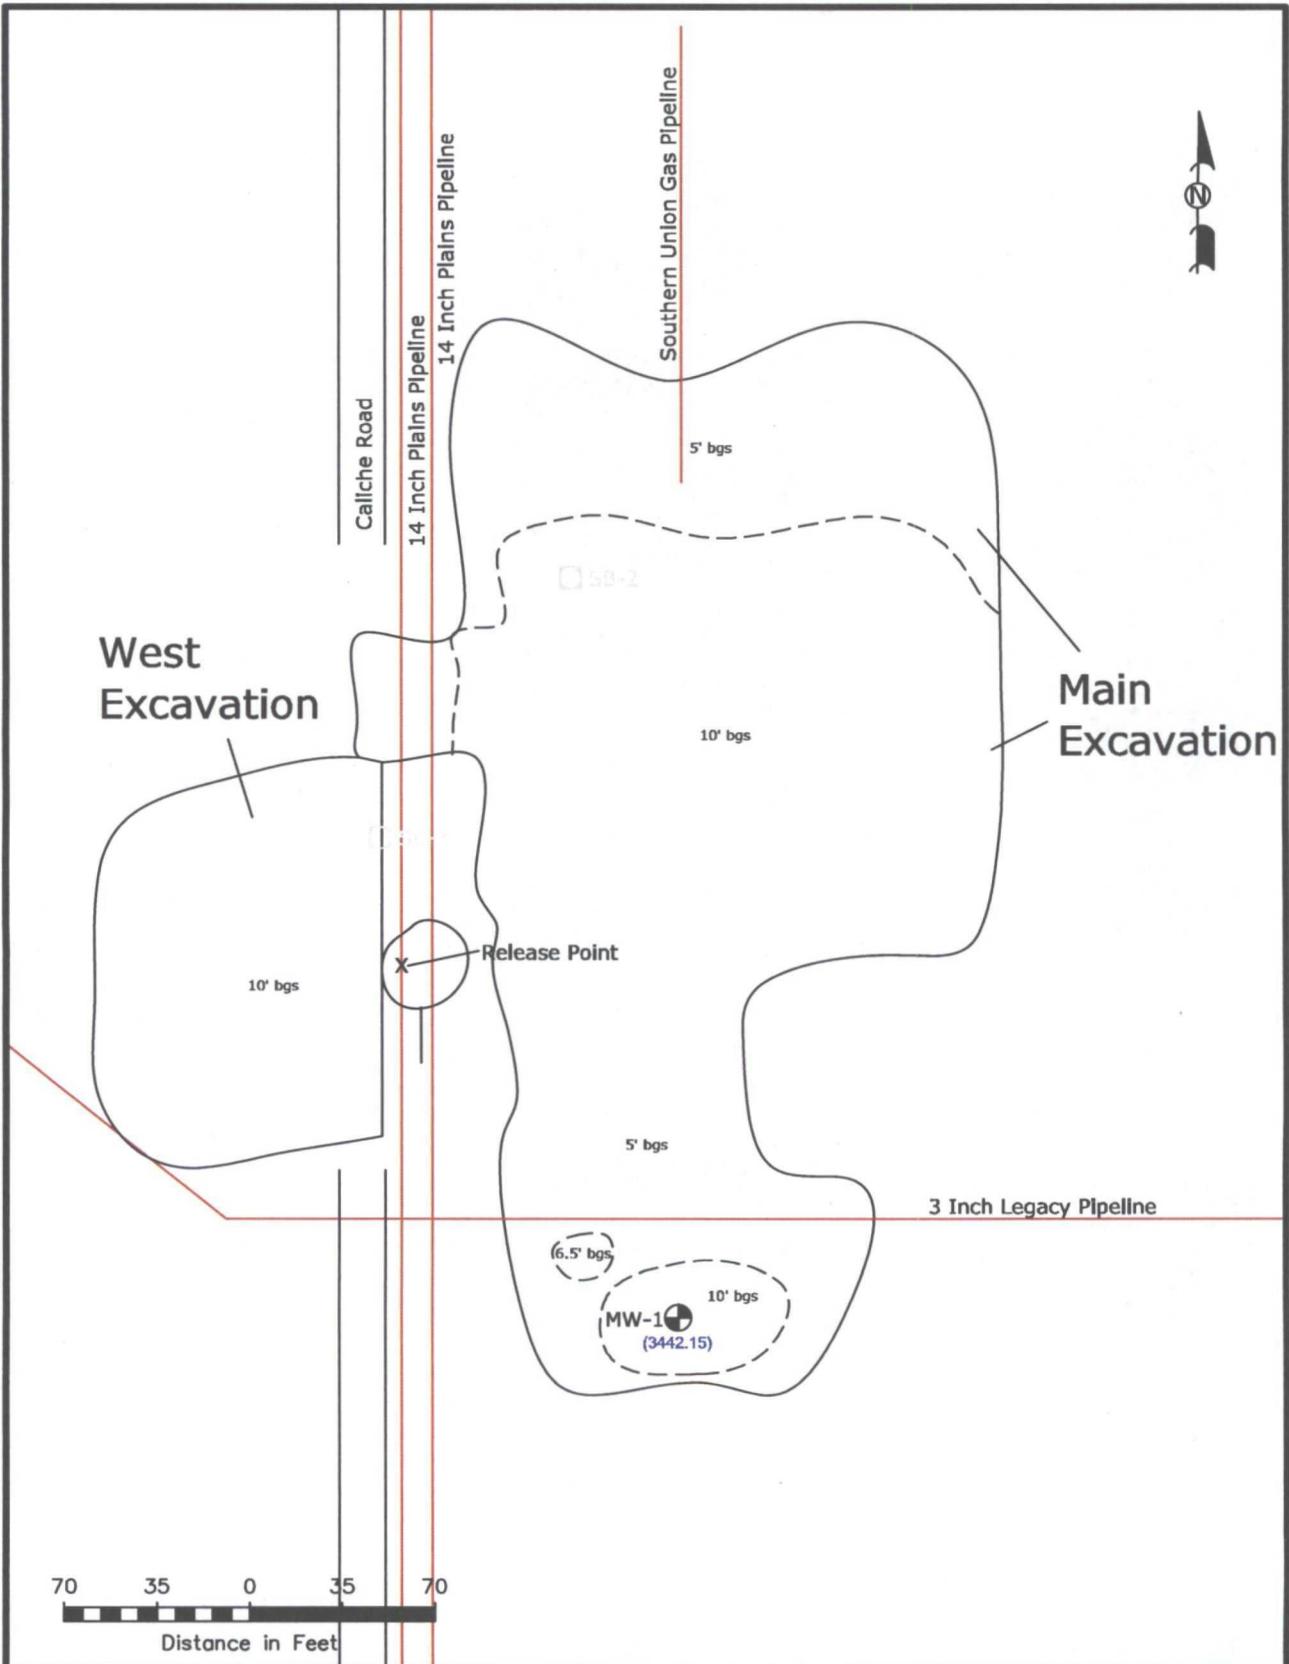
Figure 2B  
 Groundwater Elevation  
 Map (9/7/2011)  
 Plains Pipeline, L.P.  
 14-Inch Vac to Jal - Legacy  
 Lea County, NM  
 SRS # 2009-092  
 1RP-2162

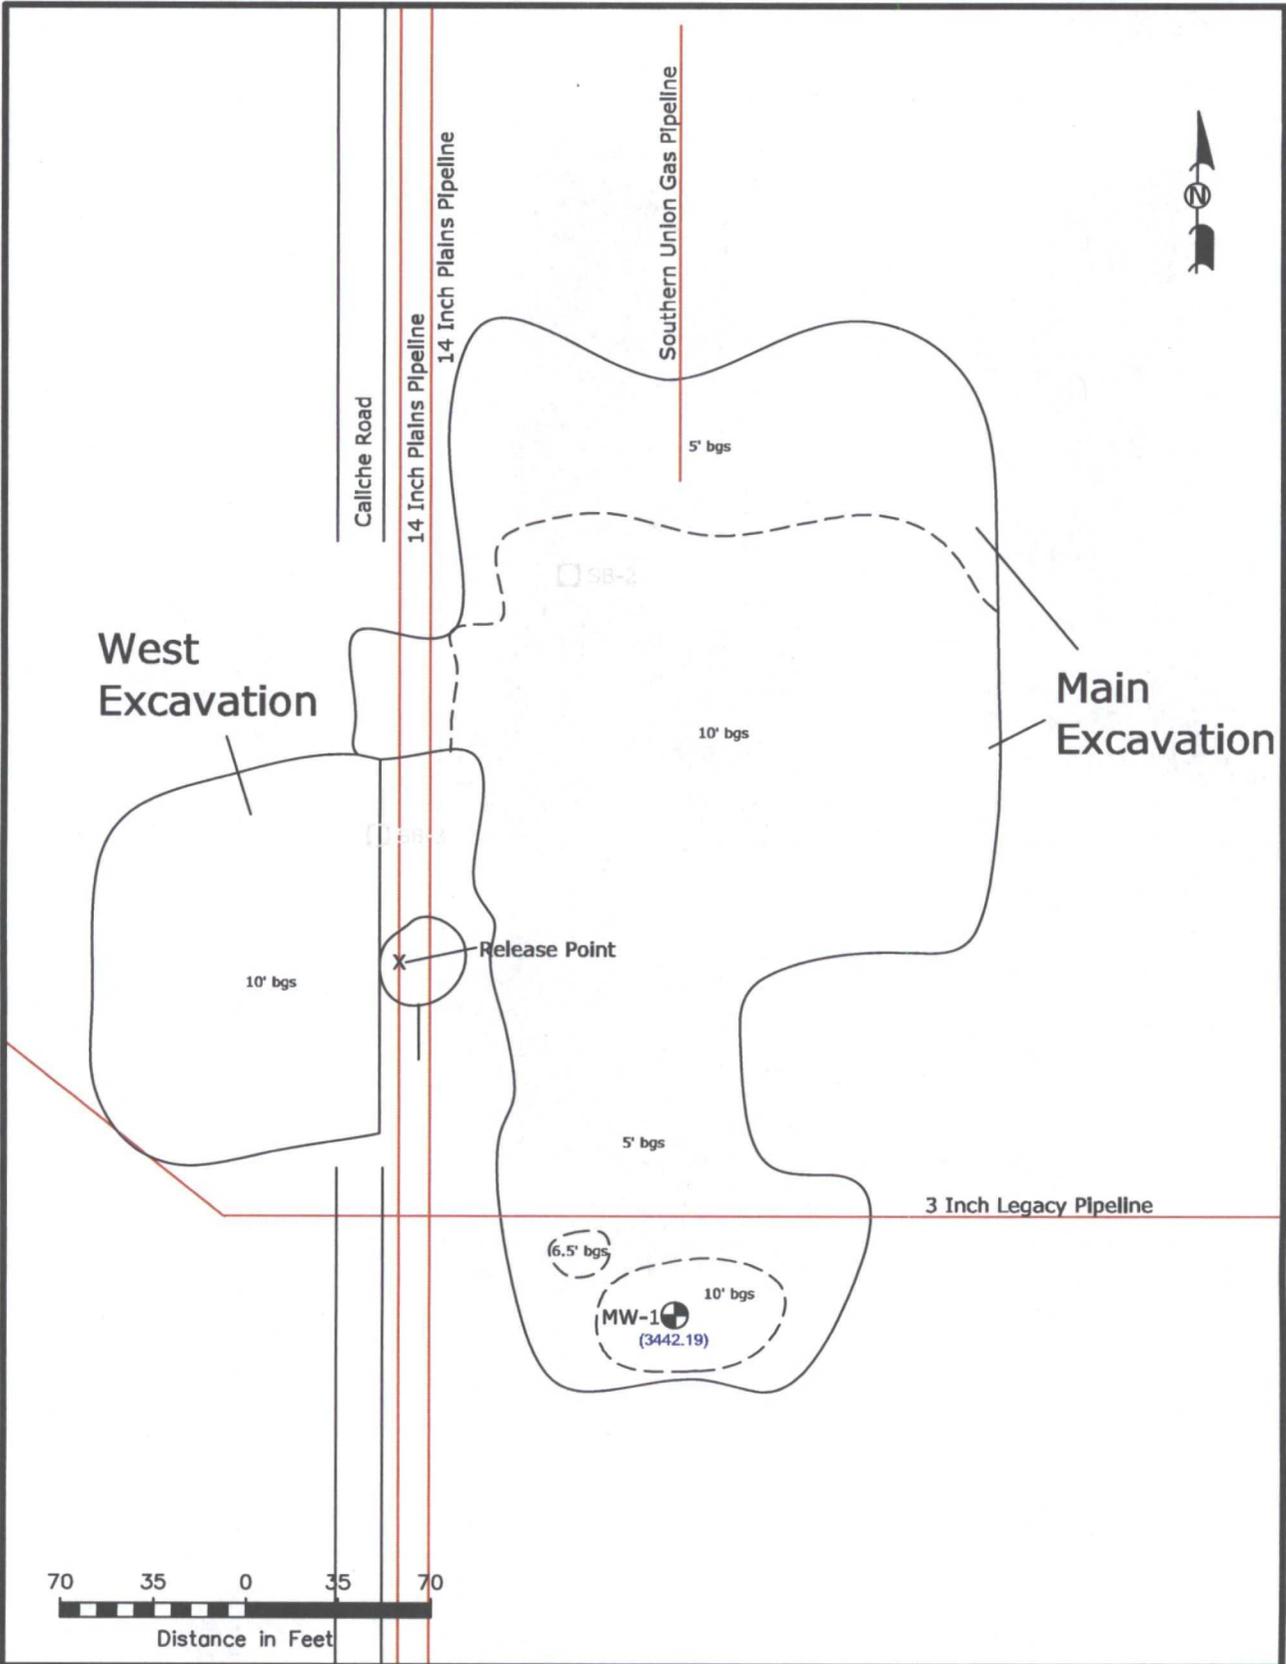
Figure 2C  
 Groundwater Elevation  
 Map (11/2/2011)  
 Plains Pipeline, L.P.  
 14-Inch Vac to Jal - Legacy  
 Lea County, NM  
 SRS # 2009-092  
 1RP-2162

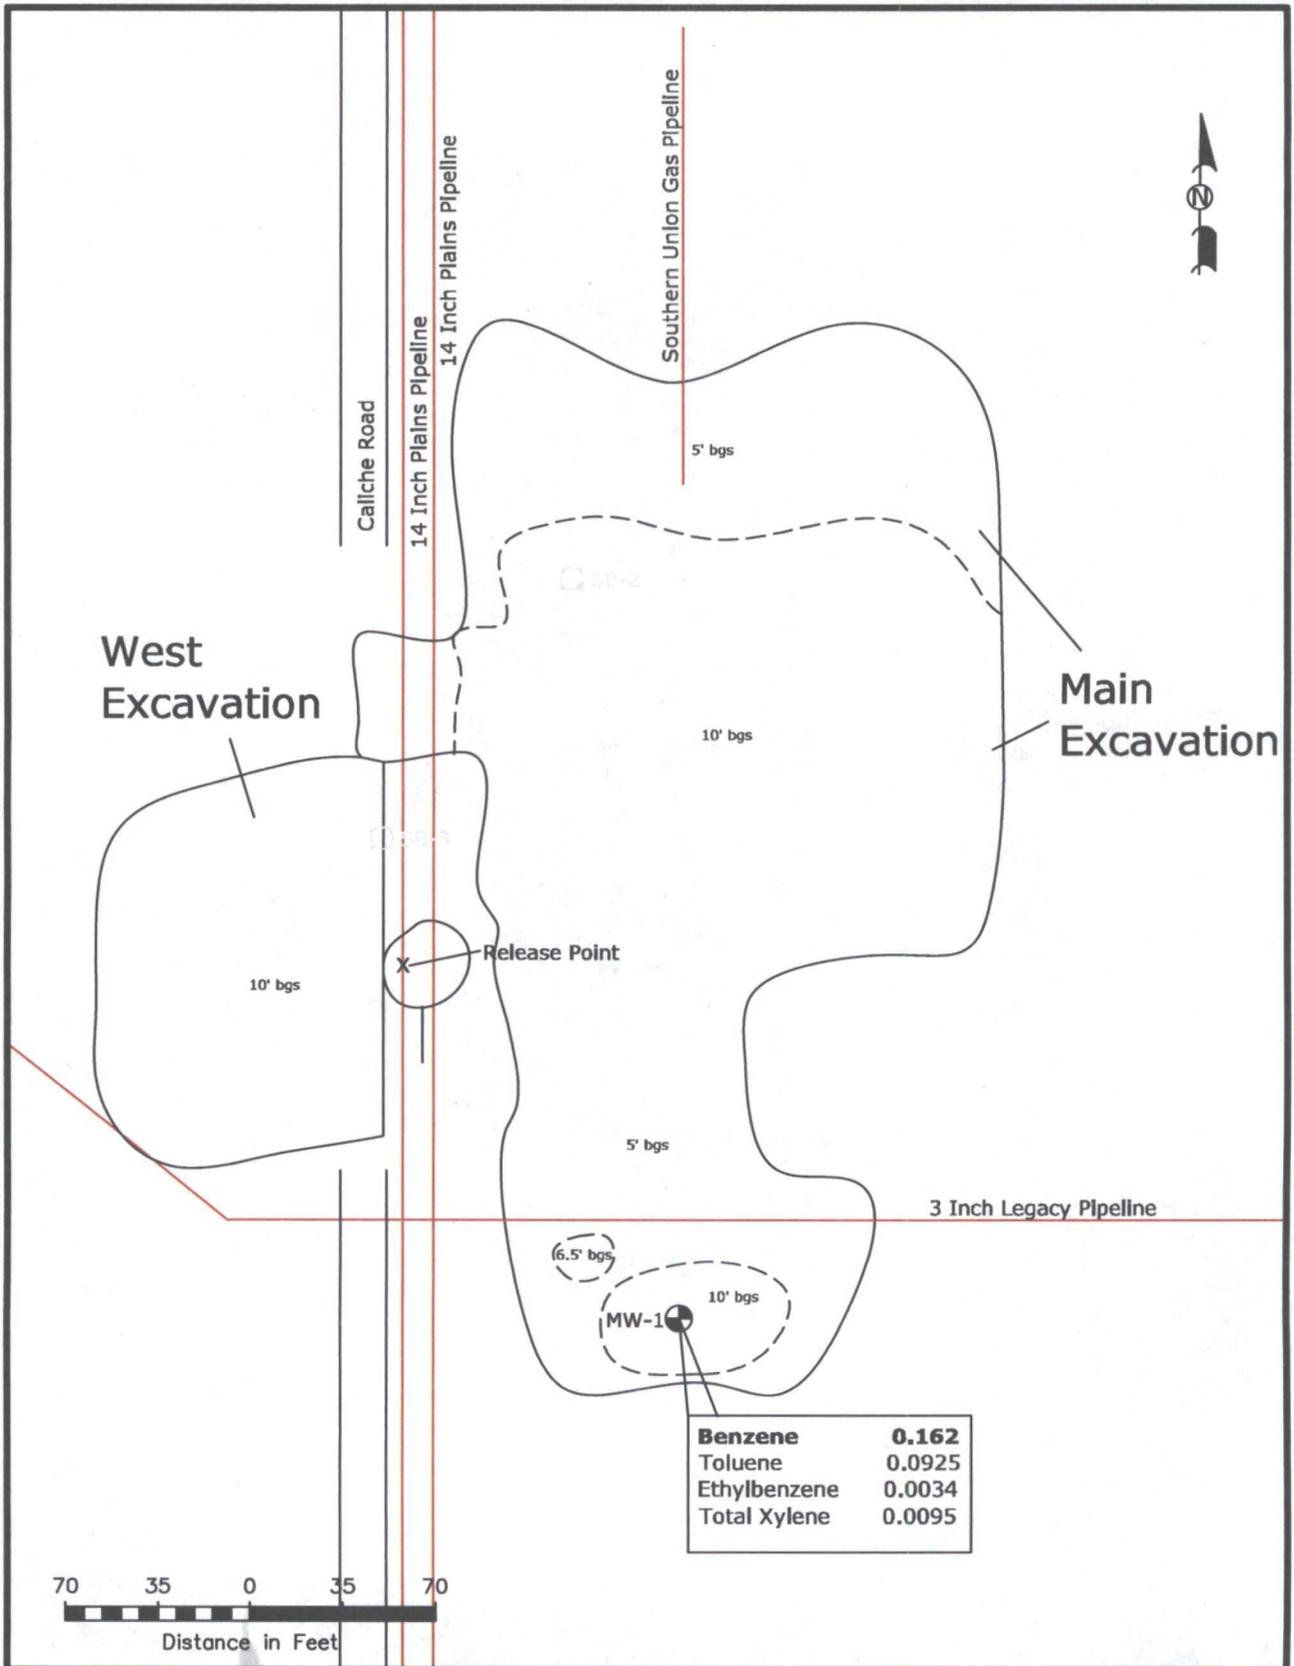
<b>Benzene</b>	<b>0.162</b>
Toluene	0.0925
Ethylbenzene	0.0034
Total Xylene	0.0095

Figure 3A  
 Groundwater Concentration  
 Map (2/28/2011)  
 Plains Pipeline, L.P.  
 14-Inch Vac to Jal - Legacy  
 Lea County, NM  
 SRS # 2009-092  
 1RP-2162

Monitor well MW-1 is sampled on a quarterly schedule. Laboratory analytical results indicate benzene concentrations ranged from 0.0662 mg/L in 4Q2011 to 0.305 mg/L 3Q2011. Toluene concentrations ranged from 0.069 mg/L in 4Q2011 to 0.18 mg/L in 3Q2011. Ethylbenzene concentrations ranged from 0.0034 mg/L in 1Q2011 to 0.0152 mg/L in 3Q2011. Total xylene concentrations ranged from 0.0095 mg/L in 1Q2011 to 0.0295 mg/L in 3Q2011. Chloride concentrations ranged from 7,880 mg/L in 4Q2011 to 9,590 mg/L in 3Q2011. TDS concentrations ranged from 15,500 mg/L in 4Q2011 to 17,300 mg/L in 3Q2011. Benzene, chloride, and TDS concentrations exceeded NMOCD regulatory standards during each quarterly sampling event. Toluene, ethylbenzene, and total xylene concentrations were less than the appropriate NMOCD regulatory standard during each quarterly sampling event.

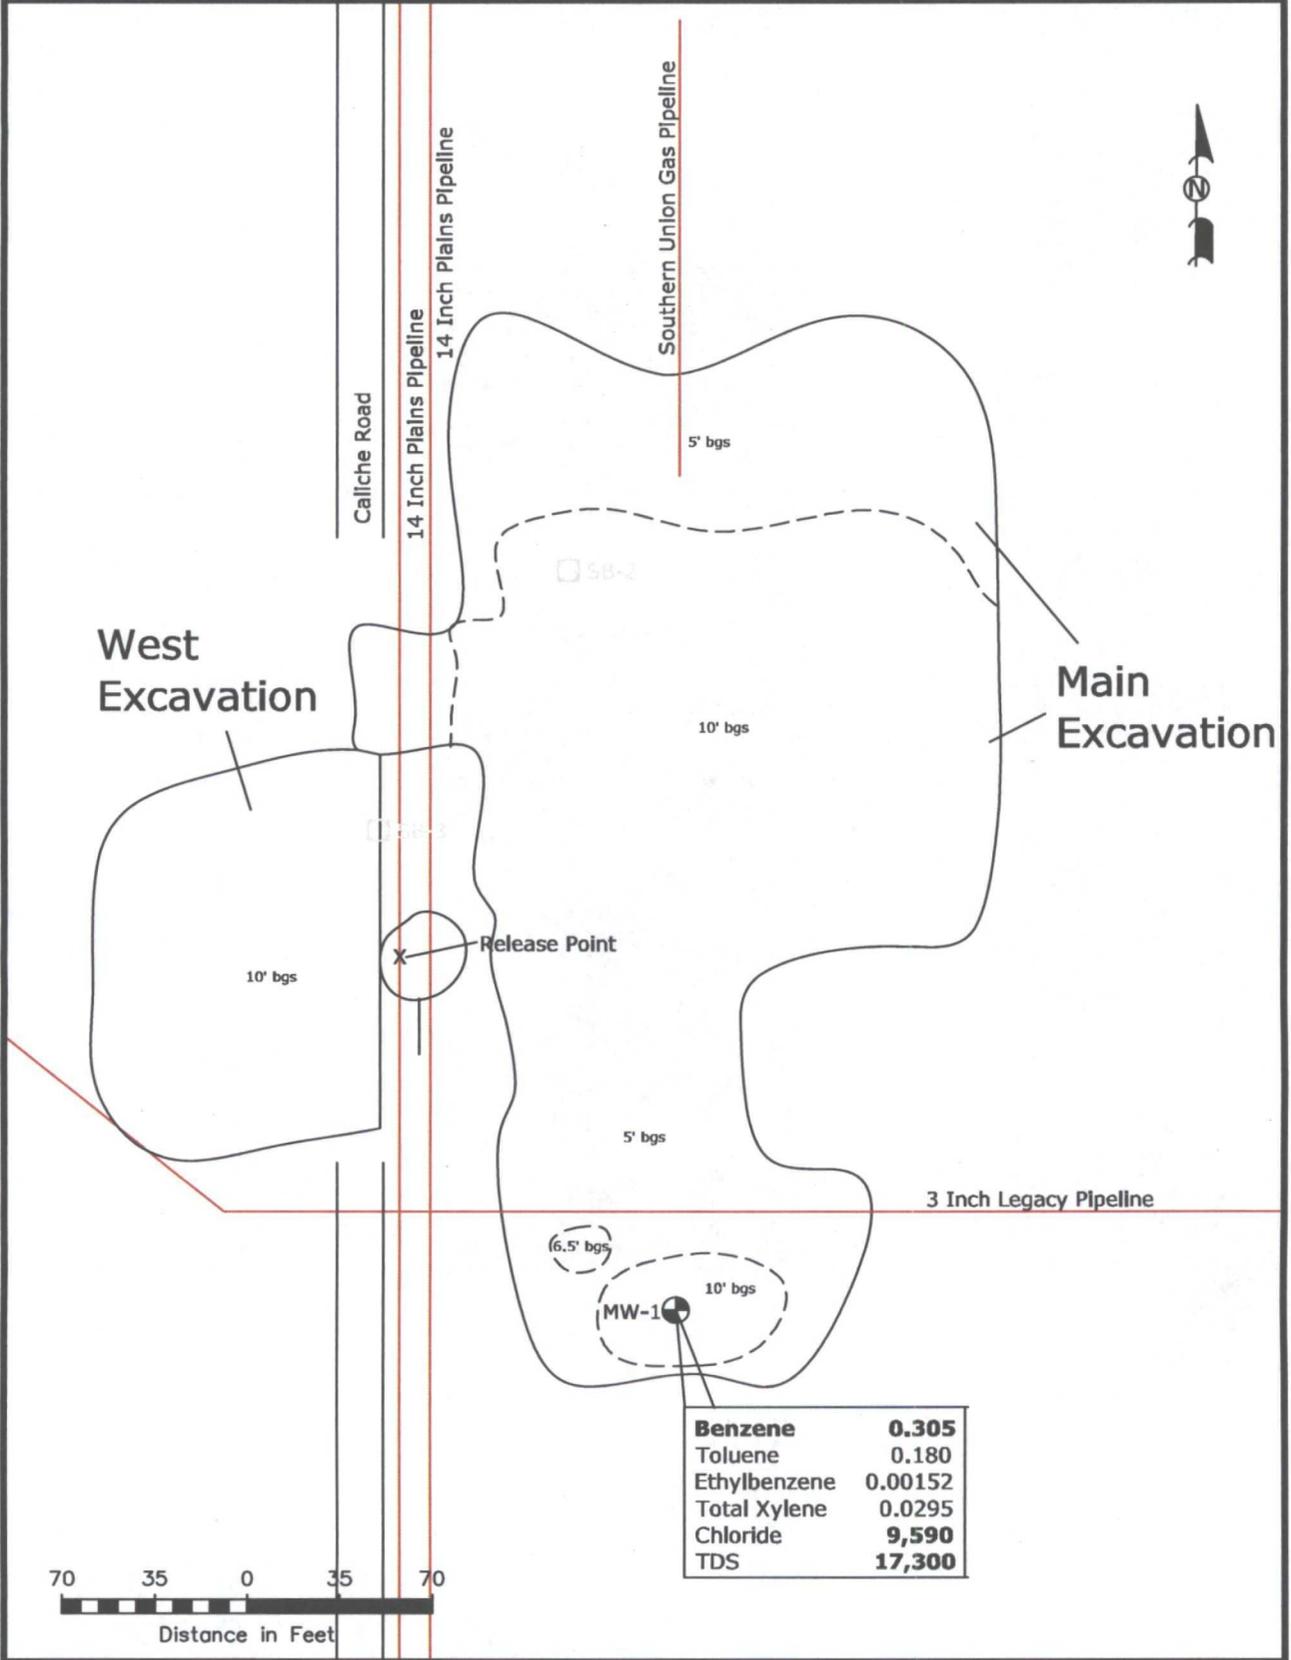
<b>Benzene</b>	<b>0.305</b>
Toluene	0.180
Ethylbenzene	0.00152
Total Xylene	0.0295
Chloride	<b>9,590</b>
TDS	<b>17,300</b>

Figure 3B  
Groundwater Concentration  
Map (9/7/2011)  
Plains Pipeline, L.P.  
14-Inch Vac to Jal - Legacy  
Lea County, NM  
SRS # 2009-092  
1RP-2162

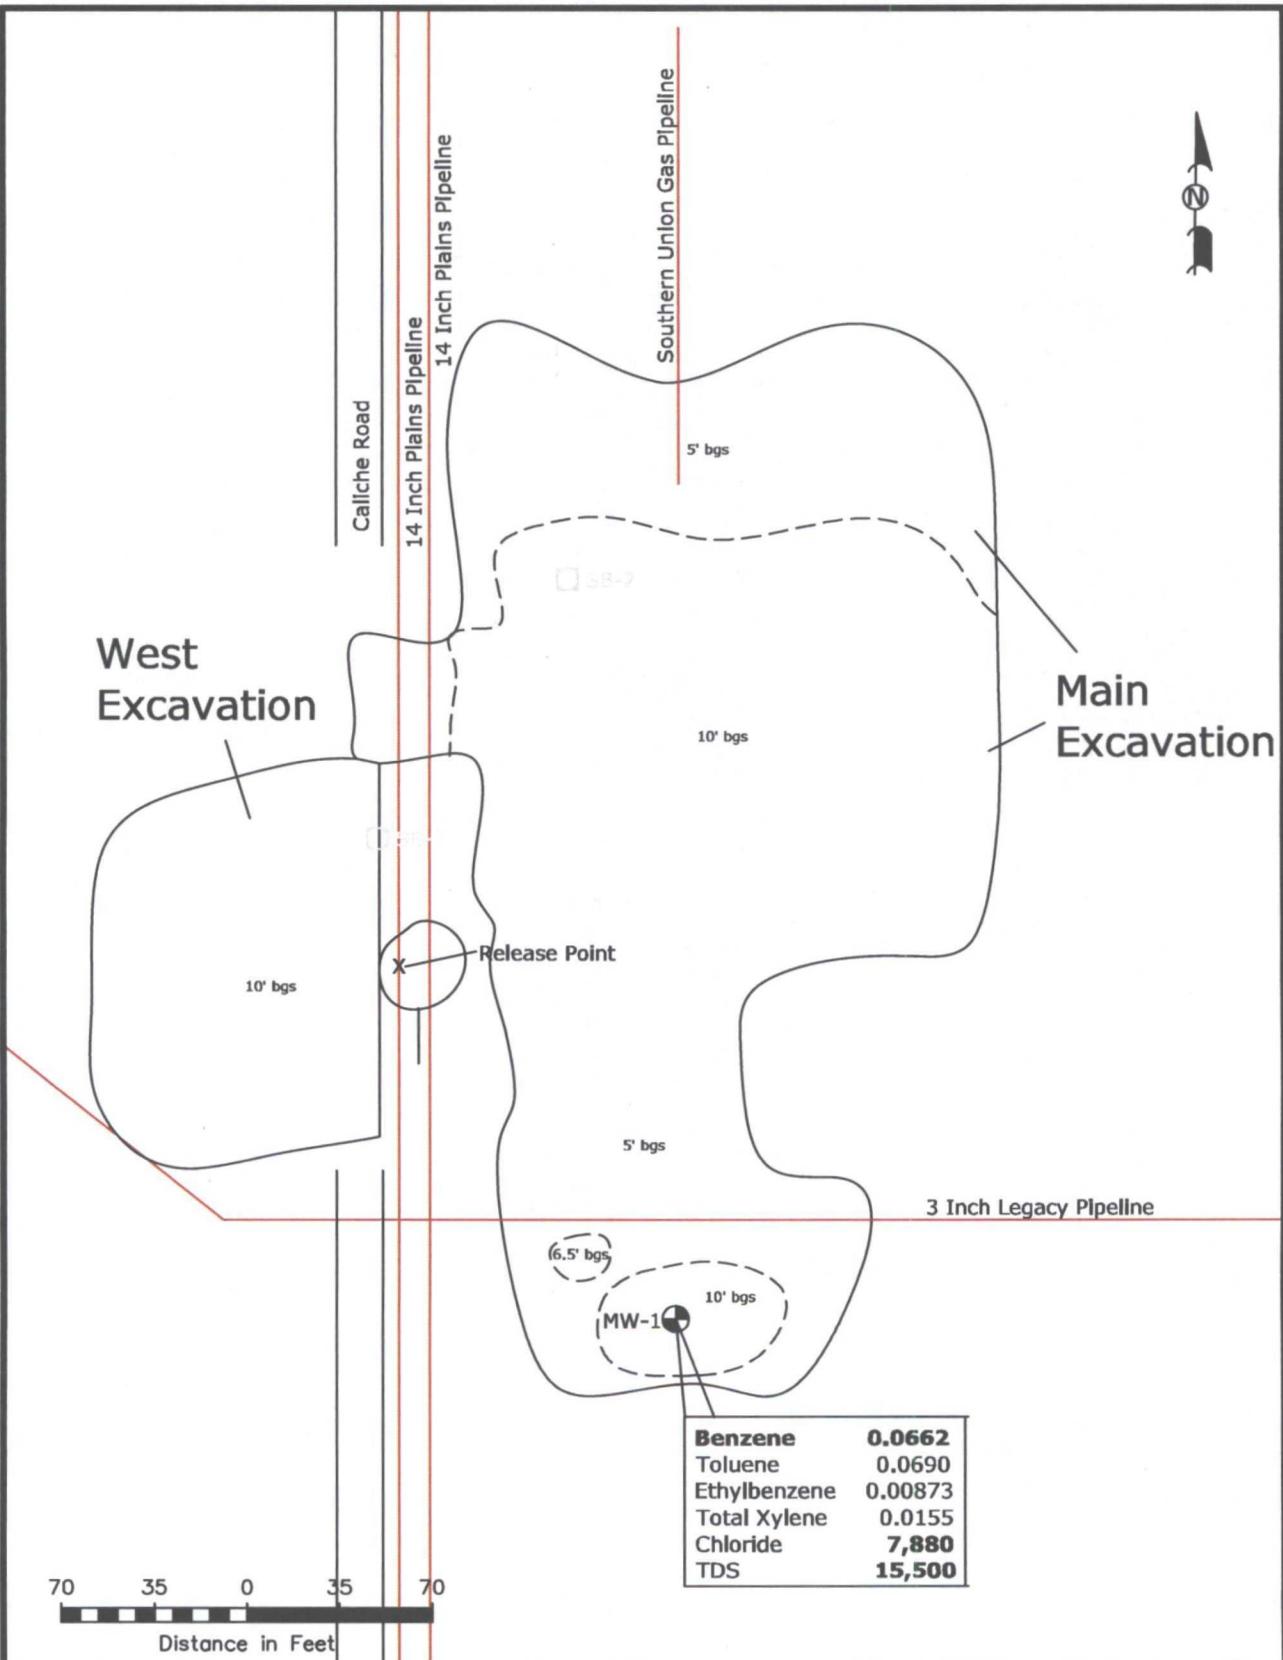
<b>Benzene</b>	<b>0.0662</b>
Toluene	0.0690
Ethylbenzene	0.00873
Total Xylene	0.0155
Chloride	<b>7,880</b>
TDS	<b>15,500</b>

Figure 3C  
Groundwater Concentration  
Map (11/2/2011)  
Plains Pipeline, L.P.  
14-Inch Vac to Jal - Legacy  
Lea County, NM  
SRS # 2009-092  
1RP-2162

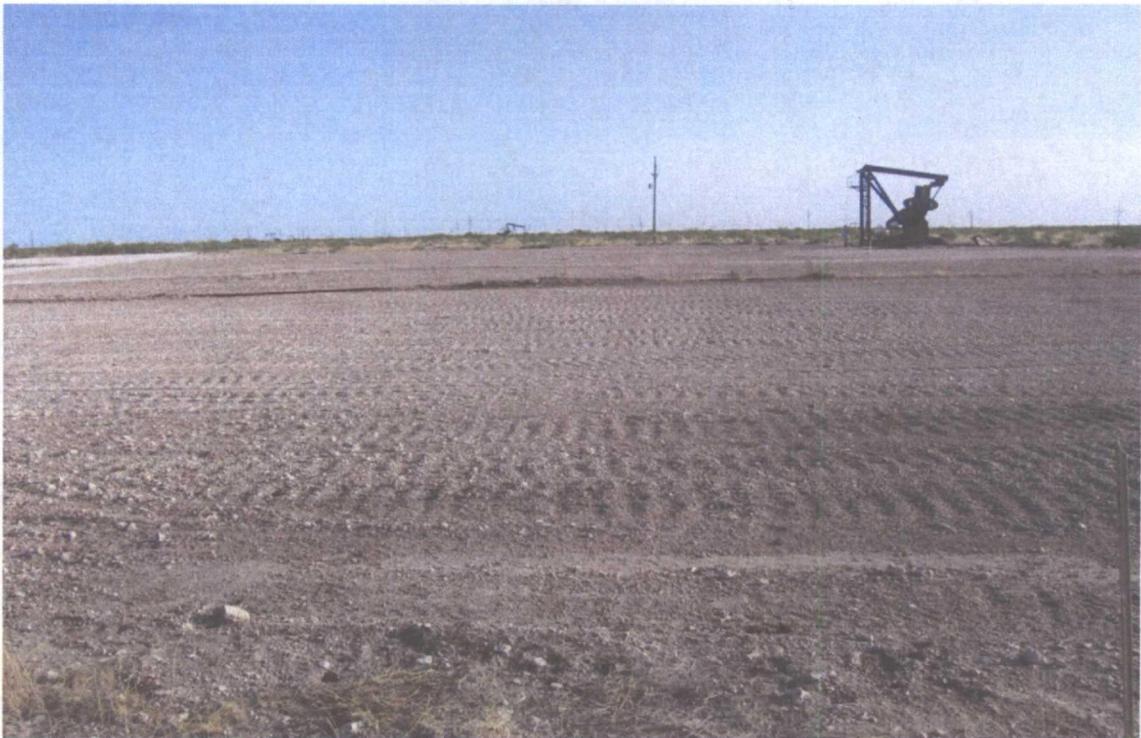
14-Inch Vac to Jal Legacy - Following Seeding (looking North)

Pursuant to correspondence from an NMOCD representative dated August 16, 2011, the 14-Inch Vac to Jal Legacy release site was seeded with an NMOCD-approved seed mixture (BLM #3) on August 25, 2011. Photographs of the seeding activities are provided in Appendix C.

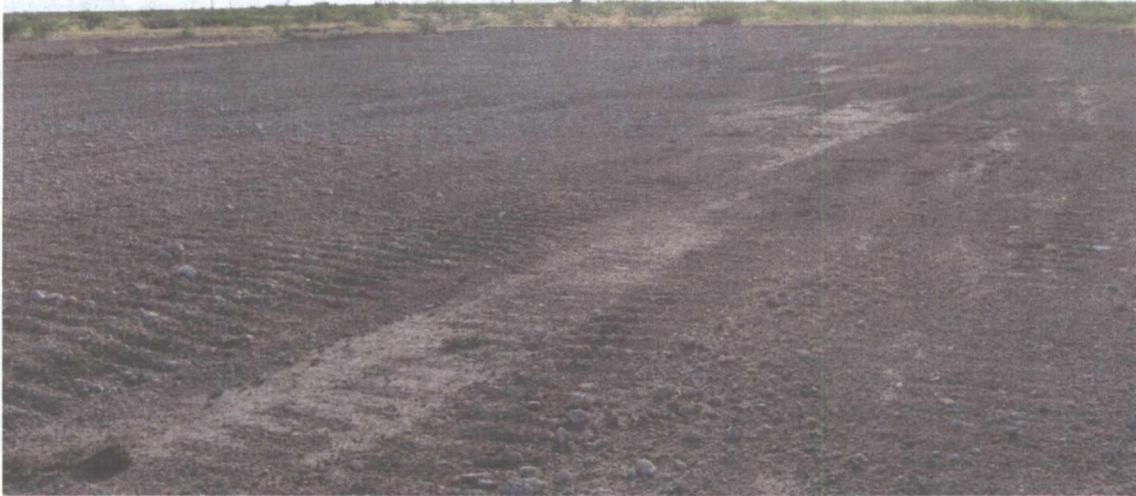
14-Inch Vac to Jal Legacy - Following Seeding (looking East-northeast)
