**From:** Hansen, Edward J., EMNRD  
**Sent:** Monday, February 04, 2013 12:39 PM  
**To:** Hack Conder (hconder@riceswd.com)  
**Cc:** Leking, Geoffrey R, EMNRD; Laura Pena (lpena@riceswd.com); Katie Jones  
<kjones@riceswd.com> (kjones@riceswd.com); Scott Curtis (scurtis@riceswd.com)  
**Subject:** Remediation Plan (1R427-22) Termination - ROC EME F-11 Site

RE: Termination Request  
EME F-11 (1R427-22): UL/F Sec. 11, T20S, R36E  
RICE Operating Company – Eunice Monument Eumont SWD System

**RICE OPERATING COMPANY  
JUNCTION BOX FINAL REPORT**

## Current Photodocumentation

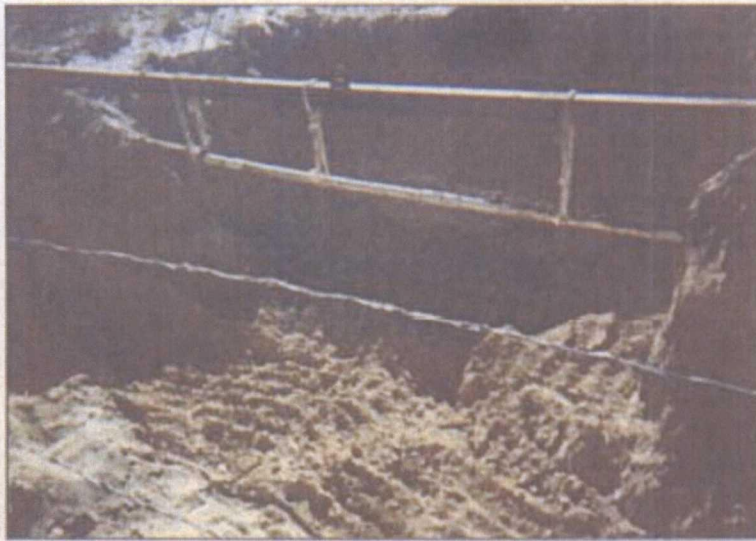
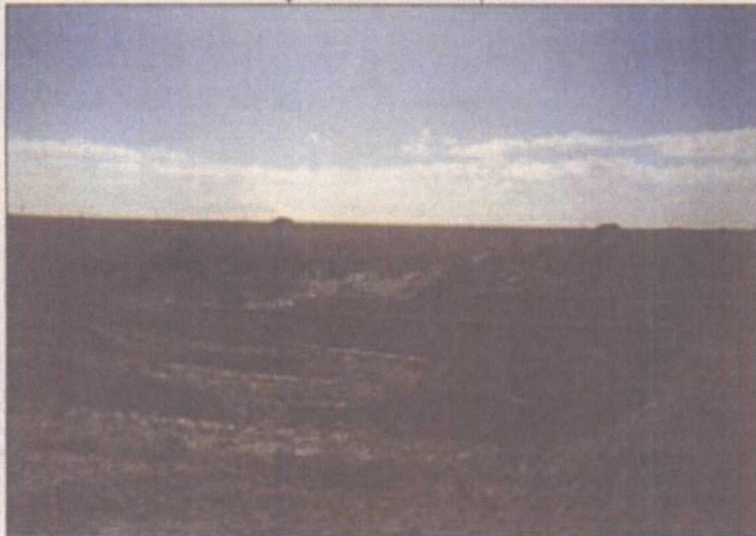
## EME jct. F-11

↓ Excavation ↑

**General Description of Remedial Action:** The box was located amongst sparsely vegetated sand dunes. The site was delineated vertically and laterally for TPH and chlorides, producing a 20' x 20' x 7' excavation. The excavated soil was landfarmed on location and then backfilled into the hole. The site was contoured to mimic the natural landscape. This site is no longer a junction so a box was not required. The disturbed surface was seeded with native vegetation and is expected to return to productive capacity at a normal rate. These activities are not detrimental to groundwater, livestock, or public health.

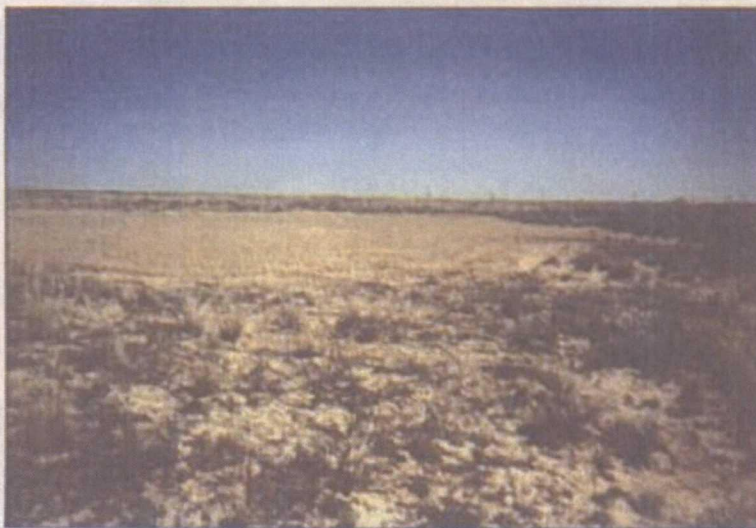
Backfilled

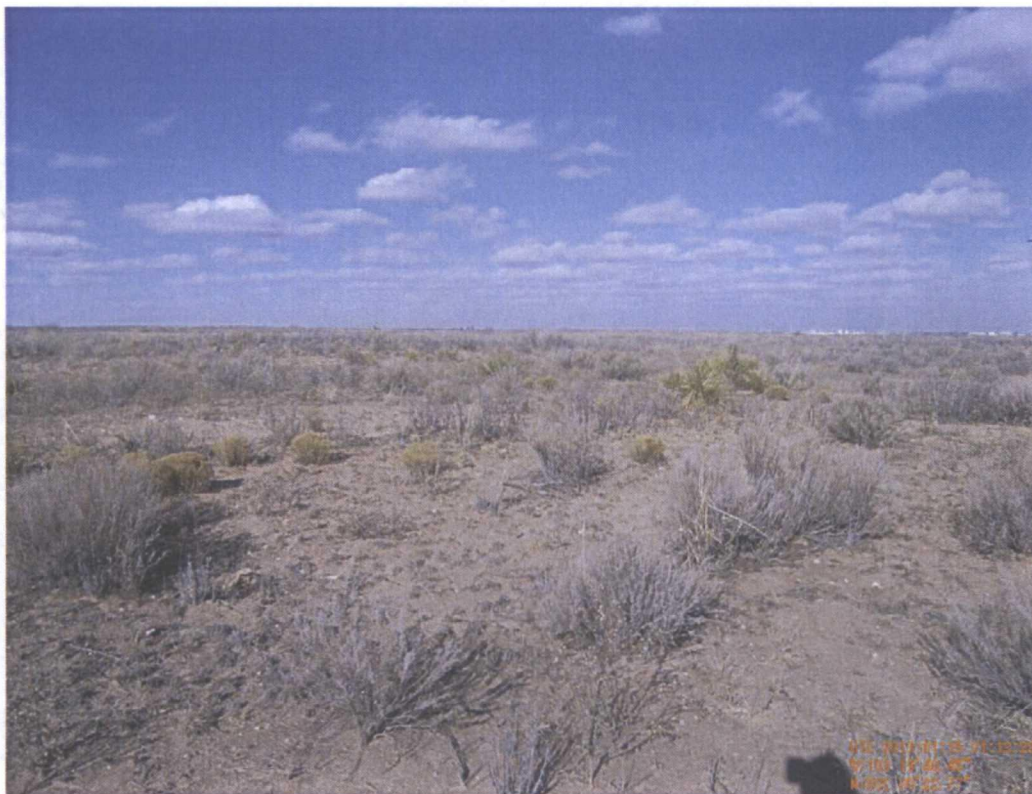
Facing North

The junction box site location map, final report, photodocumentation, laboratory analysis and current photodocumentation are attached. Vegetation has rebounded at the site so no re-vegetation efforts are needed.
