Release Notification and Corrective Action

Name of Company	Southern Union Gas Services, Ltd.	Contact	Rose Slade
Address	801 S. Loop 464, Monahans, TX, 79756	Telephone No.	432-940-5147
Facility Name: S & W 4" Lateral (RP-1018) Lea Co. Field Dept.	Facility Type		Natural Gas Gathering

Basin Environmental Service Technologies, LLC

On May 22, 2008, Southern Union discovered a release had occurred on the S & W 4" Lateral Pipeline. The "Release Notification and Corrective Action Form" (Form C-141) indicated failure of a section of four-inch (4") steel natural gas gathering pipeline resulted in the release of twenty-two and one half (22.5) Mcf of natural gas and fifteen barrels (15 bbls) of natural gas liquids, including iron sulfide. The release was reported to the New Mexico Oil Conservation Division (NMOCD) Hobbs District Office on August 28, 2006. During initial response activities, the line was blocked in and allowed to blow down. The affected segment of pipe was replaced on September 11, 2006. The Form C-141 indicated a mist of iron sulfide and natural gas liquids affected approximately two thousand, one hundred and seventy-five square feet (2,175 ft²) of pasture land. General pho

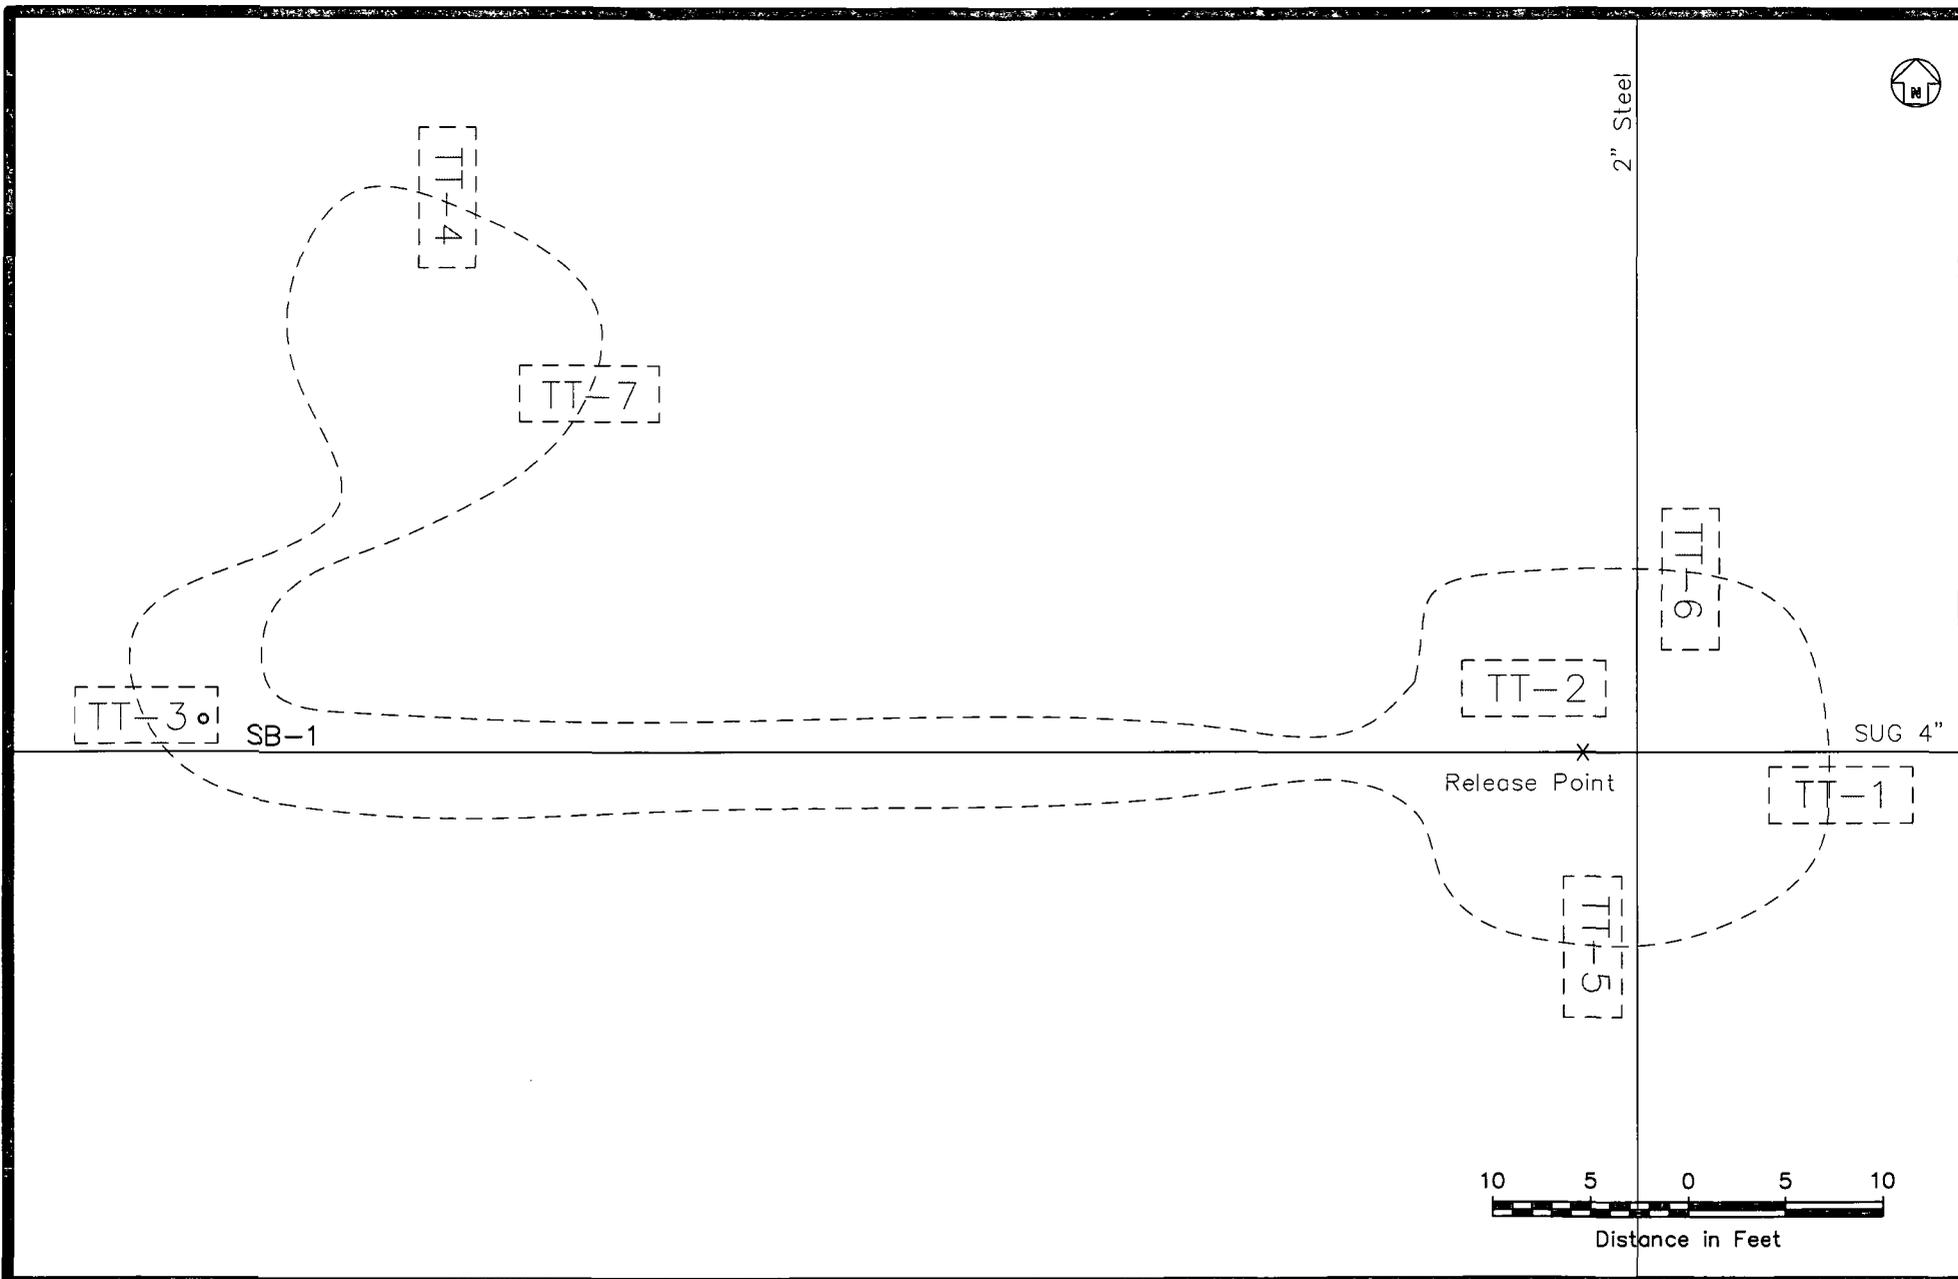
Figure 2
 Site & Sample Location Map
 Southern Union Gas Services
 S & W 4" Lateral
 NMOCD Ref RP-1018
 Lea County, New Mexico

Legend	
---	Inferred Flow Path
[]	Test Trench
o	Soil Boring Location

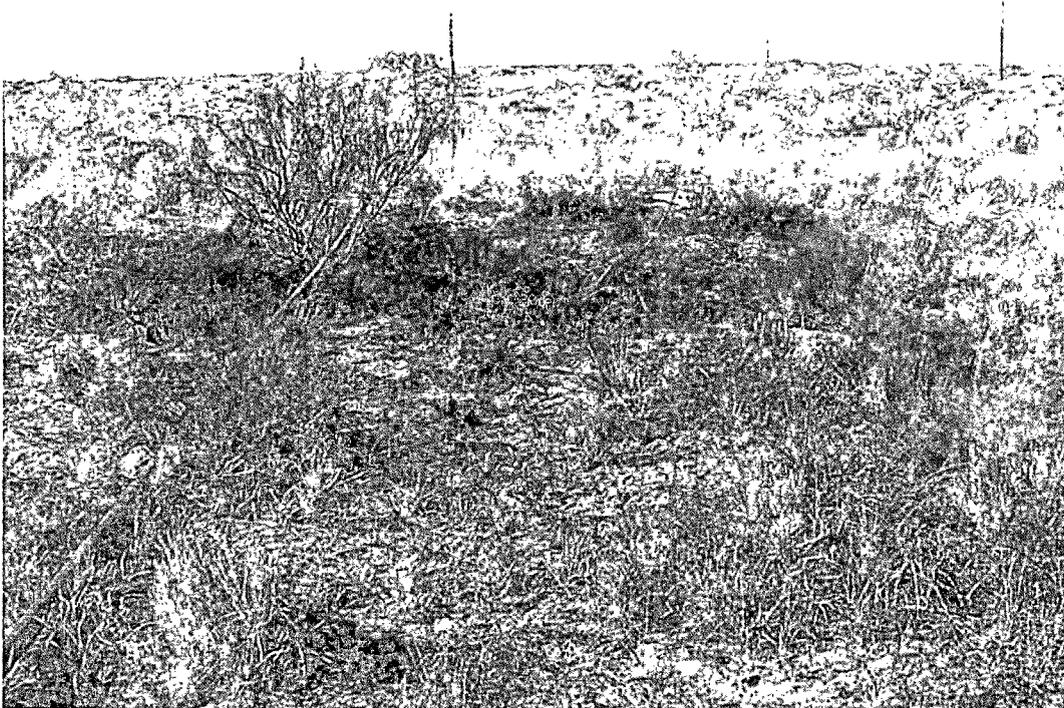
Photograph of the initial release at the S & W 4" Historical Release Site.

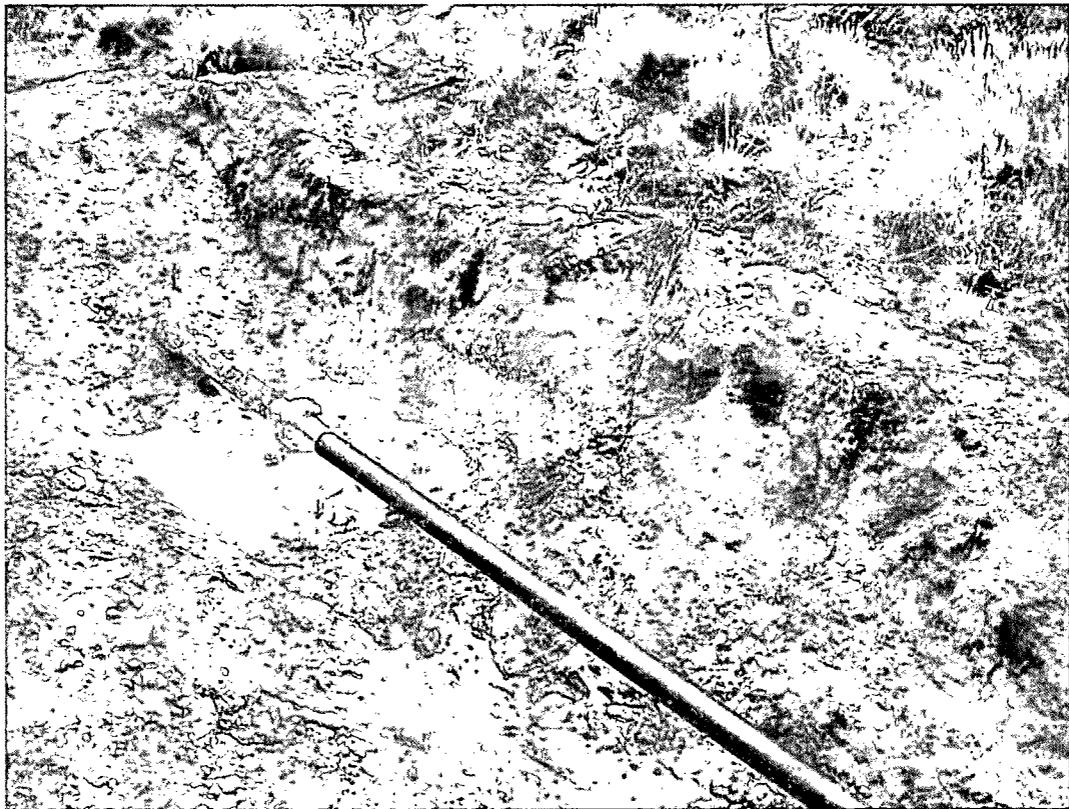
Photograph of the pipeline replacement and excavation activities at the S & W 4" Historical Release Site.

The 4" steel gathering pipeline, operating at 20 psi developed a leak, the line was blocked in and allowed to blow down on 5/27/06. Repair crews replaced the affected area of pipe by replacing approximately 400 ft. of steel pipe with poly-pipe on 8/11/06. Normal operating pressure on the line is 20 psi to 30 psi, with a potential H₂S content of 4000 ppm.

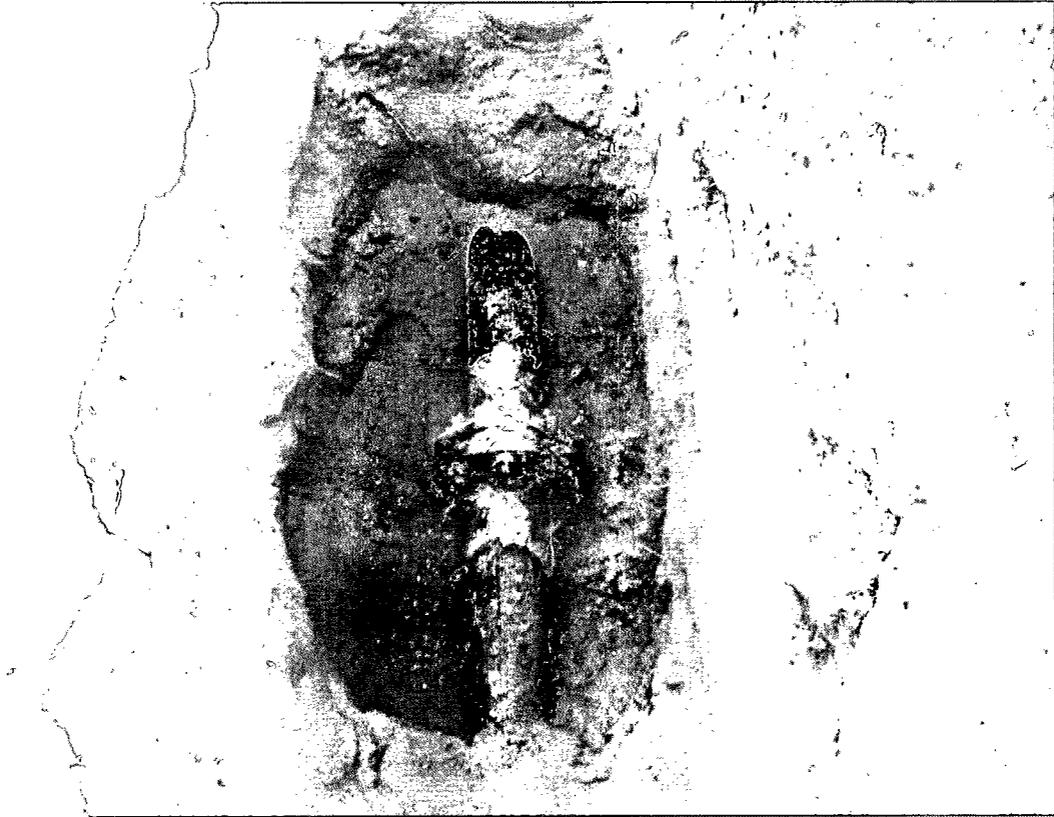
Photograph of delineation activities at the S & W 4" Historical Release Site.

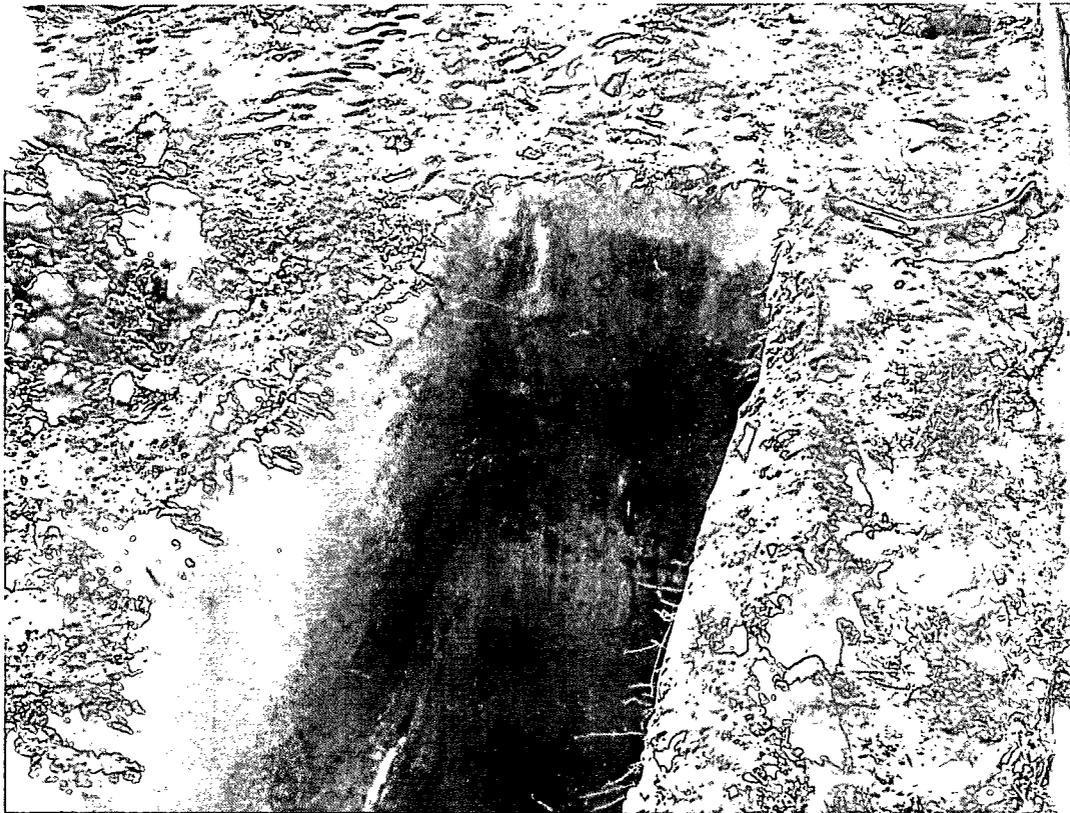
Photograph of delineation activities at the S & W 4" Historical Release Site.

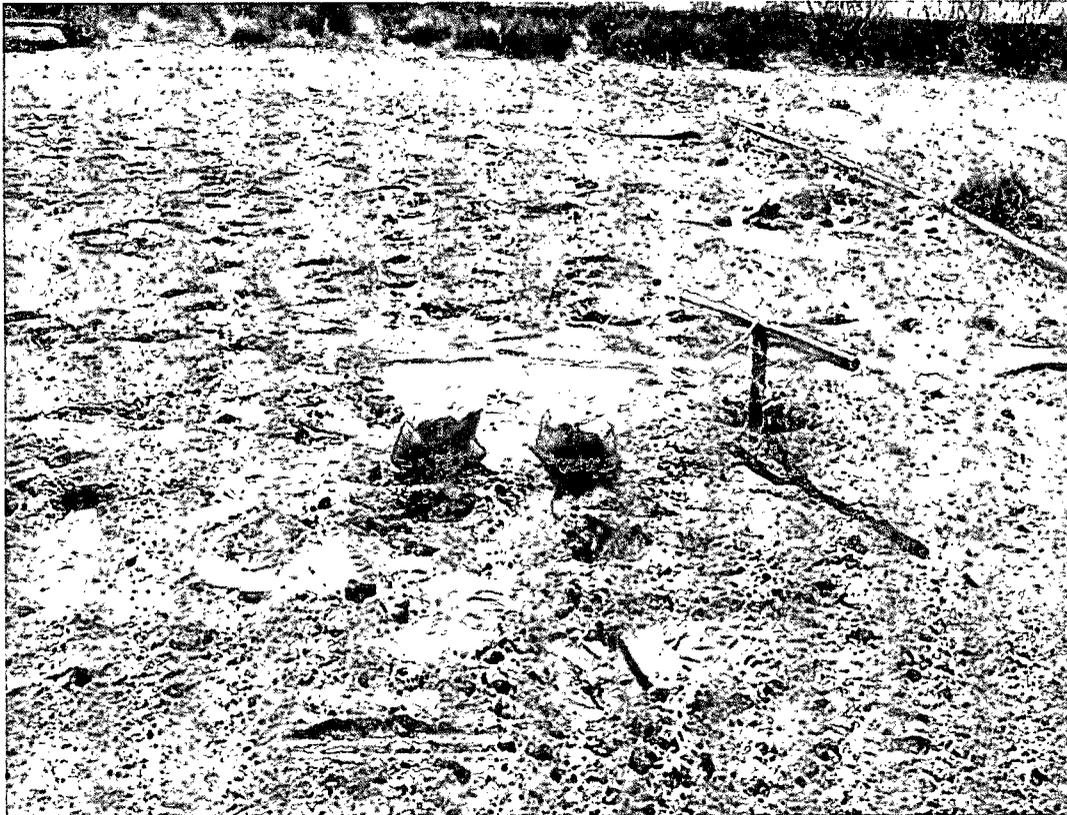
Photograph of the advancement of Soil Boring SB-1 at the S & W 4" Historical Release Site.

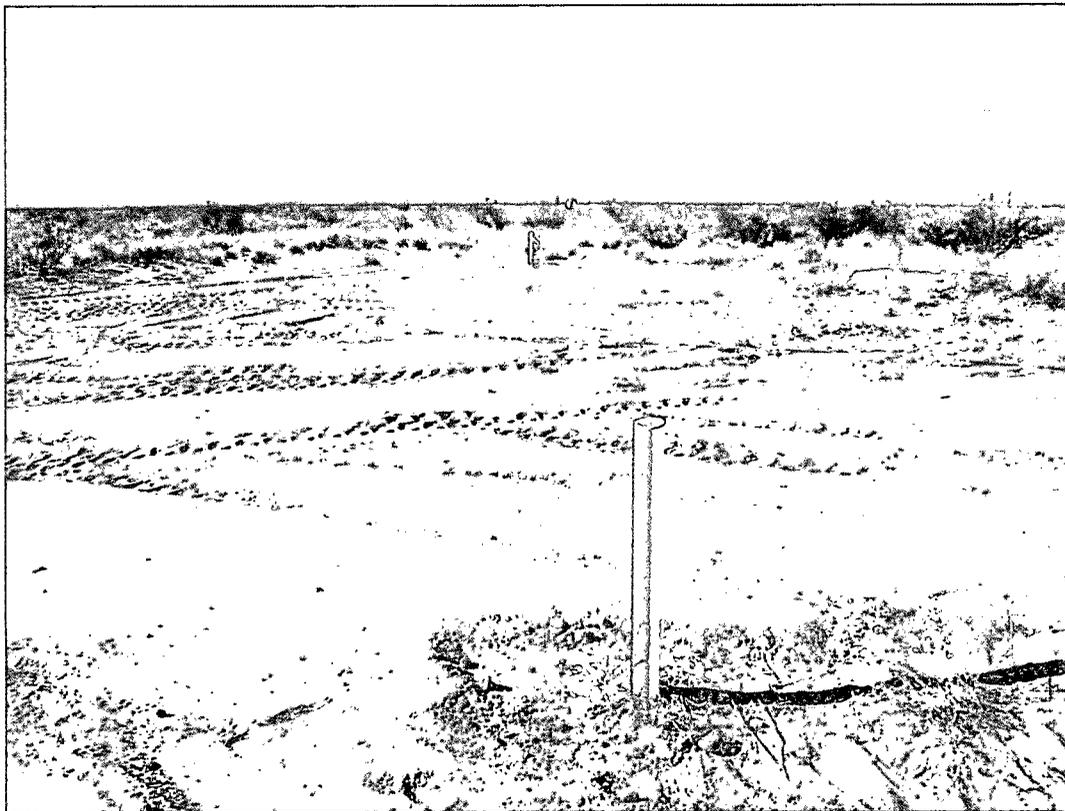
Photograph of the S & W 4" Historical Release Site after delineation activities.

Confirmation soil samples collected from the S & W 4" Lateral Historical Release Site were analyzed by an NMOCD-approved laboratory, which determined that benzene, BTEX, TPH, chloride and sulfide concentrations were less than NMOCD regulatory remediation action levels for each of the submitted soil samples. Based on these laboratory analytical results, Basin recommends Southern Union provide the NMOCD Hobbs District Office and the NMSLO a copy of this *Remediation Summary & Site Closure Request* and request the NMOCD grant site closure to the S & W 4" Lateral Historical Release Site.
