**RE: Termination Request  
for the Rice Operating Company's  
EME D-17 EOL Site  
Unit Letter D, Section 17, T21S, R36E, NMPM, Lea County, New Mexico  
Remediation Plan (1R427-323) Termination**

RE: Termination Request  
EME D-17 EOL (1R427-323): UL/D, Sec. 17, T21S, R36E  
RICE Operating Company – Eunice Monument Eumont SWD System

RICE OPERATING COMPANY  
JUNCTION BOX FINAL REPORT

## EME D-17 EOL

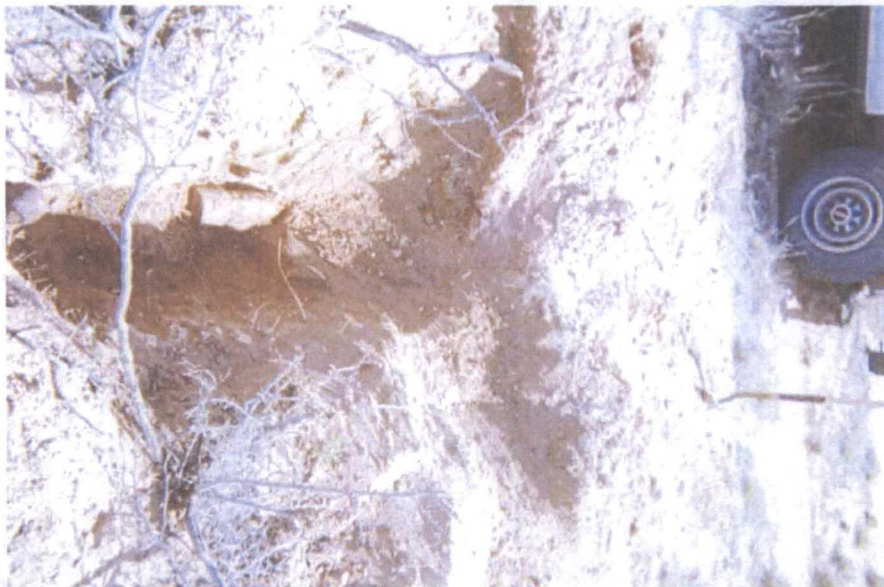
Site prior to excavation

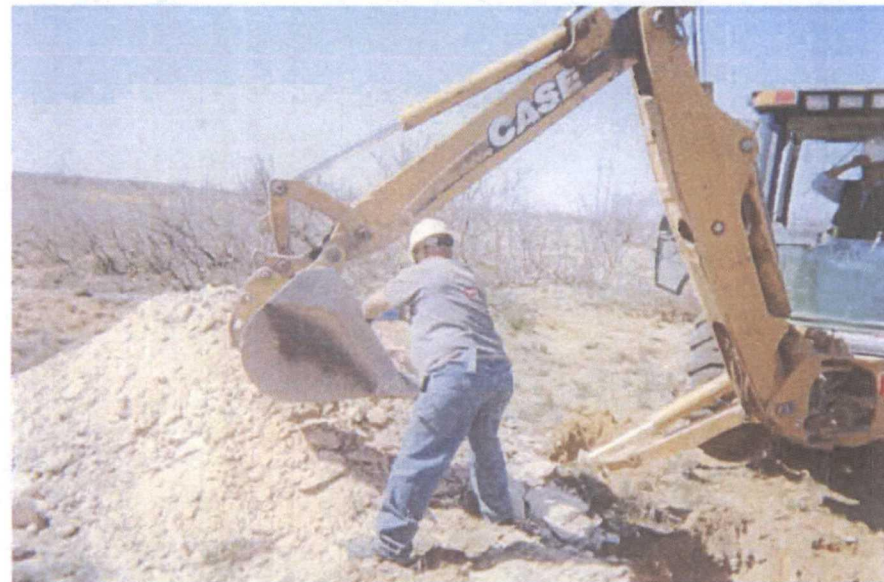
Collecting a soil sample

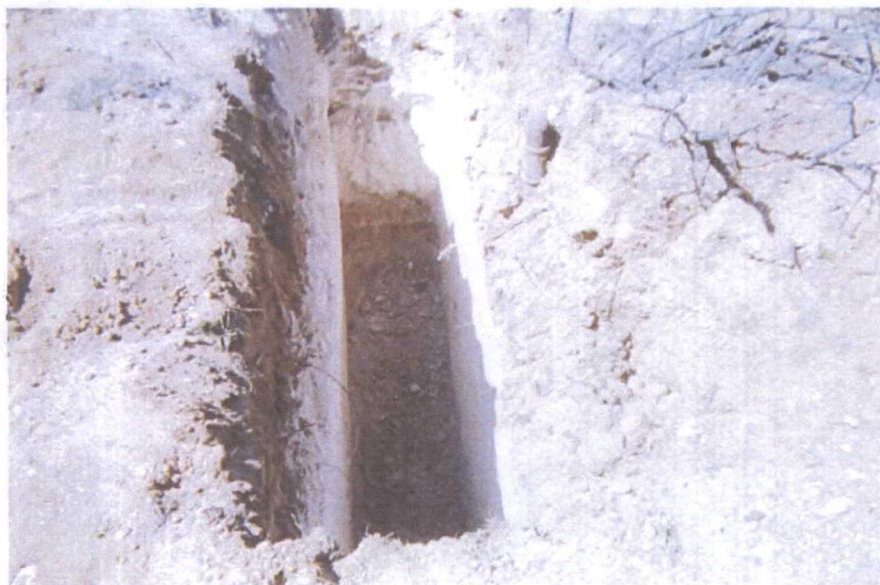
Final excavation

**General Description of Remedial Action:** This junction box and line were eliminated during the pipeline replacement/upgrade program. After the former junction box was removed, an investigation was conducted using a backhoe to collect soil samples at regular intervals producing a 5x3x8-ft-deep excavation. Chloride field tests performed on each sample yielded low concentrations similar to that of the background. Organic vapors were measured using a PID and also yielded low concentrations. The deepest sample, 8 ft. BGS was sent to a commercial laboratory for analysis of chloride and TPH, which confirmed low concentrations. The excavated soil was returned to the excavation to ground surface and contoured to the surrounding area. On 4/7/2010, the site was seeded with a blend of native vegetation and is expected to return to a productive capacity at a normal rate.

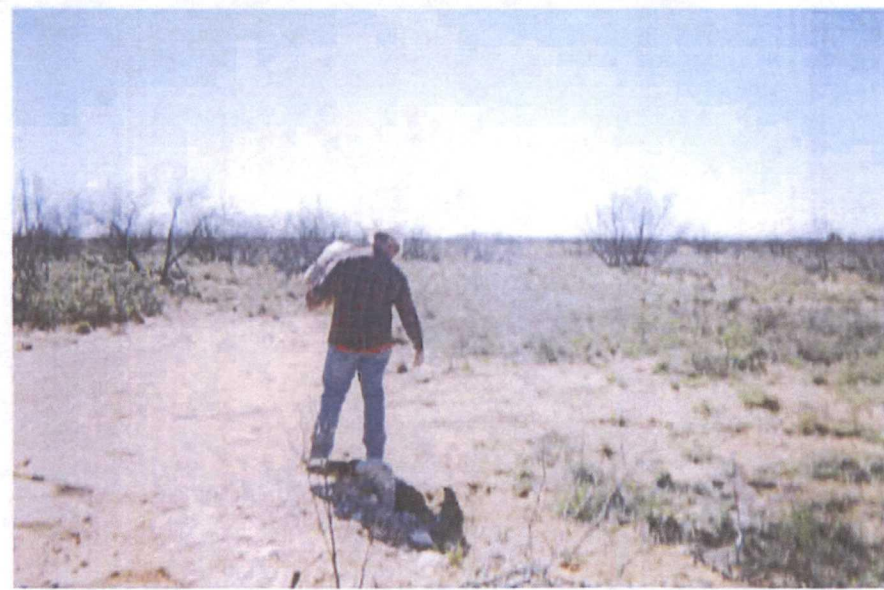
Seeding excavation

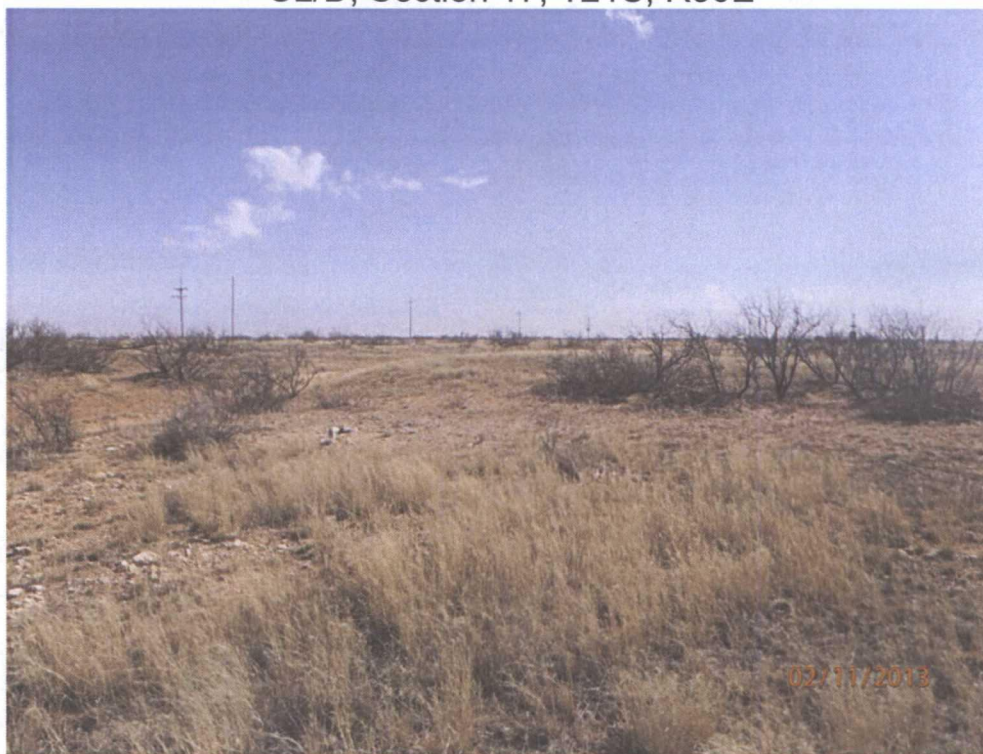
Facing south

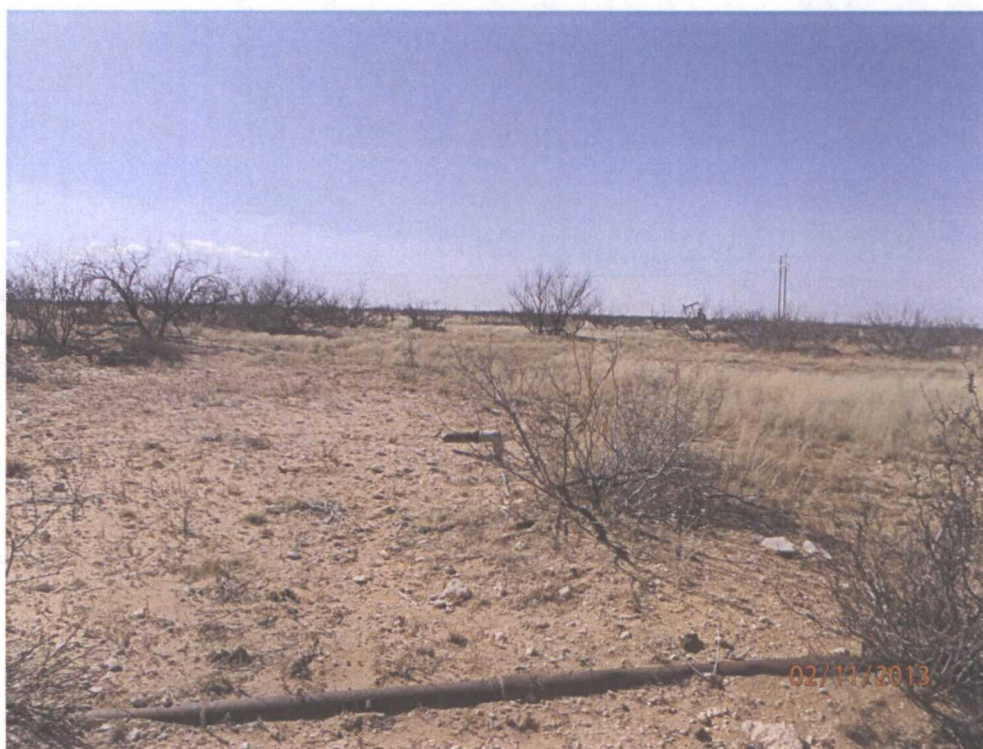
Facing west
