From: Hansen, Edward J., EMNRD
Sent: Monday, March 25, 2013 5:32 PM
To: Hack Conder (hconder@riceswd.com)
Cc: Leking, Geoffrey R, EMNRD; Laura Pena (lpena@riceswd.com); Katie Jones <kjones@riceswd.com> (kjones@riceswd.com); Scott Curtis (scurtis@riceswd.com)
Subject: Remediation Plan (1R427-336) Termination - ROC EME Jct P-17 Site

RE: Termination Request
EME Jct. P-17 (1R427-336): UL/P, Sec. 17, T21S, R36E
RICE Operating Company – Eunice Monument Eumont SWD System

RICE OPERATING COMPANY JUNCTION BOX FINAL REPORT

2012 ANNUAL GROUNDWATER REPORT
NMOCD Case # 1R426-153
Blinebry-Drinkard (BD) N-32 Vent
T21S, R37E, Section 32, Unit N, Lea County, New Mexico

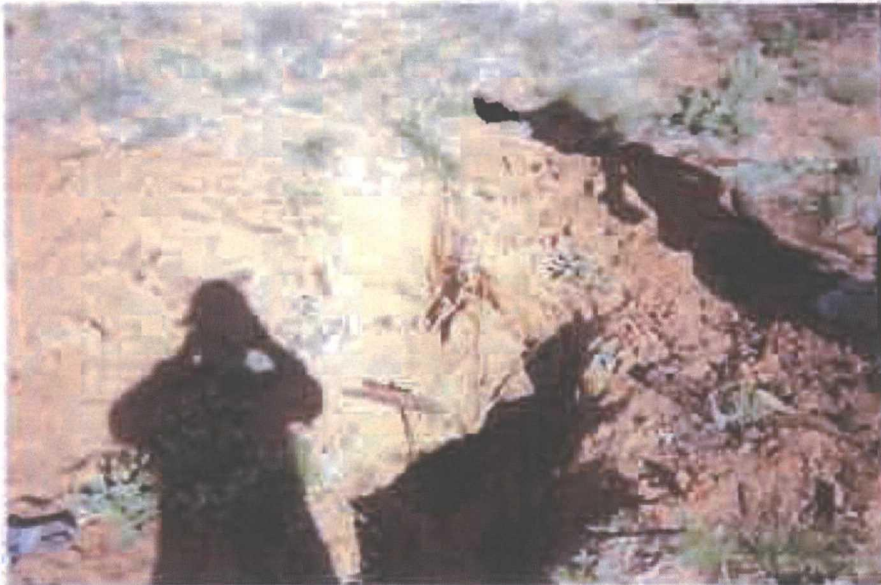
Site prior to excavation

General Description of Remedial Action: This junction box and line were eliminated during the pipeline replacement/upgrade program. After the former junction box was removed, an investigation was conducted using a backhoe to collect soil samples at regular intervals producing a 5x3x6-ft. deep excavation. Chloride field tests performed on each sample yielded low concentrations similar to that of the background. Organic vapors were measured using a PID, which yielded low concentrations. The deepest sample, 6 ft. BGS was sent to a commercial laboratory for analysis of chloride and TPH, which confirmed low concentrations. The excavated soil was returned to the excavation to ground surface and contoured to the surrounding area. On 7/13/2010, the site was seeded with a blend of native vegetation and is expected to return to a productive capacity at a normal rate.

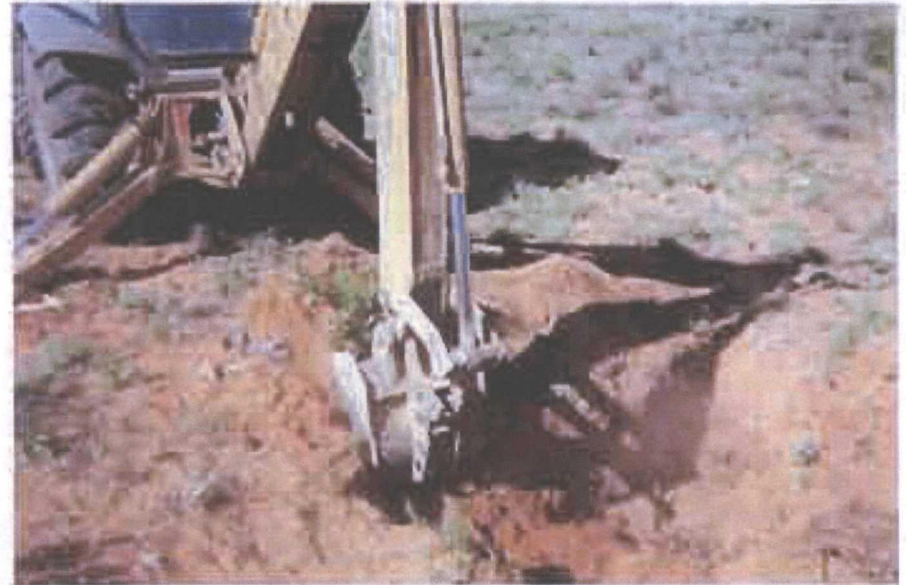
Delineation trench being excavated

LOCATION	DEPTH	mg/kg
background	6"	83
vertical delineation trench at the junction (source)	2'	151
	3'	143
	4'	87
	5'	270
	6'	165

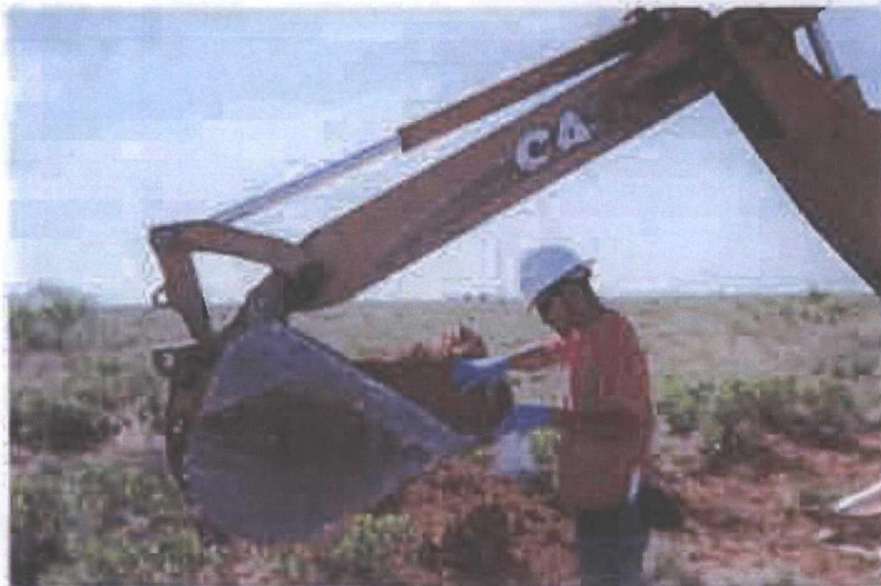
Sample being collected

FINAL ANALYTICAL RESULTS: Sample Date 5/11/2010 Sample Depth 6 ft.

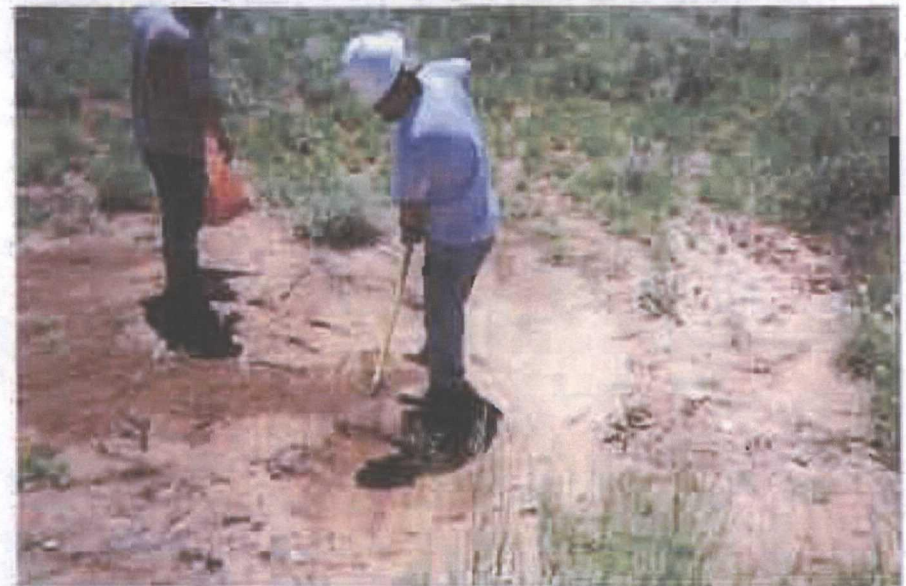
Seeding excavation

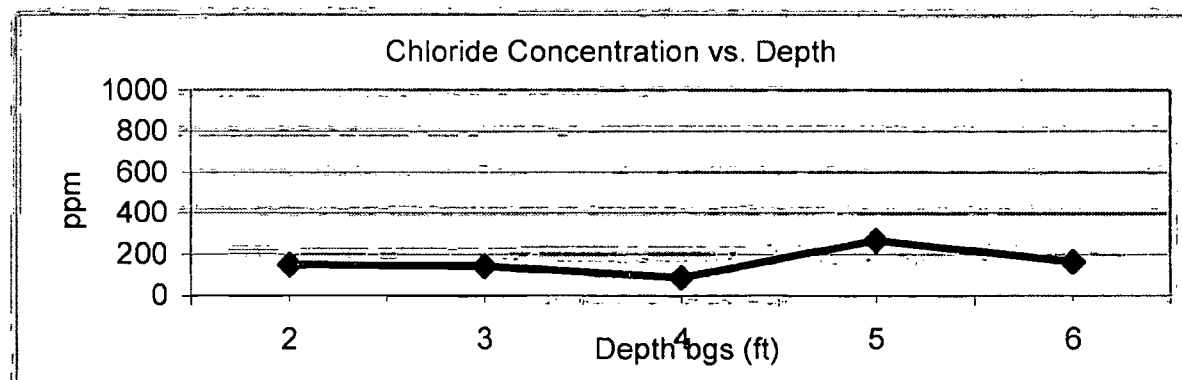
CHLORIDE CONCENTRATION CURVE

Backhoe samples at the junction (source)

Depth bgs (ft)	[Cl ⁻] ppm
2	151
3	143
4	87
5	270
6	165

Groundwater = 170 ft.

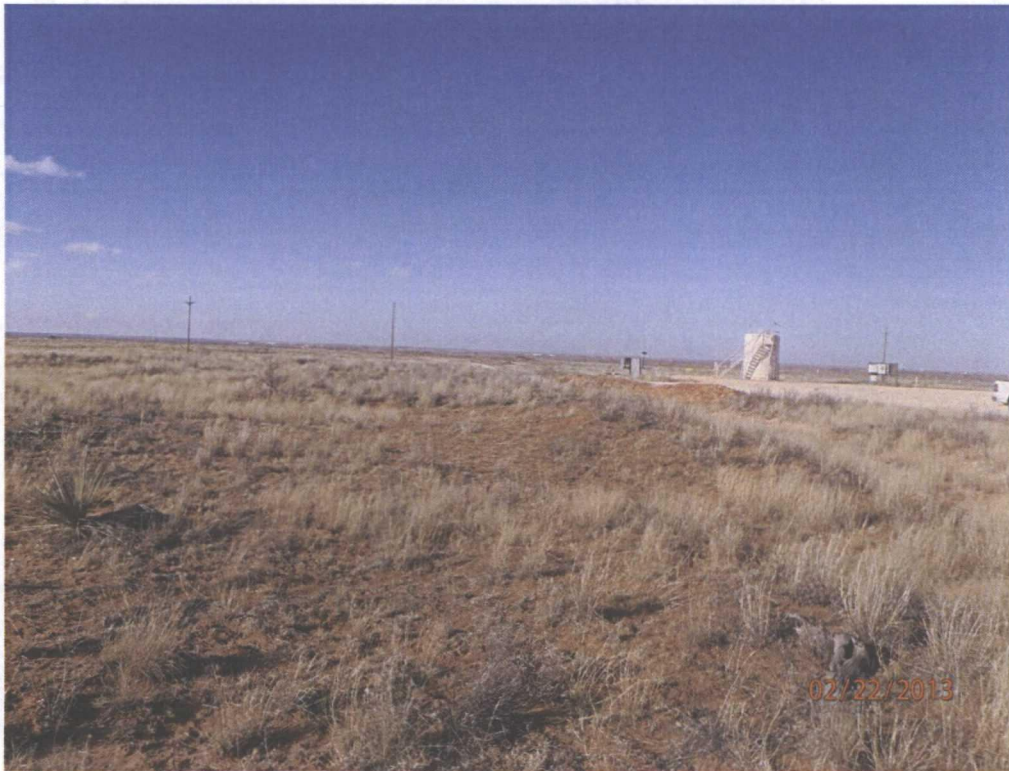
Facing north

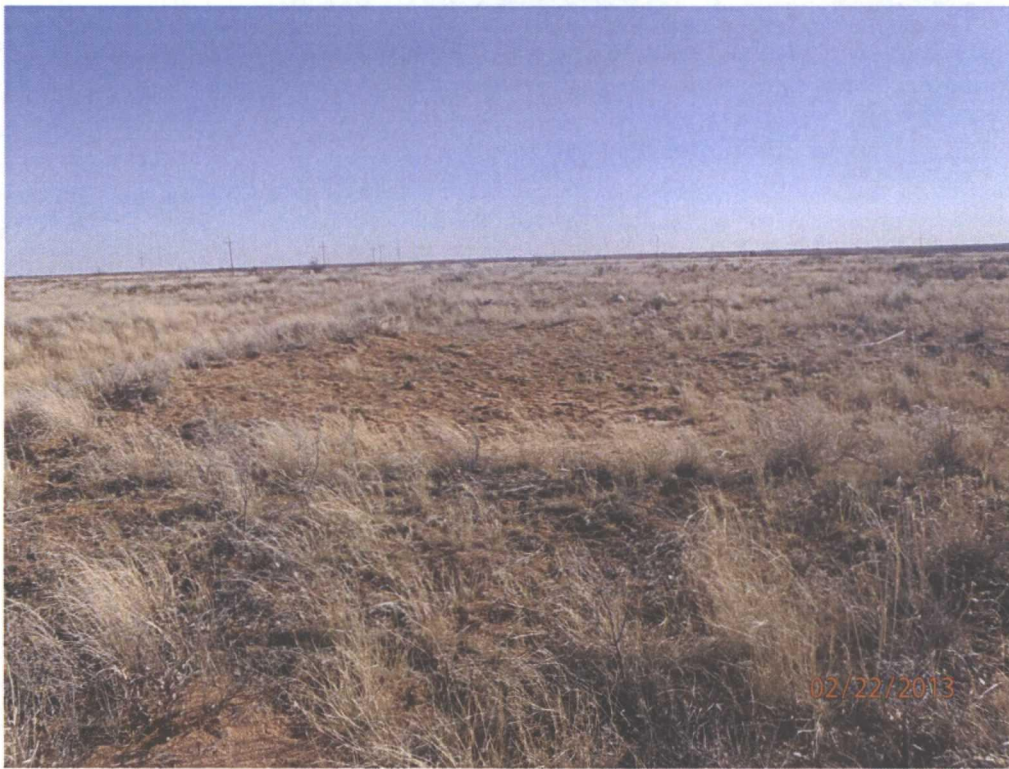
Facing south
