RE: Termination Request
EME Jct. D-15 (1R427-309): UL/D, Sec. 15, T21S, R36E
RICE Operating Company – Eunice Monument Eumont SWD System

**RICE OPERATING COMPANY
JUNCTION BOX FINAL REPORT**

EME Jct. D-15

Unit D, Section 15, T21S, R36E

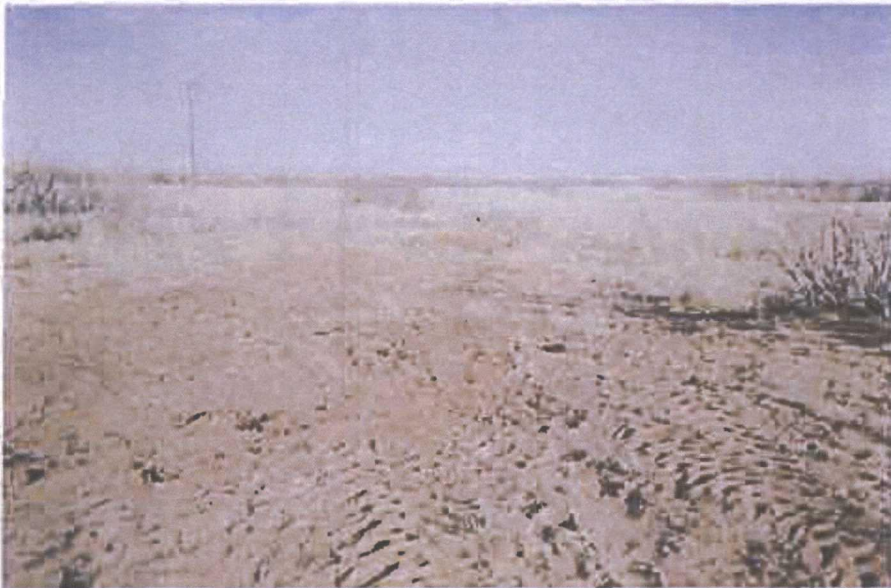
site prior to excavation, facing north

1/13/2009

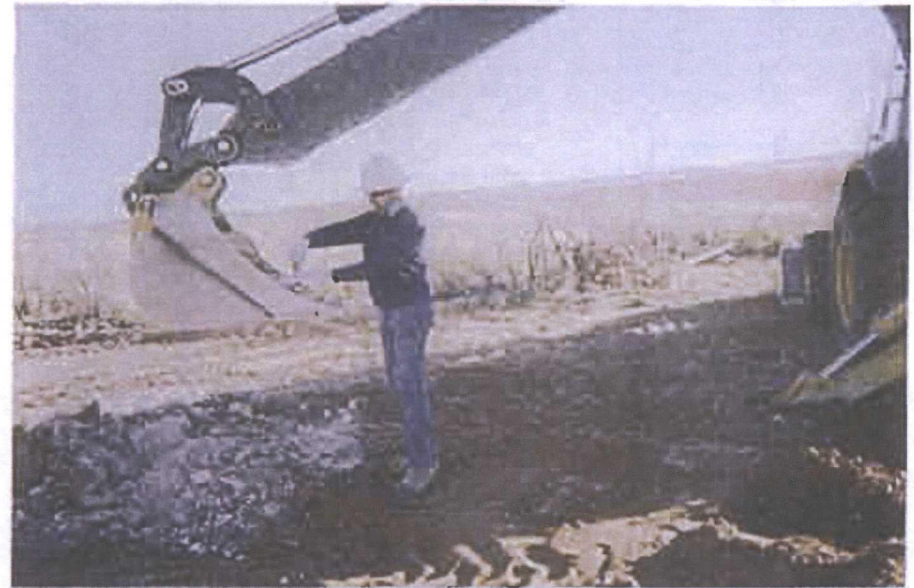
collecting a soil sample, facing east

1/19/2009

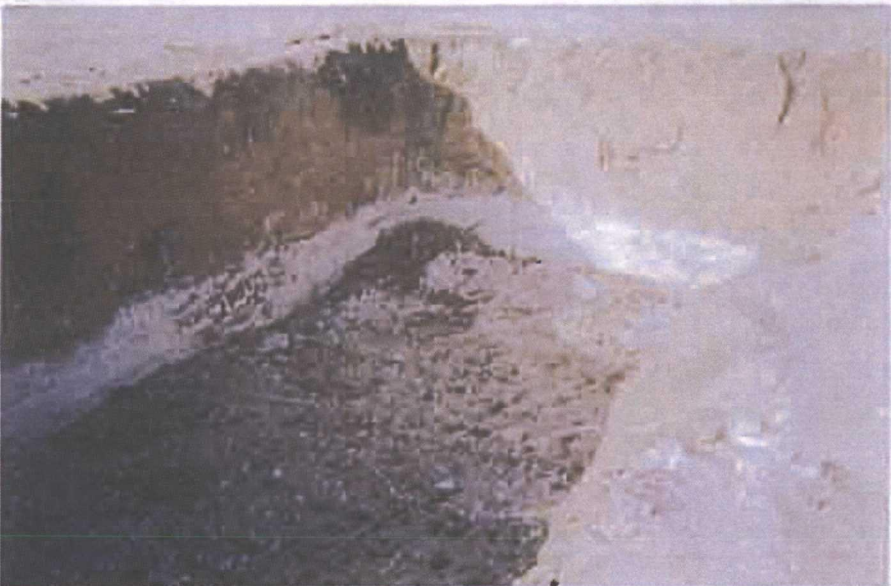
final 35x25x12-ft excavation, facing west

2/24/2009

This junction was eliminated during the pipeline replacement/upgrade program. After the former junction box was removed, an investigation was conducted using a backhoe to collect soil samples at regular intervals producing a 35x25x12-ft-deep excavation. Chloride field tests were performed on each sample, which yielded generally low concentrations. Organic vapors were measured using a PID, which also yielded low concentrations. The excavated soil was blended on site with clean, imported soil. Representative composite samples were collected from the excavation walls, bottom, and blended excavated soil. Laboratory analysis of the representative samples confirmed low concentrations. The blended excavated soil was returned to the excavation to ground surface and contoured to the surrounding area. On 2/25/2009, the site was seeded with a blend of native vegetation and is expected to return to a productive capacity at a normal rate.

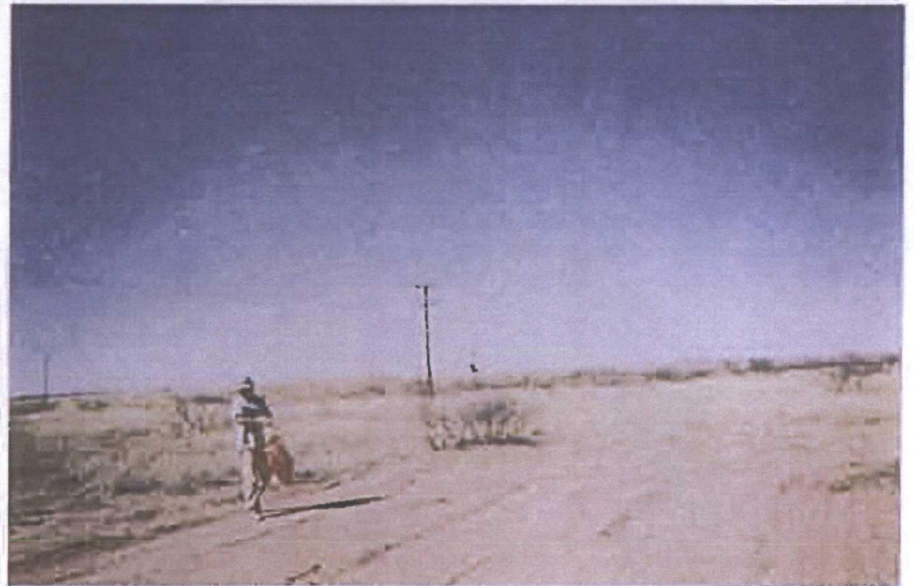
seeding backfilled site, facing north

2/25/2009

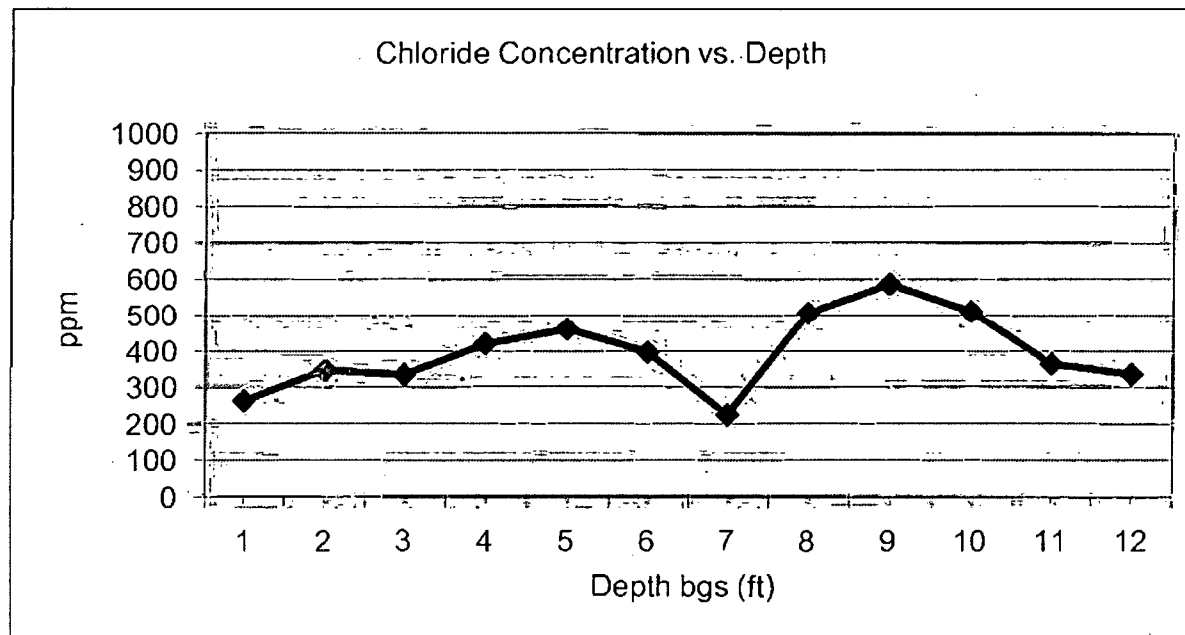
Backhoe samples at 15 ft North of the junction (source)

Depth bgs (ft)	[Cl ⁻] ppm
1	264
2	348
3	335
4	420
5	461
6	397
7	224
8	506
9	586
10	511
11	365
12	336

Groundwater = 195 ft

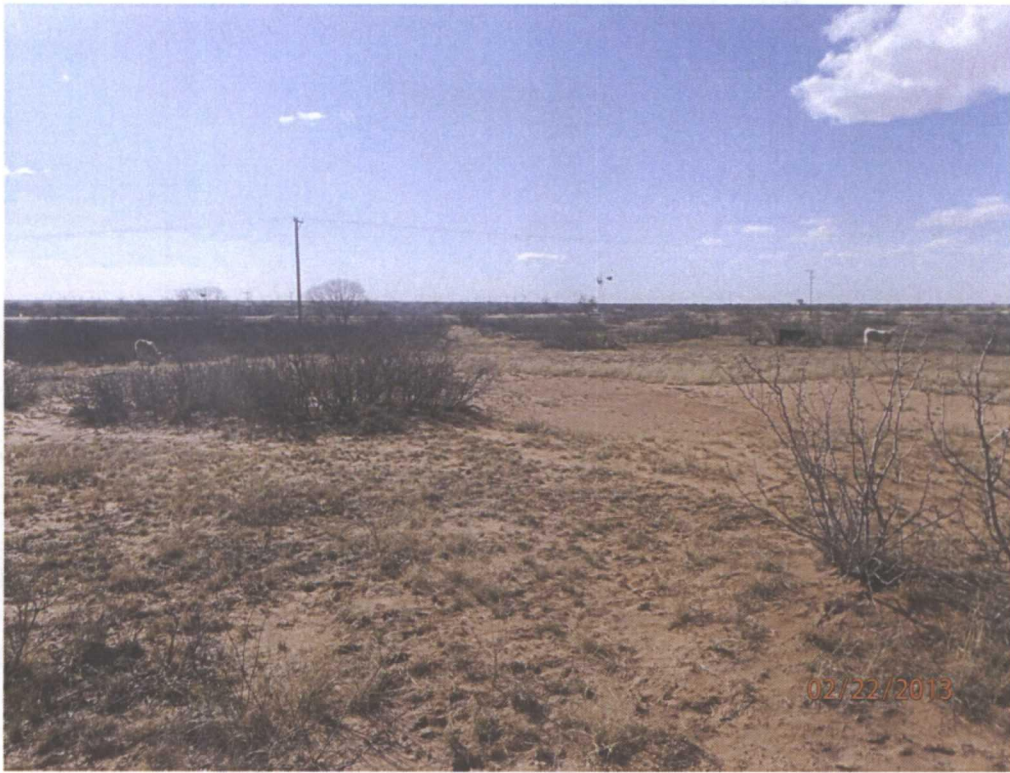
Facing west

2/22/2013

In 2009, ROC initiated work on the former D-15 junction box. The site is located in UL/D, Sec. 15, T21S, R36E. NM OSE records indicate that groundwater would likely be encountered at a depth of approximately 195 +/- feet. The site was delineated using a backhoe to collect soil samples at regular intervals, creating a 35x25x12 ft deep excavation. Each sample was field titrated for chlorides and field screened using a PID for hydrocarbons, resulting in chloride concentrations that decreased with depth. The excavated soil was blended on site and representative composite samples were collected from the excavation walls, bottom and blended backfill, resulting in a 4-wall chloride concentration of 160 mg/kg, and concentrations of gasoline range organics (GRO) and diesel range organics (DRO) below detectable limits. The bottom sample resulted in a chloride concentration of 352 mg/kg, a GRO concentration below detectable limits and a DRO concentration of 39.9 mg/kg. The blended backfill sample resulted in a chloride concentration of 96 mg/kg, a GRO concentration below detectable limits and a DRO concentration of 21.9 mg/kg. The blended backfill was returned to the excavation to ground surface and contoured to the surrounding area. On 2/25/2009, the site was seeded with a blend of native vegetation. A junction box is no longer needed at the site. Vegetation has rebounded at the site, so no re-vegetation efforts are needed. Vegetation

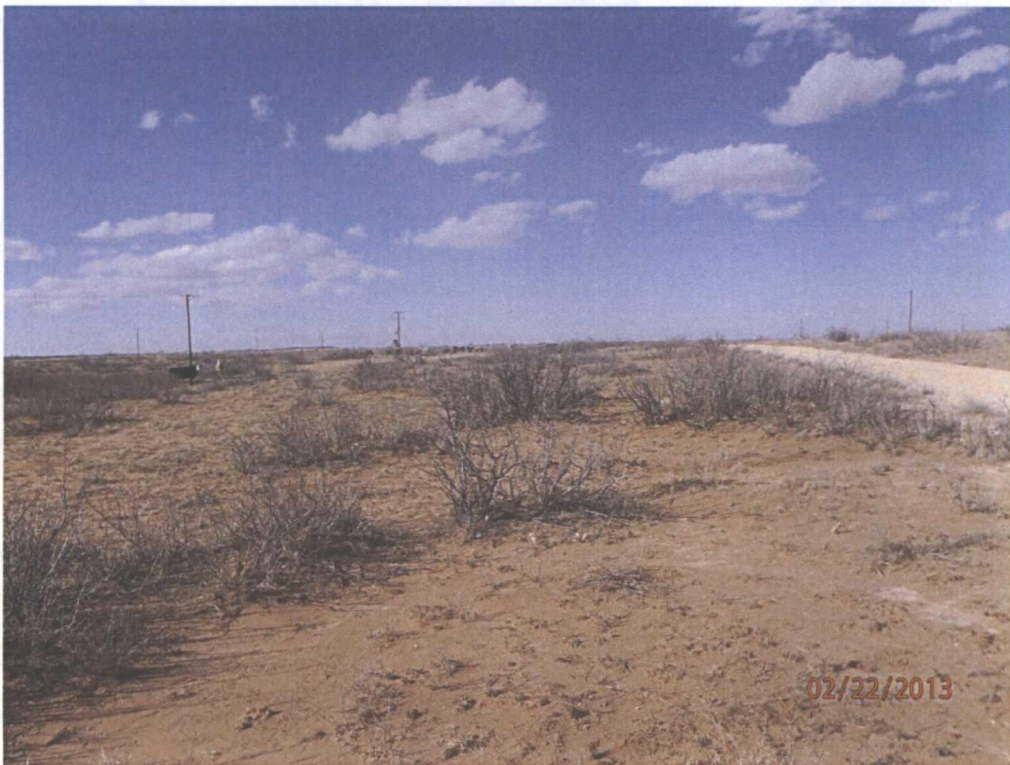
Facing north

2/22/2013
