**RE: Termination Request
for the Rice Operating Company's
EME L-15 EOL Site
Unit Letter L, Section 15, T21S, R36E, NMPM, Lea County, New Mexico
Remediation Plan (1R427-346) Termination**

RE: Termination Request
EME L-15 EOL (1R427-346): UL/L, Sec. 15, T21S, R36E
RICE Operating Company – Eunice Monument Eumont SWD System

Junction Box Report

**RICE OPERATING COMPANY
JUNCTION BOX FINAL REPORT**

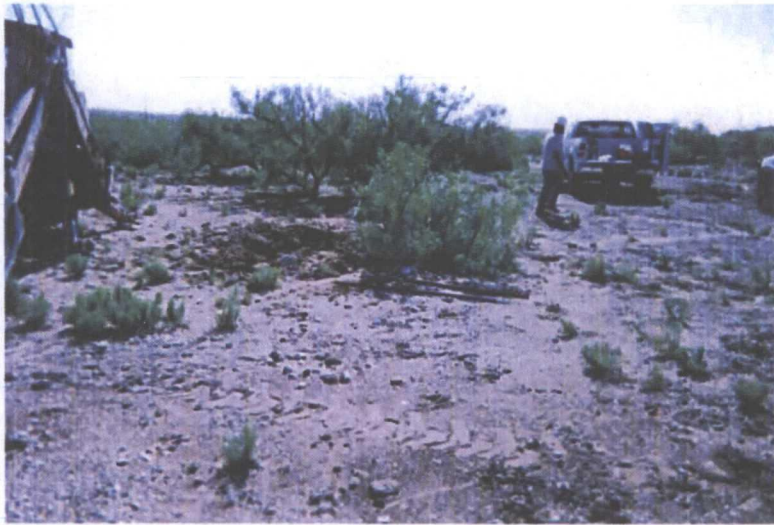
SITE PRIOR TO EXCAVATION

General Description of Remedial Action: This junction and line were eliminated during the pipeline replacement/upgrade program. After the former junction box was removed, an investigation was conducted using a backhoe to collect soil samples at regular intervals producing a 5x3x8-ft-deep excavation. Chloride field tests were performed on each sample which yielded low concentrations. Organic vapors, measured using a PID, yielded low concentrations of organic vapors. Laboratory analysis confirmed low concentrations of chloride and organics. The excavated soil was returned to the excavation, to ground surface and contoured to the surrounding area. On 12/03/2010, site was seeded with a blend of native vegetation and is expected to return to a productive capacity at a normal rate.

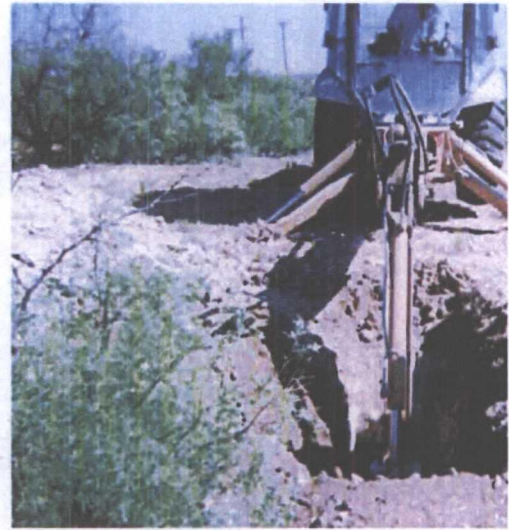
DELINEATION TRENCH BEING EXC.

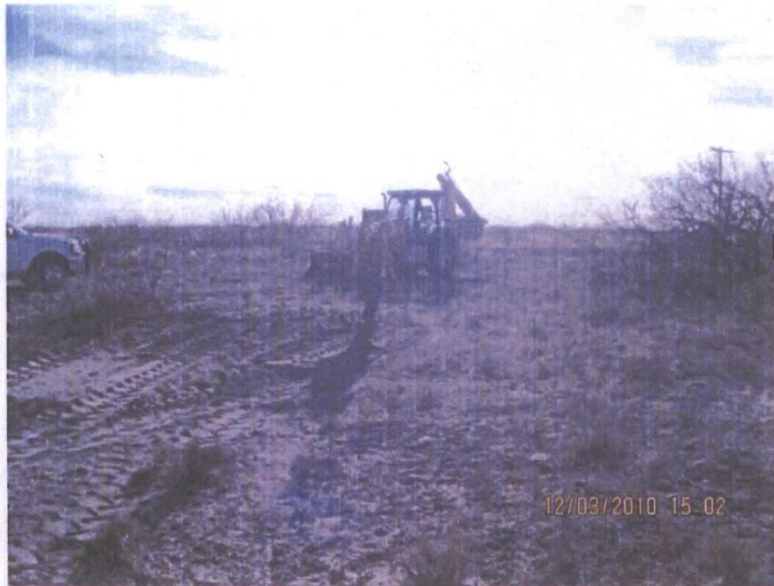
SEEDING SITE

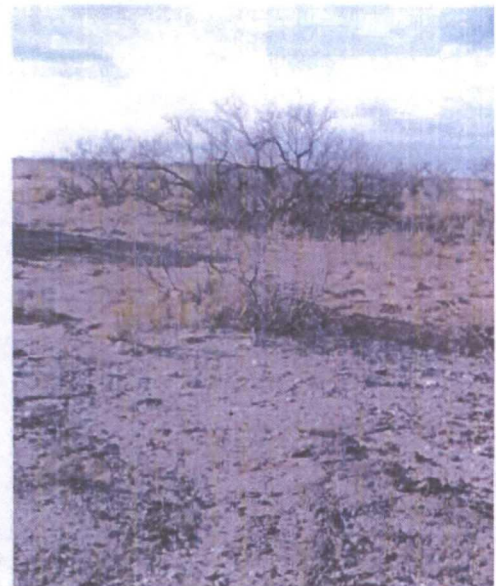
SITE COMPLETE

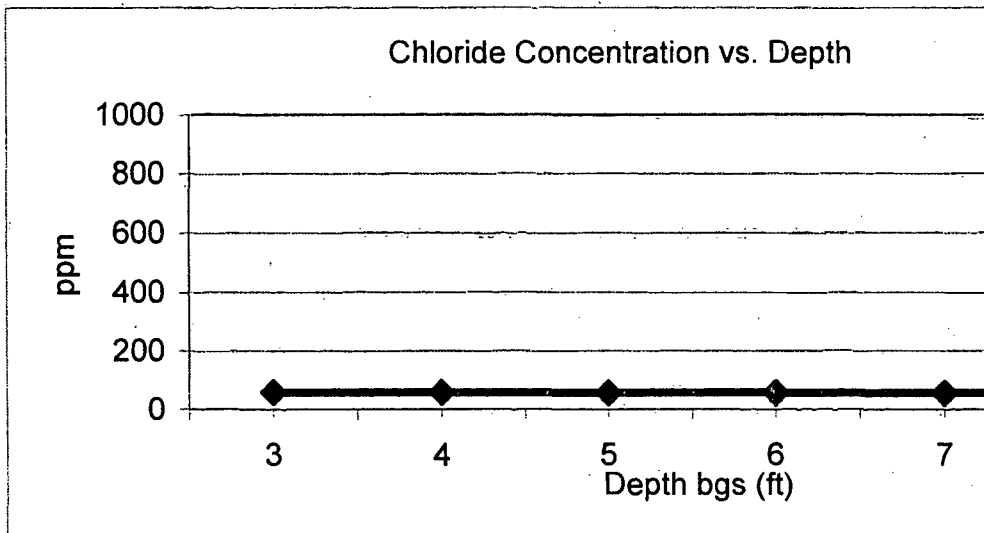
CHLORIDE CONCENTRATION CURVE

Delineation of Source

Depth bgs (ft)	[Cl] ppm
3	59
4	57
5	56
6	56
7	55
8	58

Groundwater = 195 ft

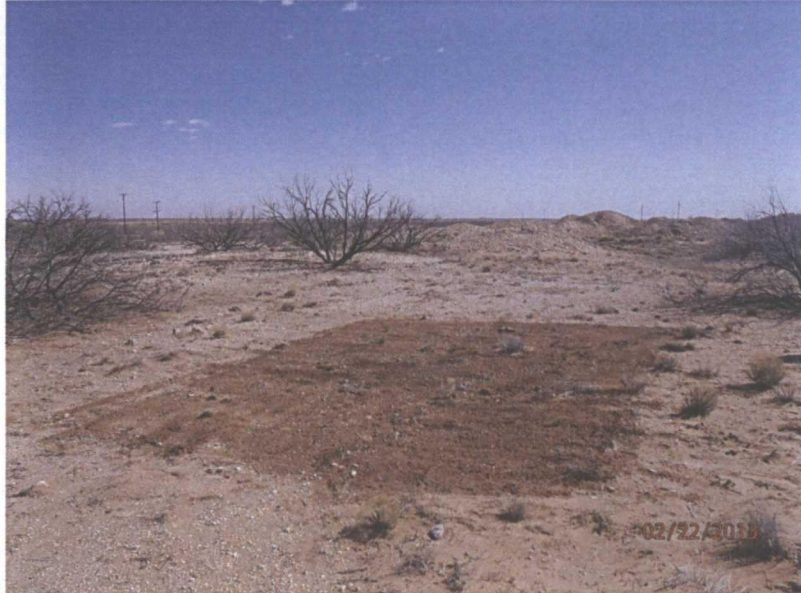
Site prior to seeding, facing east

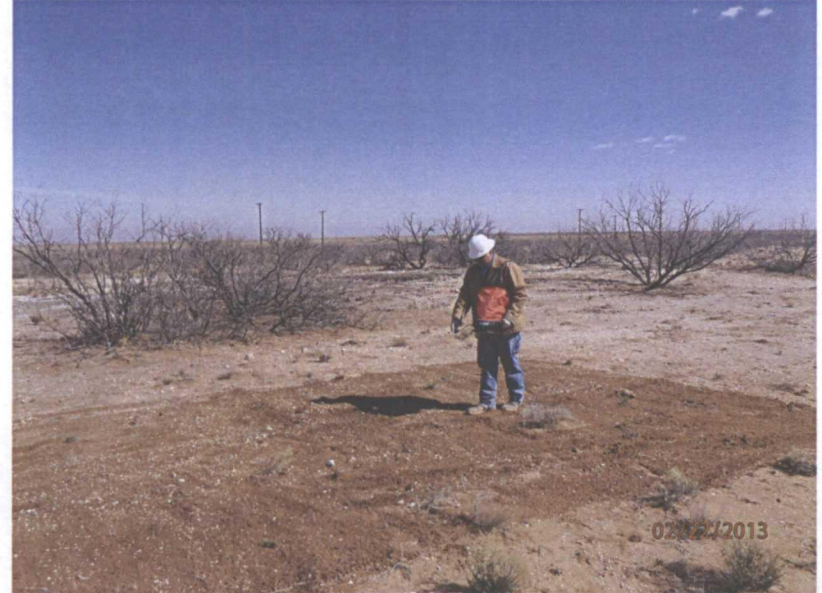
Seeding site, facing north

On 2/22/2013, RECS personnel were on site to seed the surrounding area. The site was seeded with a blend of native vegetation and is expected to return to a productive capacity at a normal rate. The site has been seeded and vegetation will inhibit the downward migration of constituents to groundwater. Vegetation will act as an evapo-

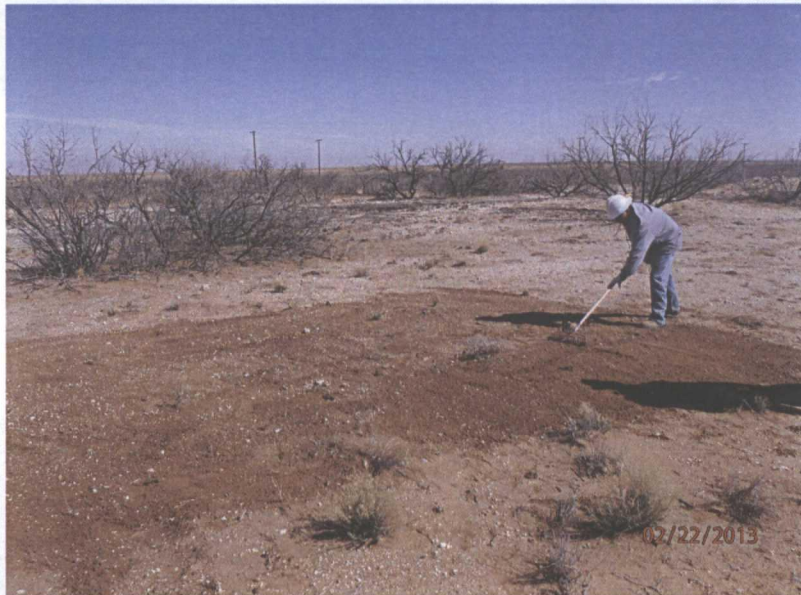
Raking in seed, facing northeast

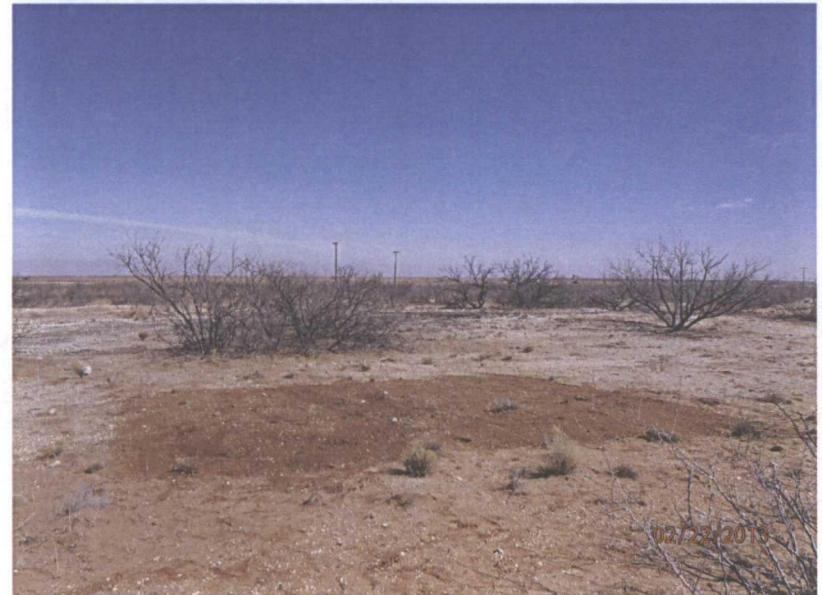
Site completed, facing northeast
