From: Hansen, Edward J., EMNRD
Sent: Tuesday, April 09, 2013 2:27 PM
To: Hack Conder (hconder@riceswd.com)
Cc: Leking, Geoffrey R, EMNRD; Laura Pena (lpena@riceswd.com); Katie Jones <kjones@riceswd.com> (kjones@riceswd.com); Scott Curtis (scurtis@riceswd.com)
Subject: Remediation Plan (1R427-355) Termination - ROC EME A-16 EOL Site

RE: Termination Request
EME A-16 EOL (1R427-355): UL/A, Sec. 16, T21S, R36E
RICE Operating Company – Eunice Monument Eumont SWD System

**RICE OPERATING COMPANY
JUNCTION BOX FINAL REPORT**

EME A-16 EOL

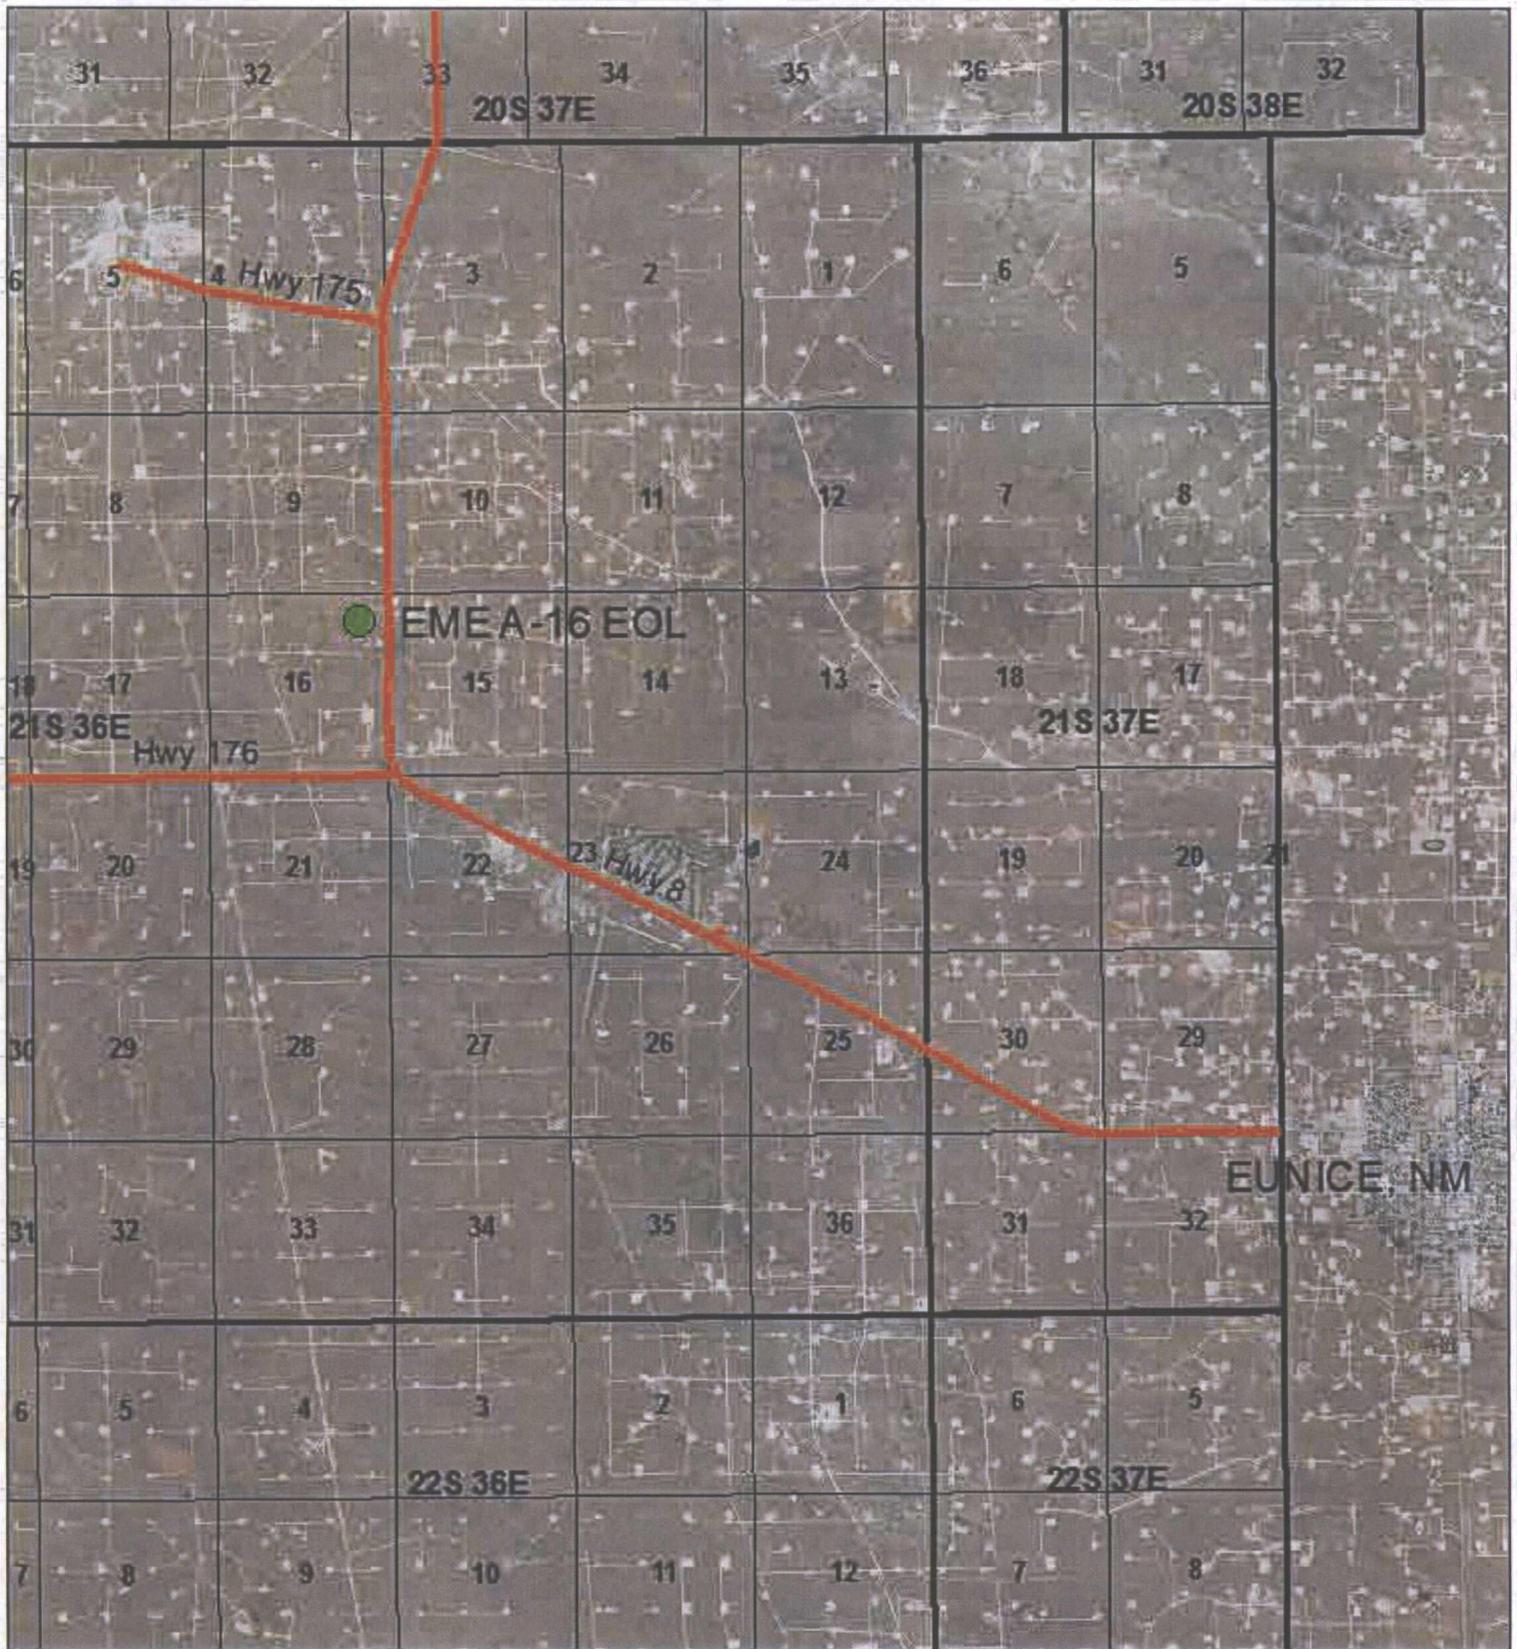
Site Location Map

EME A-16 EOL

UL A SECTION 16
T-21-S R-36-E
LEA COUNTY, NM

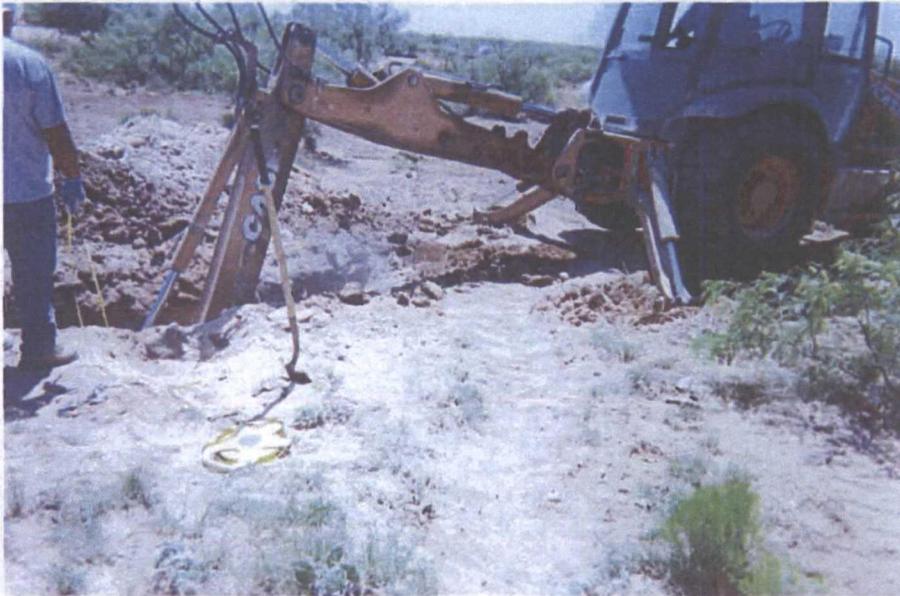
Delineation trench being excavated

6/25/2010

General Description of Remedial Action: This junction and line were eliminated under the pipeline replacement/upgrade program. After the former junction was removed, an investigation was conducted using a backhoe to collect soil samples at regular intervals, creating a 5x3x12-ft. Excavation. Chloride field tests were performed on each sample, which yielded low concentrations of chloride similar to that of the background sample. Organic vapors were measured using a PID, which also yielded low concentrations. The deepest sample, 12 ft BGS, was sent to a commercial laboratory for analysis, which confirmed low concentrations of chloride and organics. The excavated soil was returned to the excavation to ground surface and contoured to the surrounding area. On 9/27/2010, site was seeded with a blend of native vegetation and is expected to return to a productive capacity at a normal rate.

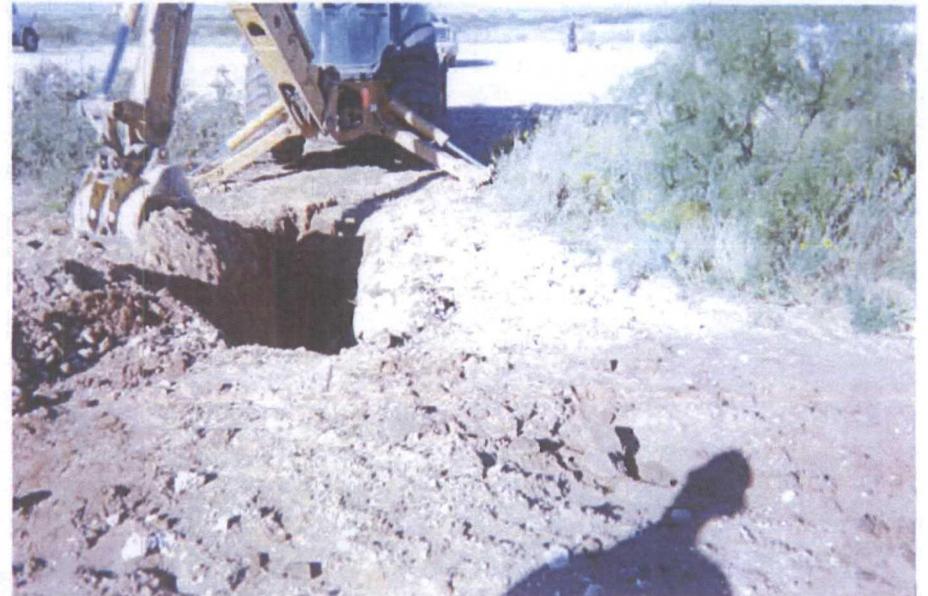
Backfilling trench

9/27/2010

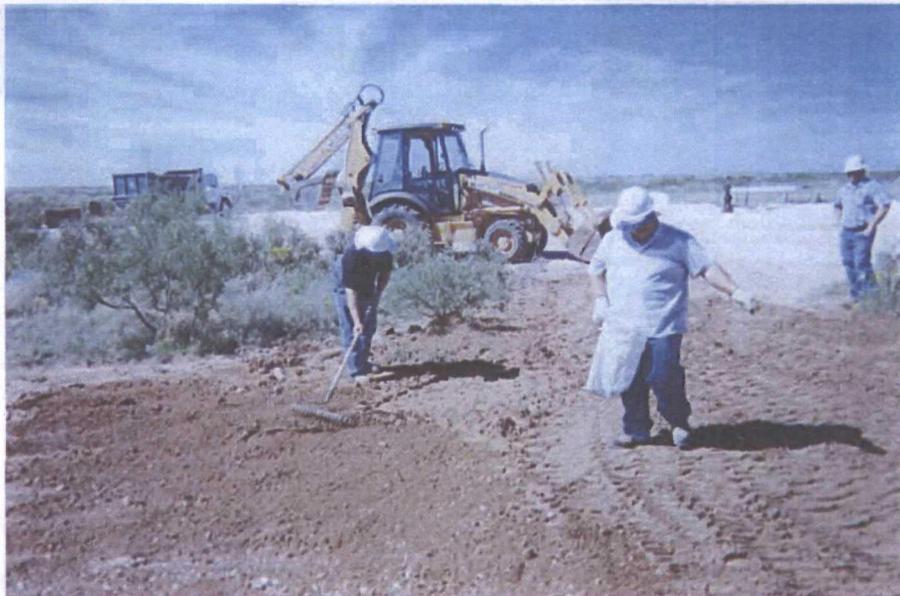
Seeding excavation

9/27/2010

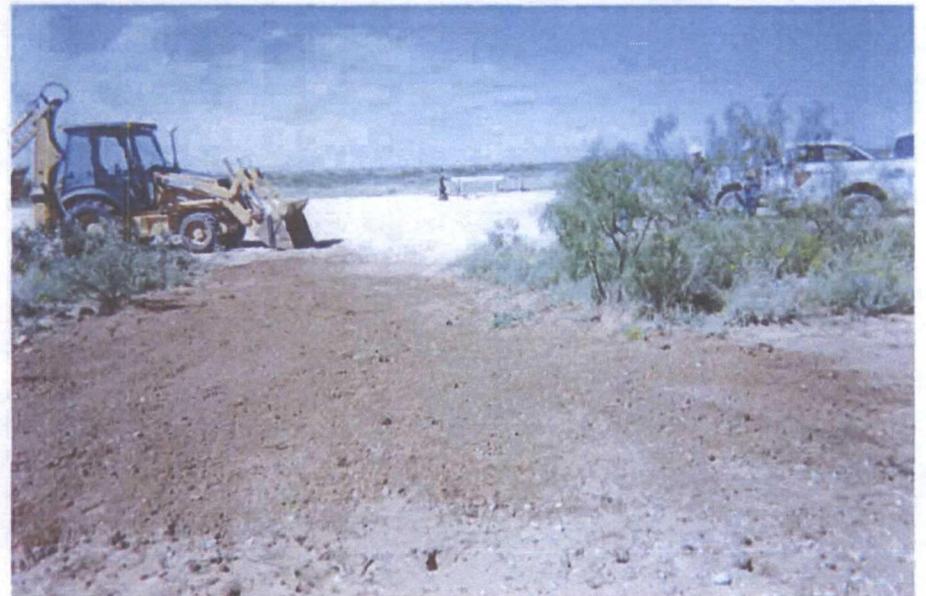
Excavation complete

9/27/2010

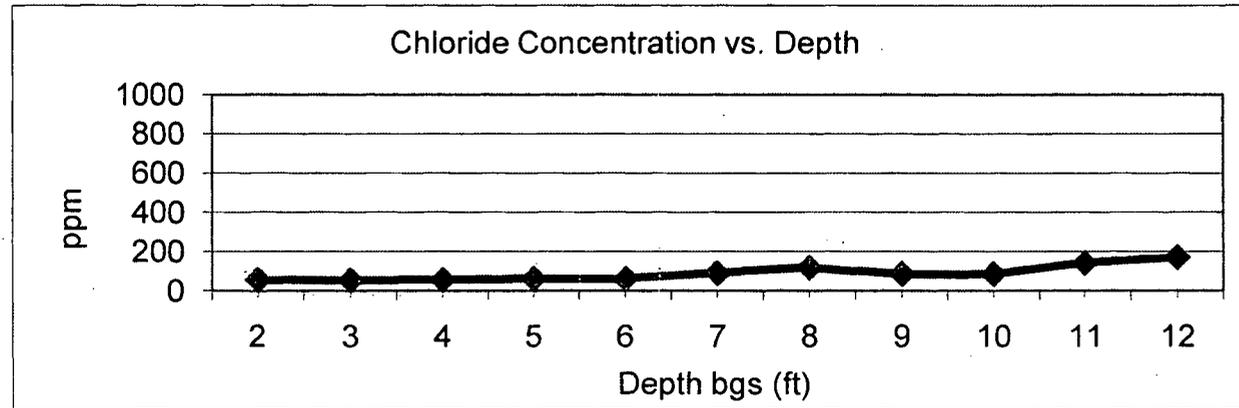
Backhoe samples at the junction (source)

Depth bgs (ft)	Cl ppm
2	57
3	54
4	57
5	61
6	62
7	92
8	118
9	86
10	85
11	141
12	170

Groundwater = 195 ft.

LOCATION	DEPTH	mg/kg
background	6'	57
vertical delineation trench at the junction (source)	2'	57
	3'	54
	4'	57
	5'	61
	6'	62
	7'	92
	8'	118
	9'	86
	10'	85
	11'	141
	12'	170

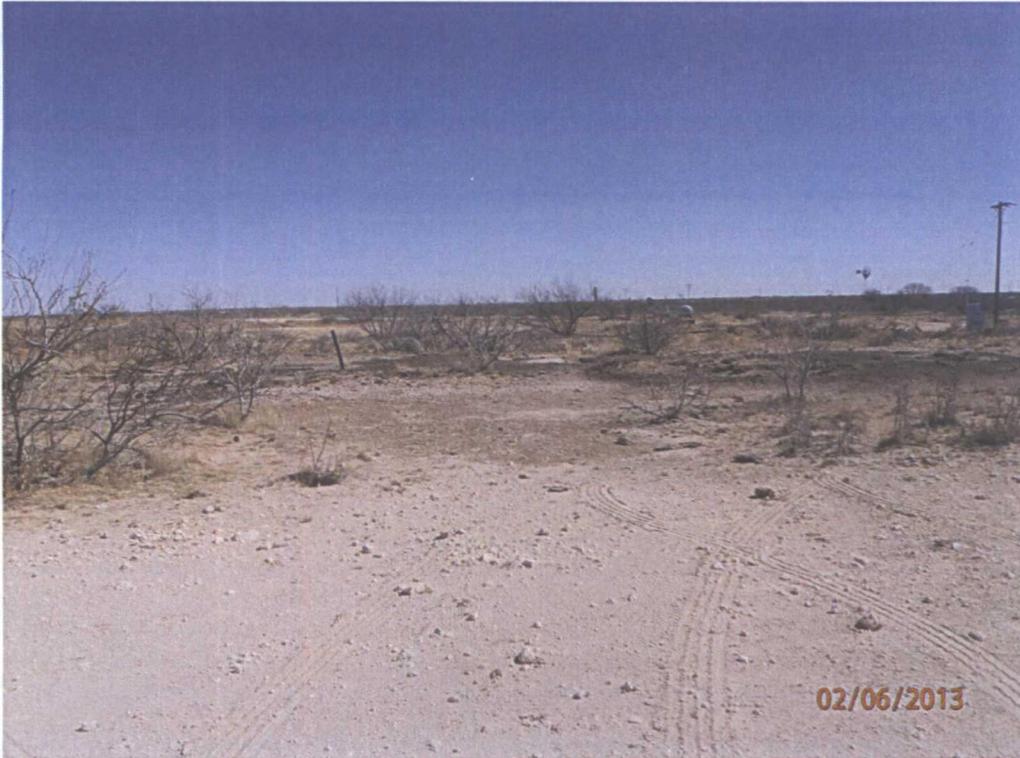
Facing northwest

2/6/2013

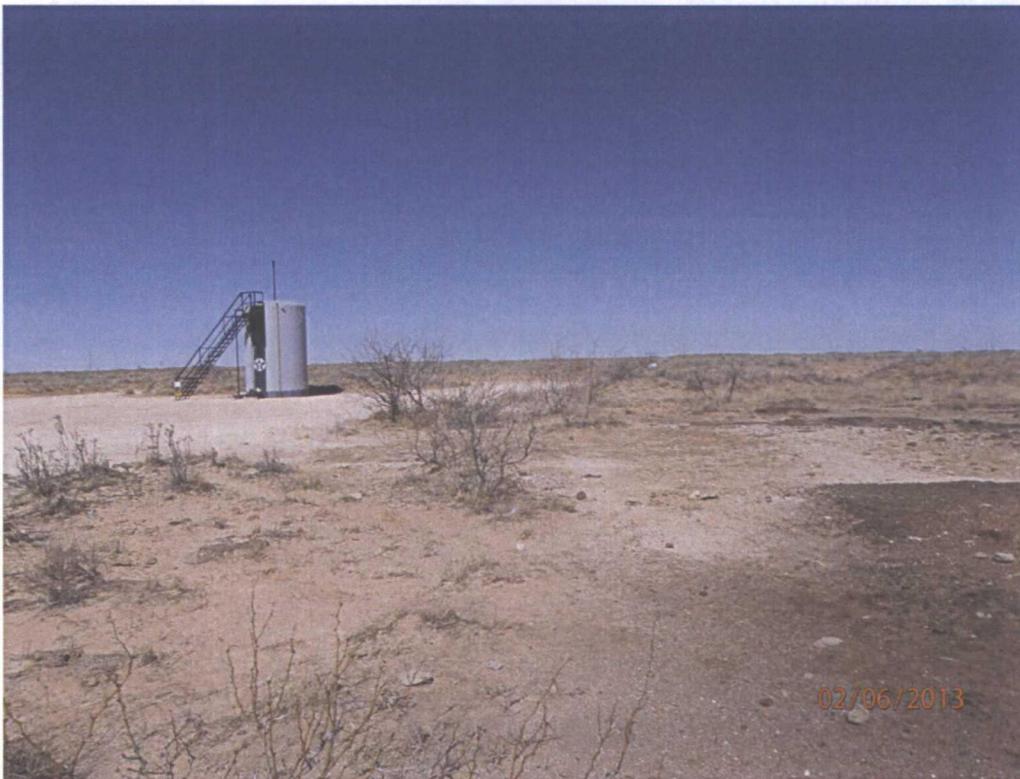
Facing east

2/6/2013
