**RE: Termination Request
for the Rice Operating Company's
EME Jct L-19-1 Site
Unit Letter L, Section 19, T20S, R37E, NMPM, Lea County, New Mexico
Remediation Plan (1R427-293) Termination**

RE: Termination Request
EME Jct. L-19-1 (1R427-293): UL/L, Sec. 19, T20S, R37E
RICE Operating Company – Eunice Monument Eumont SWD System

EME Jct. L-19-1

**RICE OPERATING COMPANY
JUNCTION BOX FINAL REPORT**

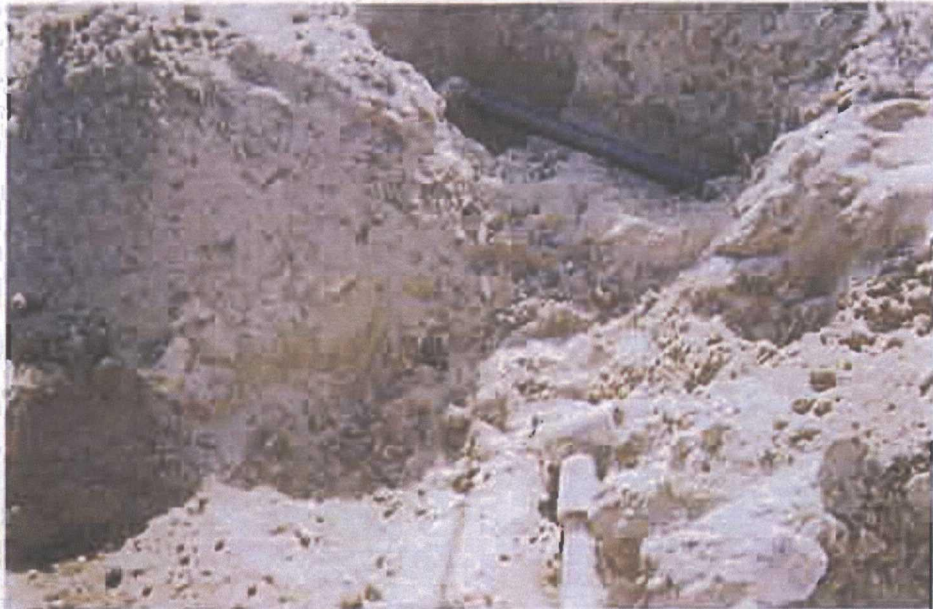
capped lines at the former
junction box, facing southeast

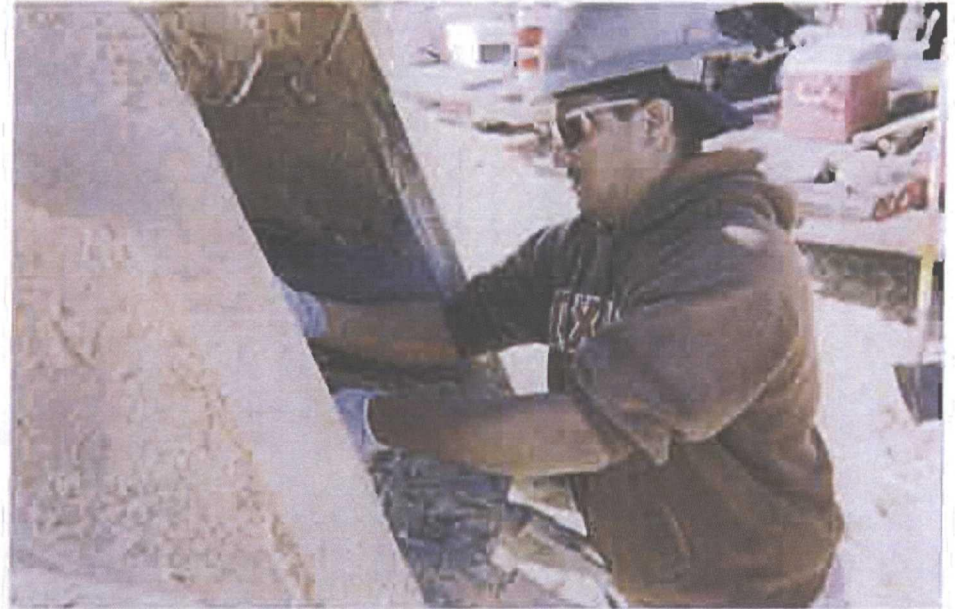
collecting a soil sample, facing southwest

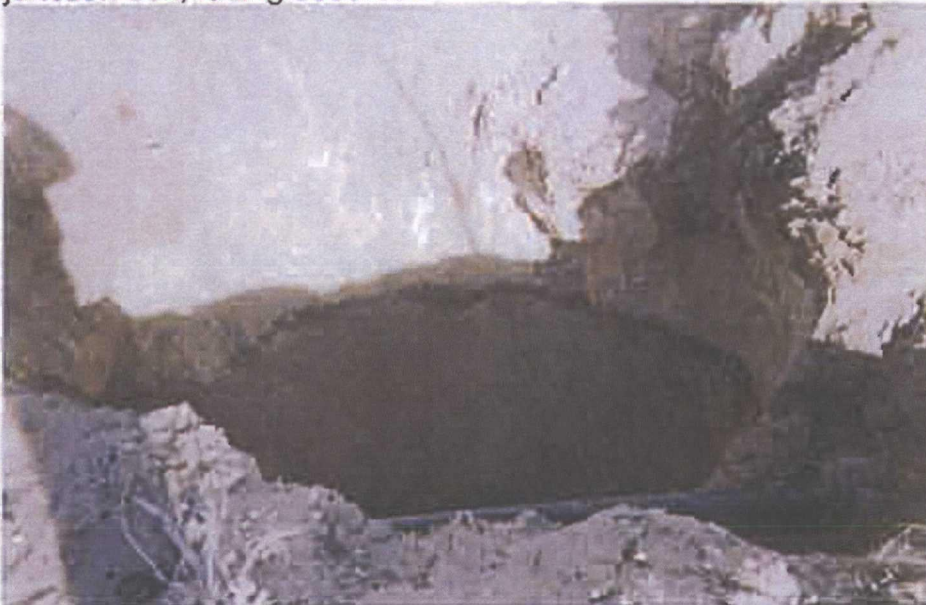
final 5x3x12-ft-deep excavation, facing north

General Description of Remedial Action: This junction box was eliminated during the pipeline replacement/upgrade program. After the former junction box was removed, an investigation was conducted using a backhoe to collect soil samples at regular intervals producing a 5x3x12-ft-deep excavation. Chloride field tests performed on each sample yielded low concentrations similar to that of the background. Organic vapors were measured using a PID and also yielded low concentrations. The deepest sample was analyzed by a commercial laboratory which confirmed low concentrations. The excavated soil was returned to the excavation to ground surface and contoured to the surrounding area. On 2/13/2009, the site was seeded with a blend of native vegetation and is expected to return to a productive capacity at a normal rate.

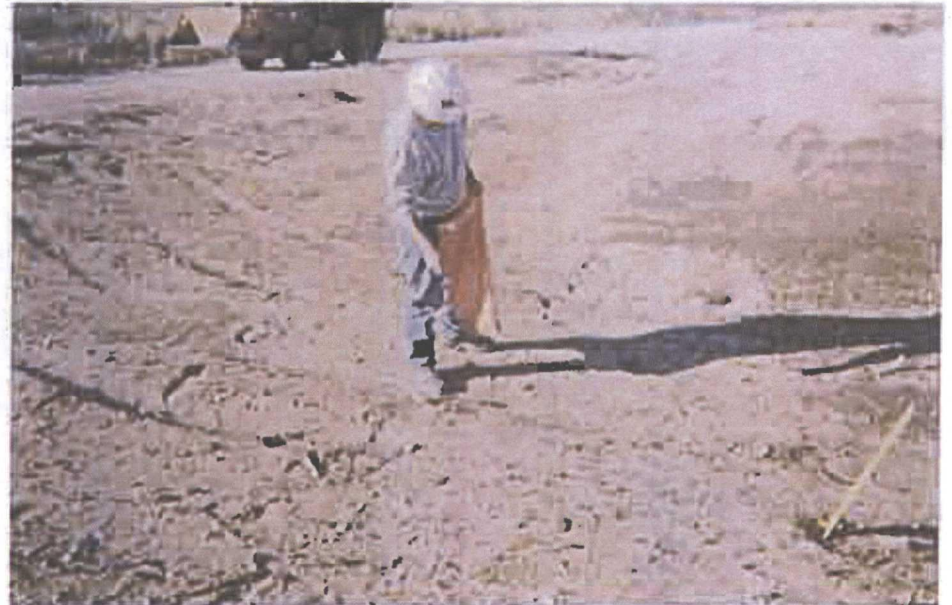
seeding backfilled site, facing north

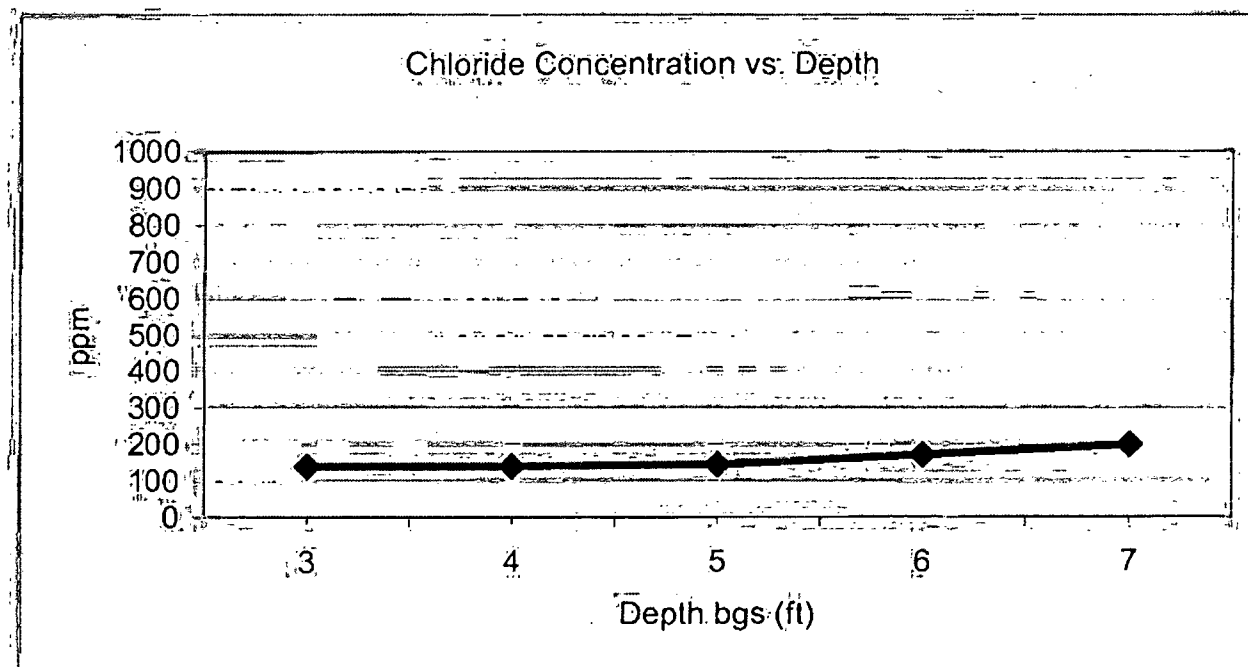
Backhoe samples at the junction (source)

Depth bgs (ft)	[Cl ⁻] ppm
3	139
4	139
5	143
6	170
7	198
8	177
9	174
10	175
11	170
12	204

Groundwater = 32 ft

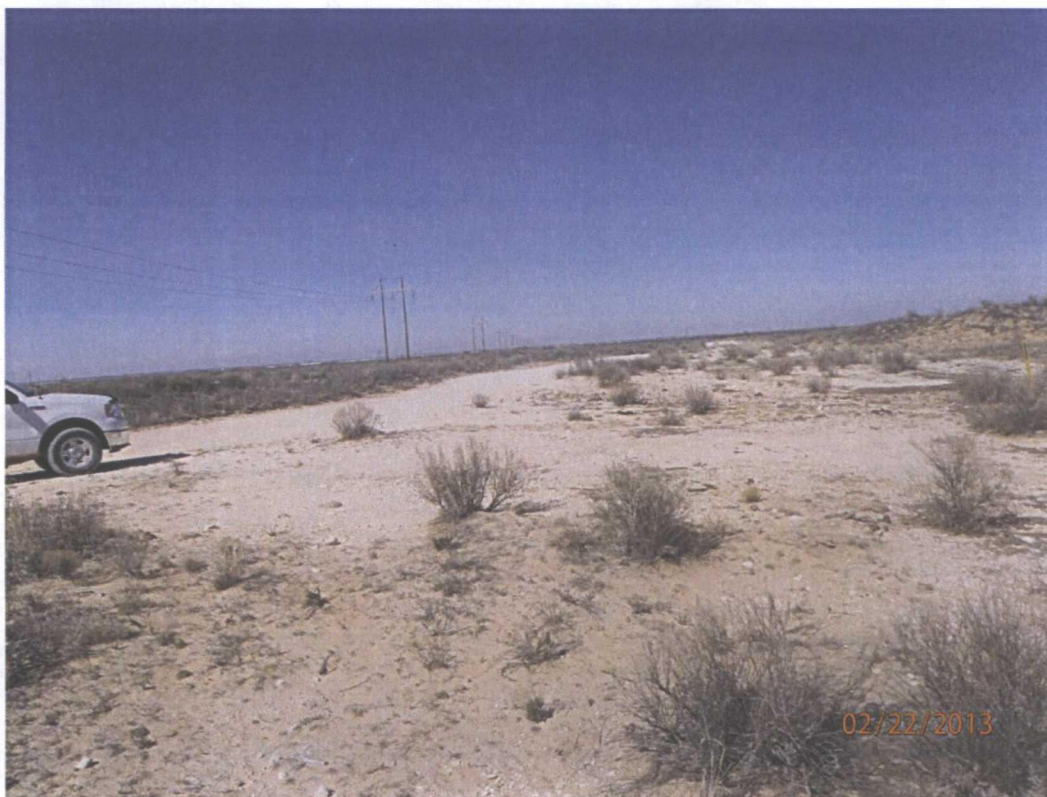
Facing north

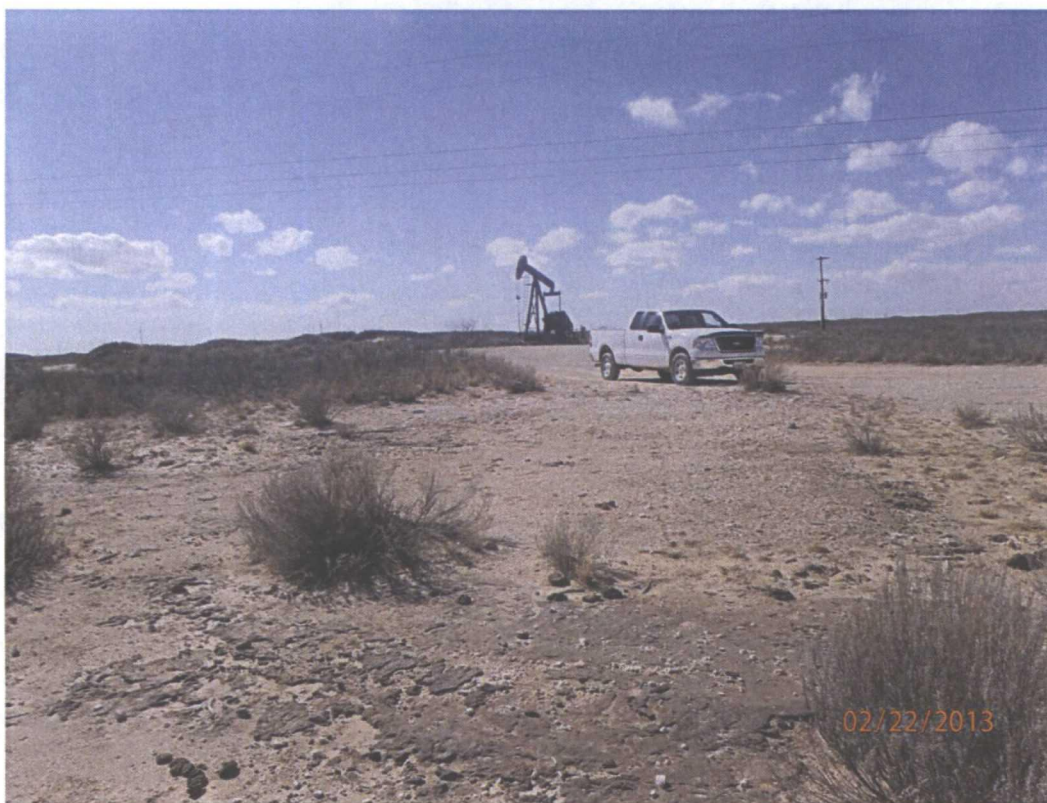
Facing west
