## **FINAL CLOSURE REPORT**

G Loop Eunice Spill

Lea County, New Mexico

Duke Energy Field Services

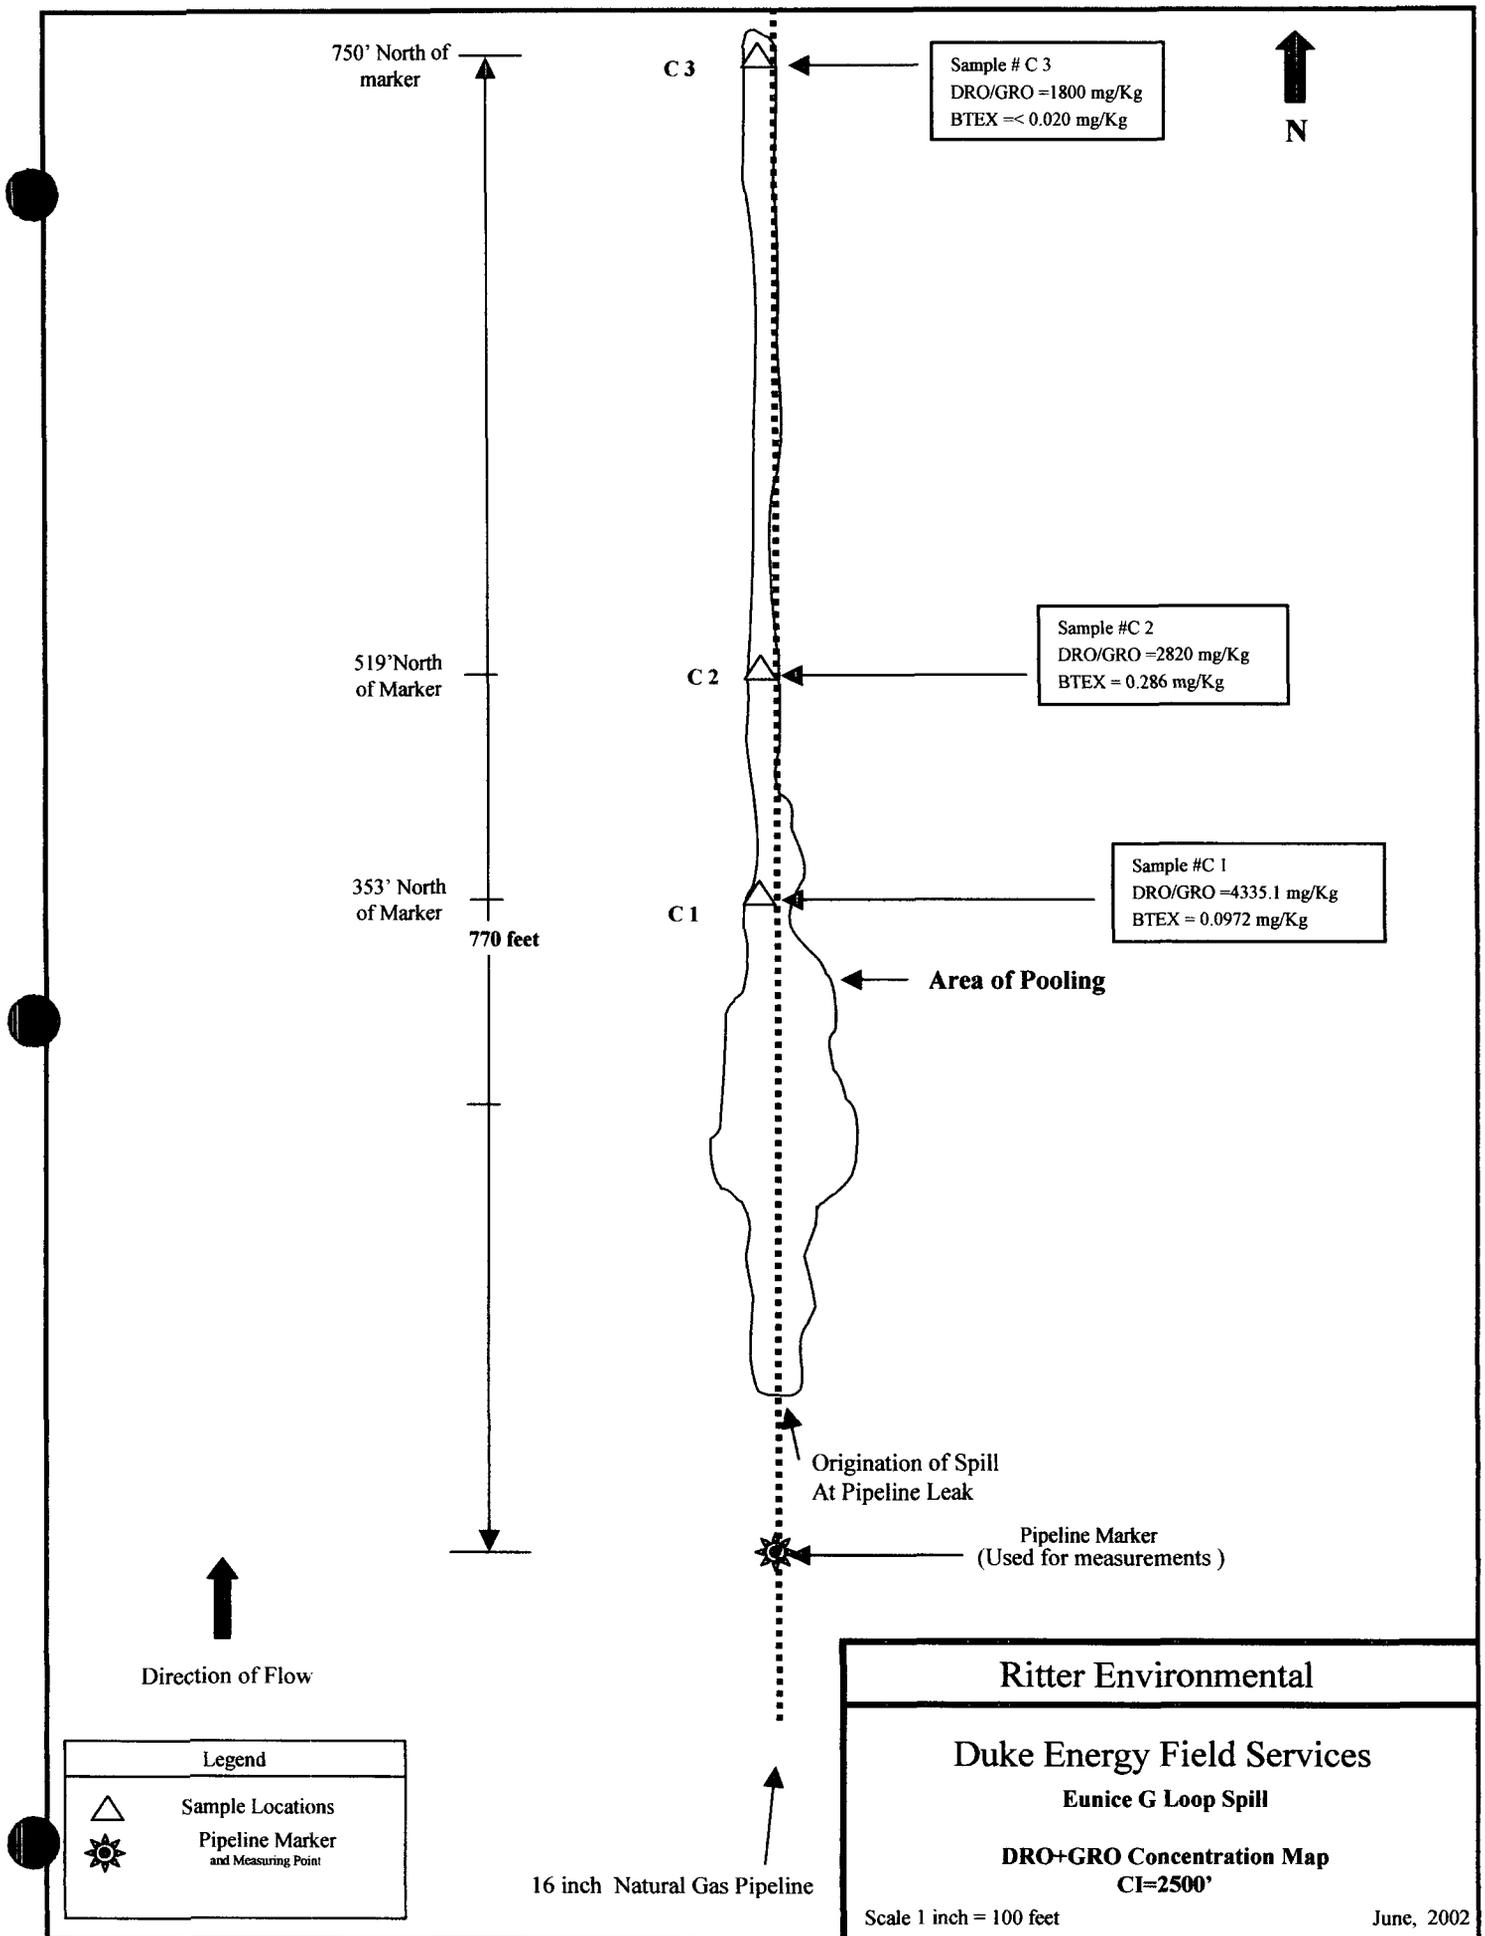
<p>Ritter Environmental</p> <p>Duke Energy Field Services</p> <p>Eunice G Loop Spill</p> <p>DRO+GRO Concentration Map</p> <p>CI=2500'</p> <p>Scale 1 inch = 100 feet</p> <p>June, 2002</p>
--

As can be determined from the above results and the accompanying site maps of TPH concentrations, it is apparent the spill site has achieved the desired results. TPH is below the 5,000 ppm level, while BTEX is below the recommended guidelines.

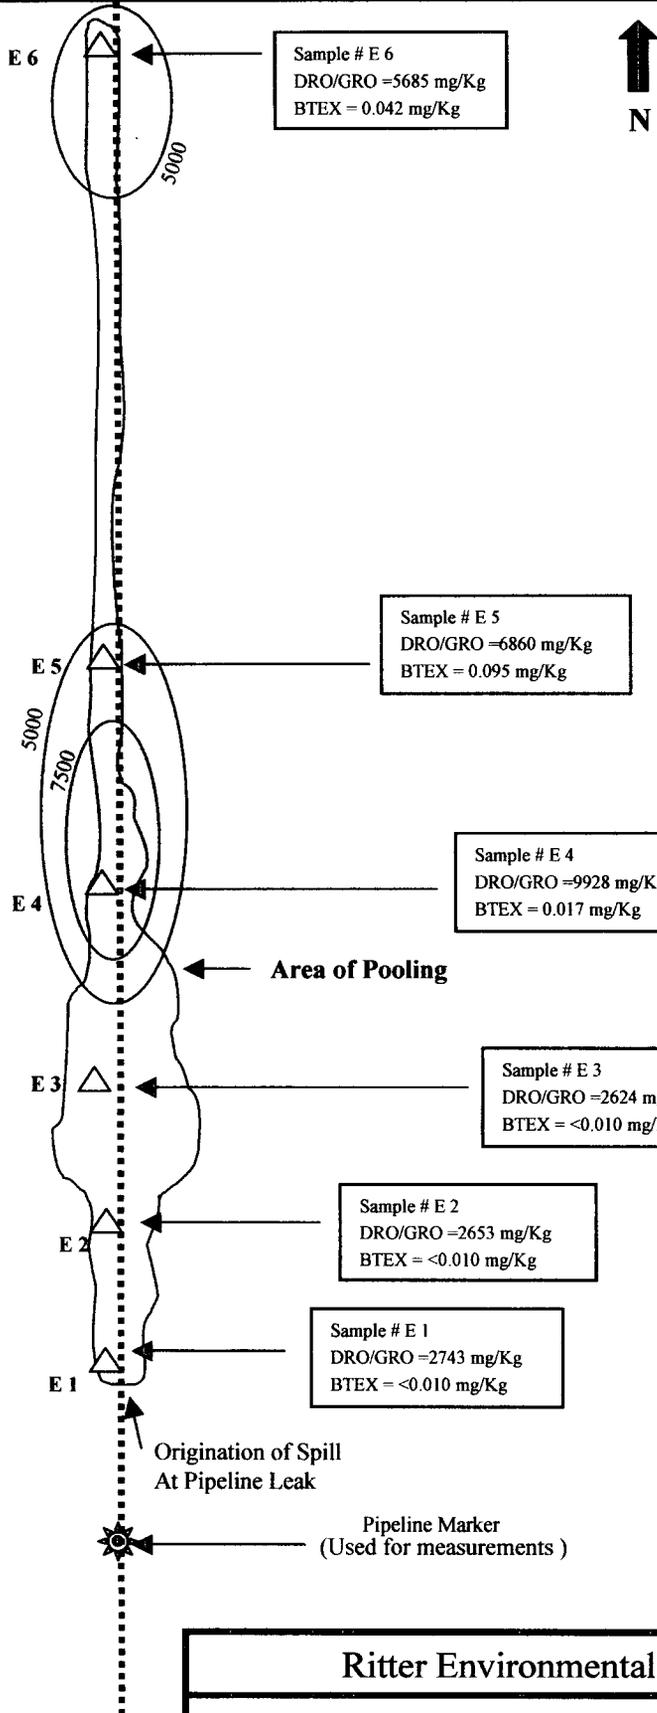
<p><b>Ritter Environmental</b></p> <p><b>Duke Energy Field Services</b></p> <p><b>Eunice G Loop Spill</b></p> <p><b>DRO+GRO Concentration Map</b></p> <p><b>CI=2500'</b></p> <p>Scale 1 inch = 100 feet</p>	<p>Nov 2001</p>
---	-----------------

The northern portion of the spill site above Sample #E-4 remains above the NMOCD guidelines for TPH only. The levels of BTEX are well below the recommended guidelines. The highest TPH level is located in the vicinity of the location of pooling of the spill near Sample #E-4. This is also the location that was identified as being most impacted at depth in the original investigation conducted in December 2000. TPH levels range from a low of 5,685 mg/Kg at the extreme northern end of the spill to 9,928 mg/Kg at the pooling area (Sample Site #E-4) near the center of the original spill area (See DRO + GRO Concentration Map November 2001).

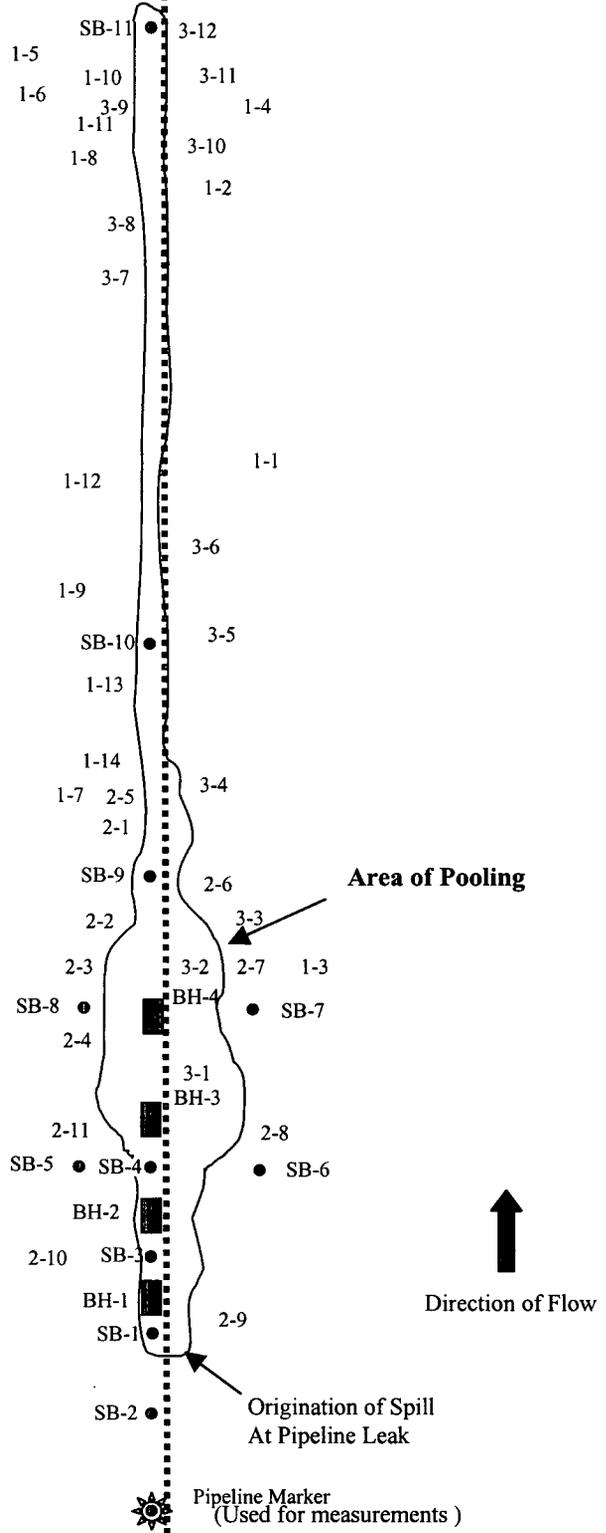
Legend	
The numbers 1-1 through 3-12 represent the location of the photograph	
	Excavations=BH
	Soil boring locations=SB
	Outline of spill area

<p><b>Ritter Environmental</b></p> <p><b>Duke Energy Field Services</b></p> <p><b>Eunice G Loop Spill</b></p> <p><b>Photo Locations</b></p> <p><b>Spill Area Map</b></p> <p><b>SE4/SW4 of Sec 6 T-22-S R-36-E Lea Co. NM</b></p> <p>Scale 1 inch = 100 feet</p> <p>August-2001</p>
--

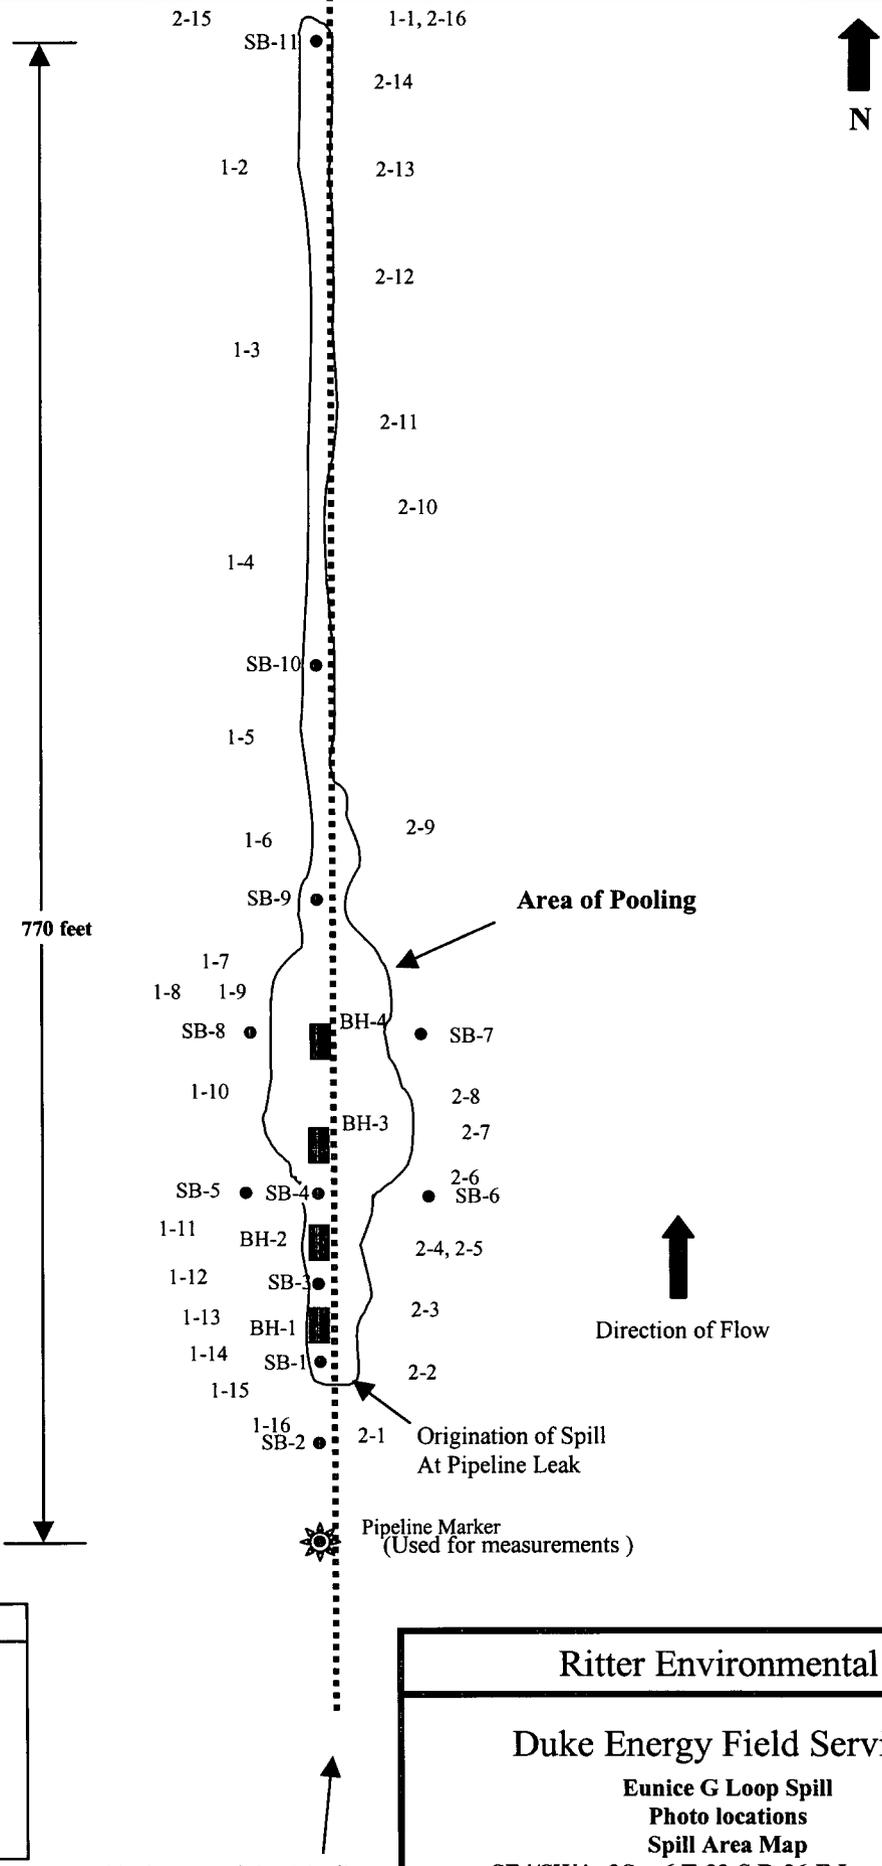
Ritter Environmental
Duke Energy Field Services
Eunice G Loop Spill
Spill Area Map
SE4/SW4 of Sec 6 T-22-S R-36-E Lea Co. NM
Scale 1 inch = 100 feet
Jan-2001
