EME L-29 EOL

CLOSURE

RE: Termination Request  
EME L-29 EOL: UL/L, Sec. 29, T19S, R37E  
RICE Operating Company – Eunice Monument Eumont SWD System

**RICE OPERATING COMPANY  
JUNCTION BOX FINAL REPORT**

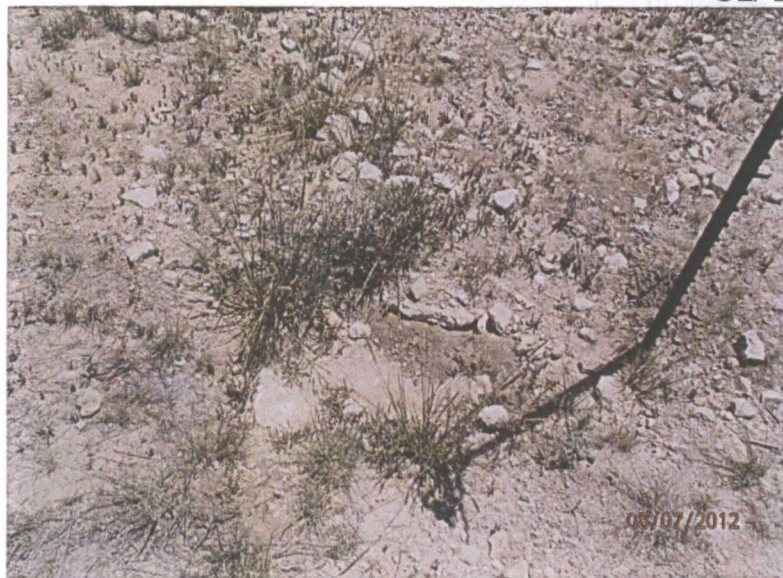
Site prior

8/7/2012

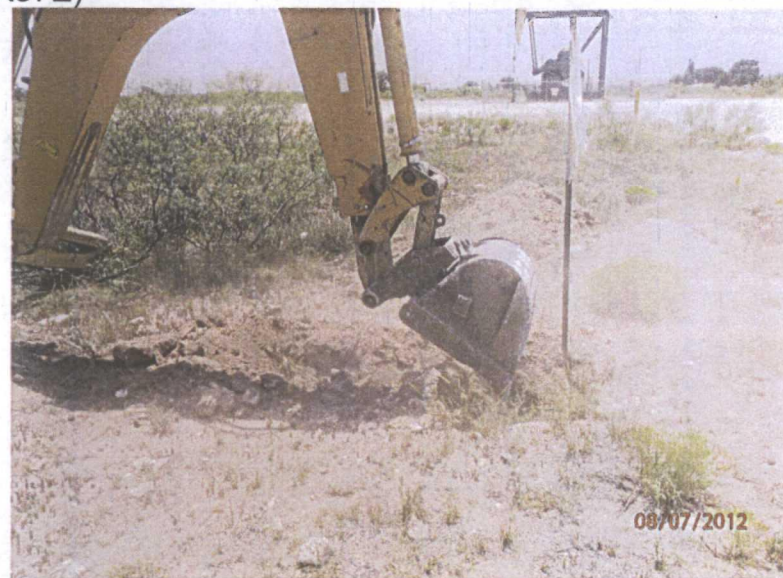
Excavating site

8/7/2012

**General Description of Remedial Action:** This junction and line were eliminated during the pipeline replacement/upgrade program. After the former junction box was removed, an investigation was conducted using a backhoe to collect soil samples at regular intervals, creating a 3x7x7 ft. deep excavation. Chloride field tests performed on each sample yielded concentrations similar to that of the background sample. Organic vapors were measured using a PID which yielded low concentrations. The deepest sample, 7 ft. below ground surface (BGS) was sent to a commercial laboratory for analysis of chloride and TPH, which confirmed low concentrations of each. The excavation was backfilled with excavated soil to ground surface and contoured to the surrounding area. On 8/13/2012, the site was seeded with a blend of native vegetation and is expected to return to a productive capacity at a normal rate.

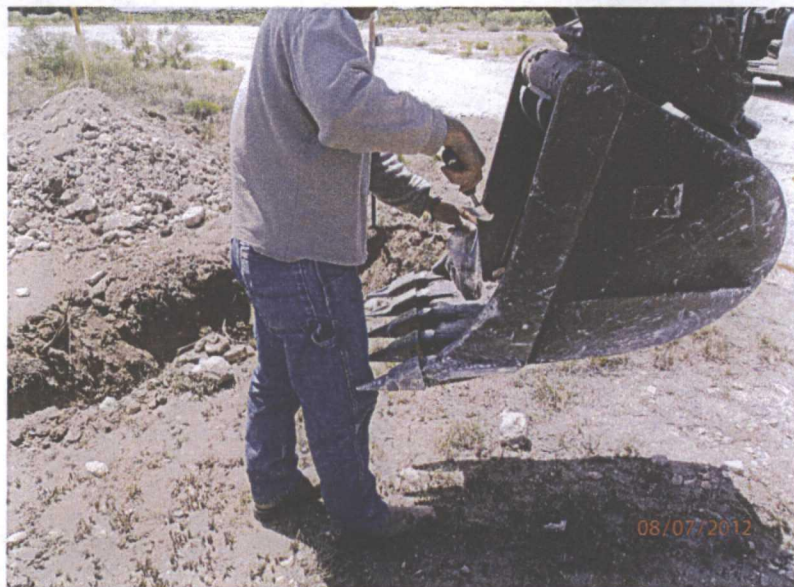
Collecting sample

8/7/2012

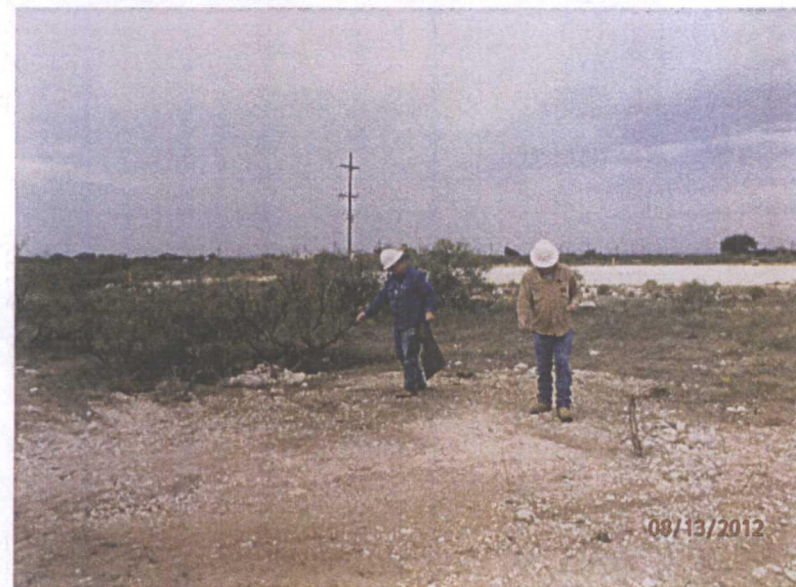
Seeding site

8/13/2012
