**RE: Initial CAP Report and Soil Closure Request
Rice Operating Company – BD SWD System
BD G-23 EOL (1R426-281): UL/G sec. 23 T22S R37E
(formerly BD B-23 EOL)**

CAP Report for Soils

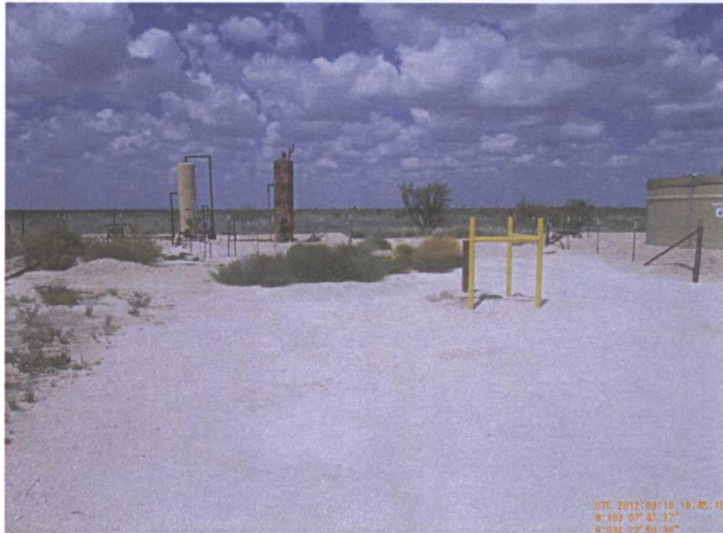
Site prior to excavation, facing northwest

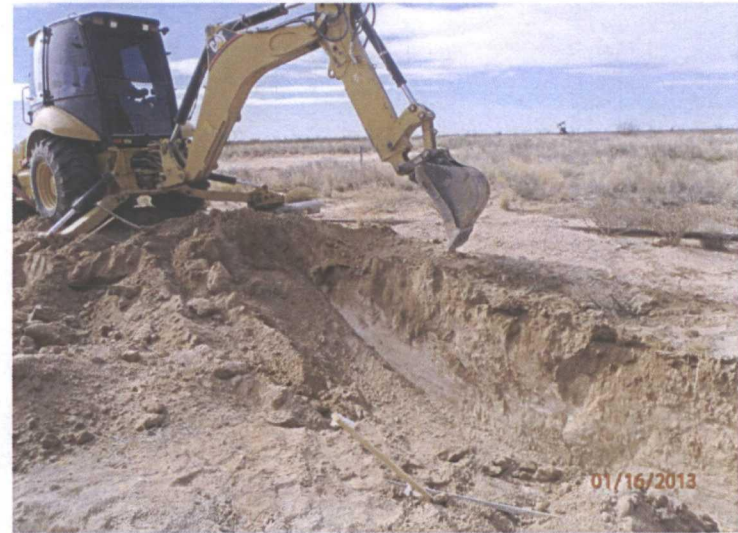
Excavating site, facing west

RECS began the excavation for liner installation on January 16th, 2013. The site was excavated to 29 ft x 36 ft to a depth of 4.5 ft bgs, uncovering the existing clay layer (Figure 2). A 20-mil reinforced poly liner was installed and properly seated at the base of the excavation. Clean, imported blow sand was used to backfill the site to 3 ft bgs and the final 3 ft was backfilled with clean, imported caliche. This site is located on a lease pad and seeding was not required. A sample of the imported blow sand and imported caliche was field tested for hydrocarbons. The blow sand returned a result of 5.6 ppm and the caliche returned a result of 4.3 ppm. A sample of the imported blow sand and imported caliche was then taken to a commercial laboratory for analysis of chlorides and returned a result of 32 mg/kg for the blow sand and 112 mg/kg for the caliche. A total of 236 yards of contaminated soil was exported to a NMOCD approved facility. A total of 60 yards of blow sand and 156 yards of caliche was imported to the site to serve a backfill material. All documentation for these activities can be found in Appendix A.

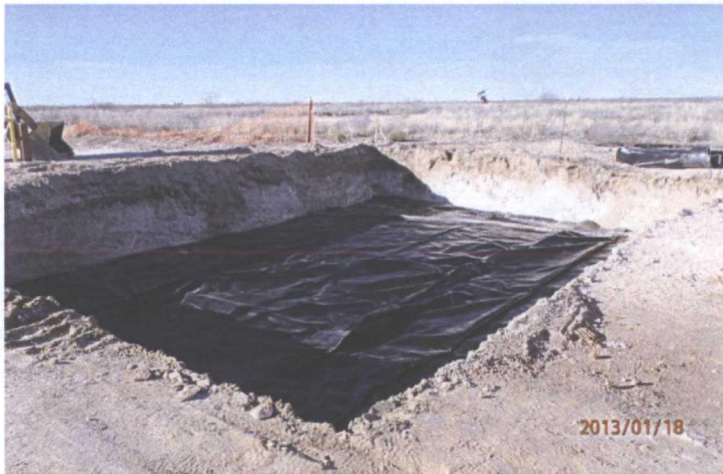
Installing liner @ 5' bgs, facing southwest

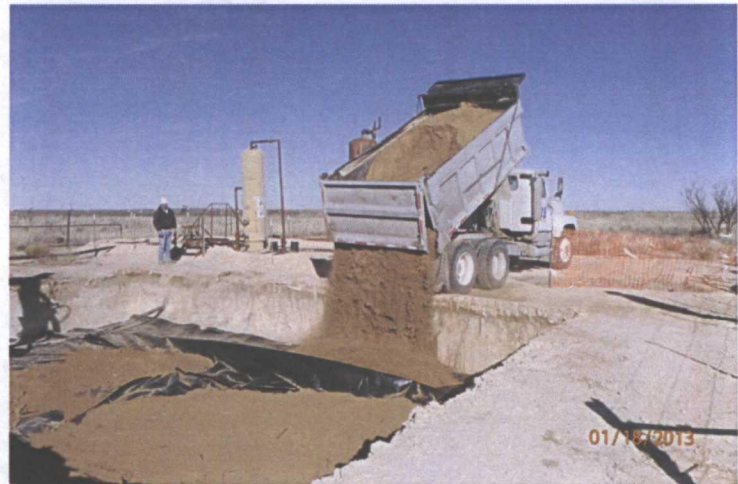
Importing blow sand, facing northwest

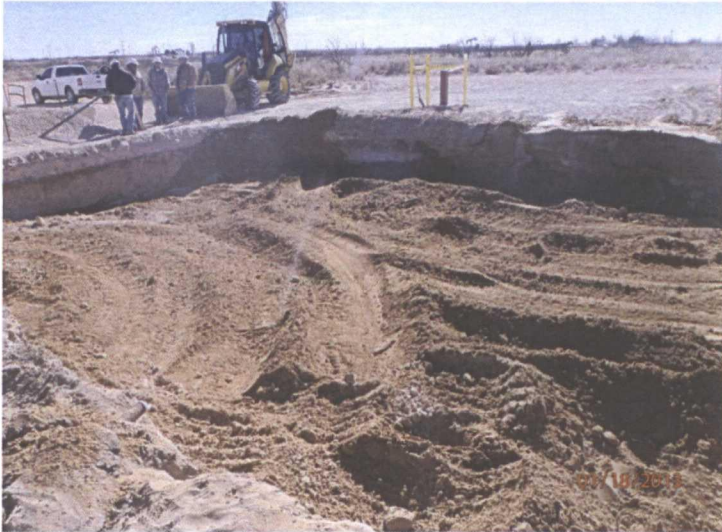
Installed a 3' pad of blow sand, facing southwest

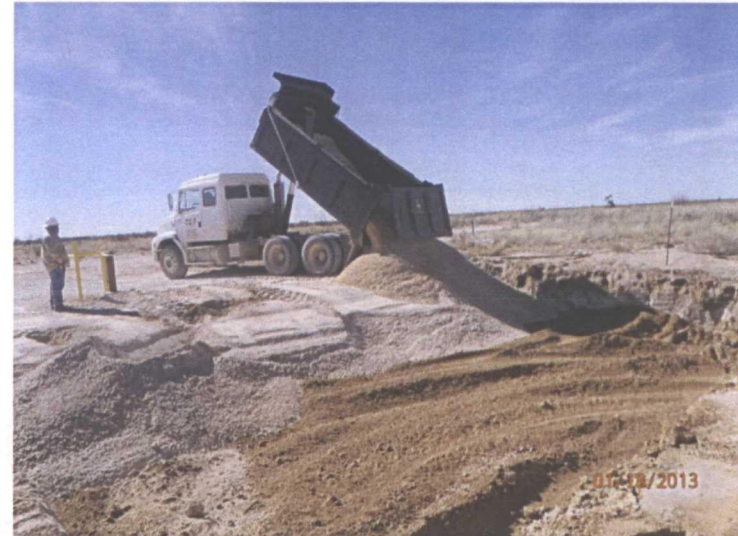
Importing caliche for backfill, facing southwest

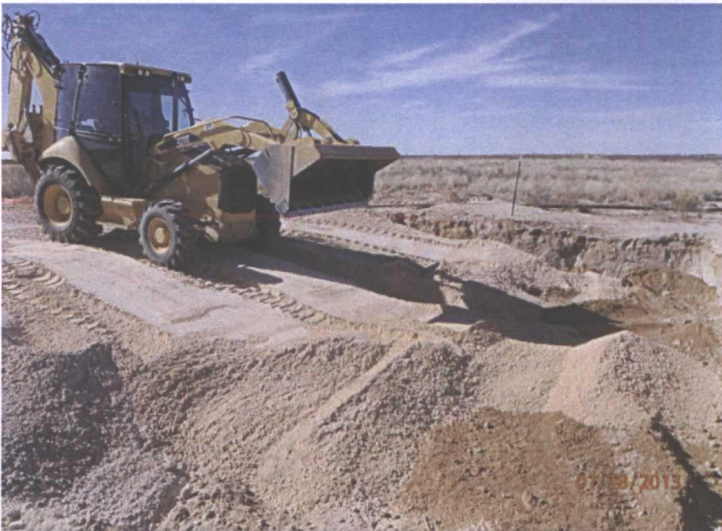
Backfilling site, facing southwest

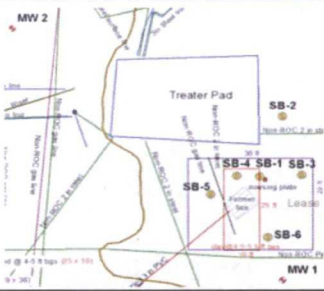
Driller:	Harrison & Cooper, Inc.			
Drilling Method:	Air Rotary		Project Name:	Well ID:
Start Date:	2/12/2013		BD G-23 EOL	MW-2
End Date:	2/12/2013		Project Consultant: RECS	
Comments: MW-2 is located 86 ft northwest of the former junction box site. All samples were from cuttings. L. Weinheimer TD = 71 ft GW = 59 ft			Location: UL/G sec. 23 T22S R37E Lat: 32°22'52.003"N County: Lea Long: 103°7'48.237"W State: NM

Depth (feet)	Chloride field tests	LAB	PID	Description	Lithology	Well Construction
				Brown Sand		
SS	114		0.7			
5 ft	154		0.8			
10 ft	745		1.0	Tan Sand With Some Caliche		
15 ft	1147	Cl-1580	1.0			
		GRO <10				
		DRO <10				
20 ft	892		1.3			
25 ft	535		0.9	Red/Tan Sand With Some Caliche		
30 ft	932		0.5			
35 ft	888		0.3
