RE: Termination Request
EME Jct. B-36 (1R427-308): UL/B, Sec. 36, T20S, R36E
RICE Operating Company – Eunice Monument Eumont SWD System

EME Jct. B-36

NMOCD #1R427-308

**RICE OPERATING COMPANY
JUNCTION BOX FINAL REPORT**

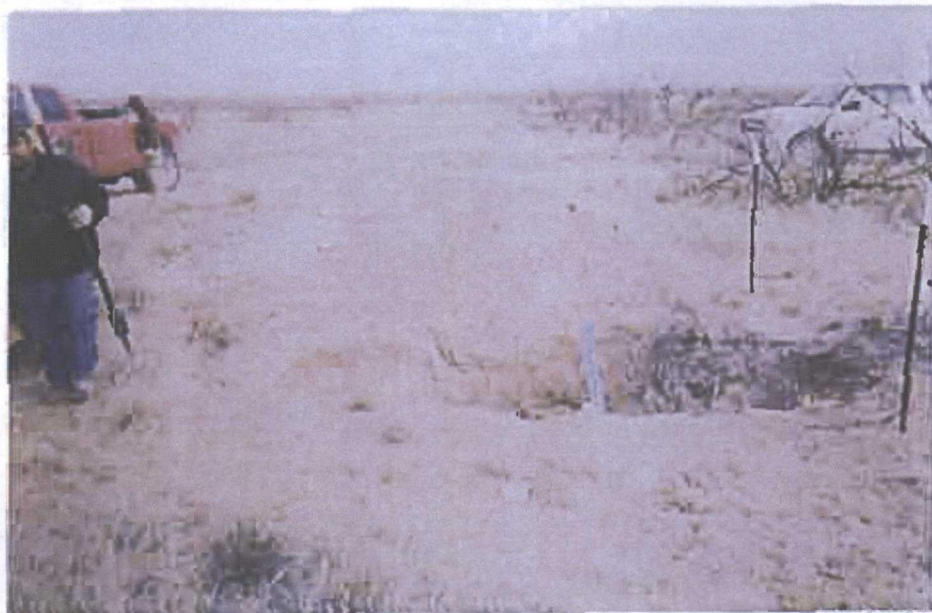
site prior to excavation, facing north

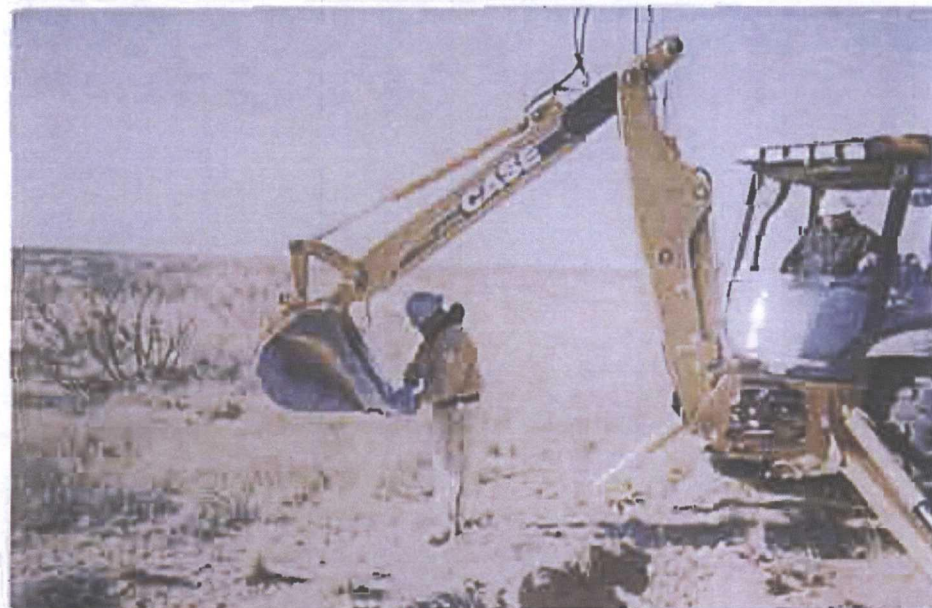
collecting a soil sample, facing southwest

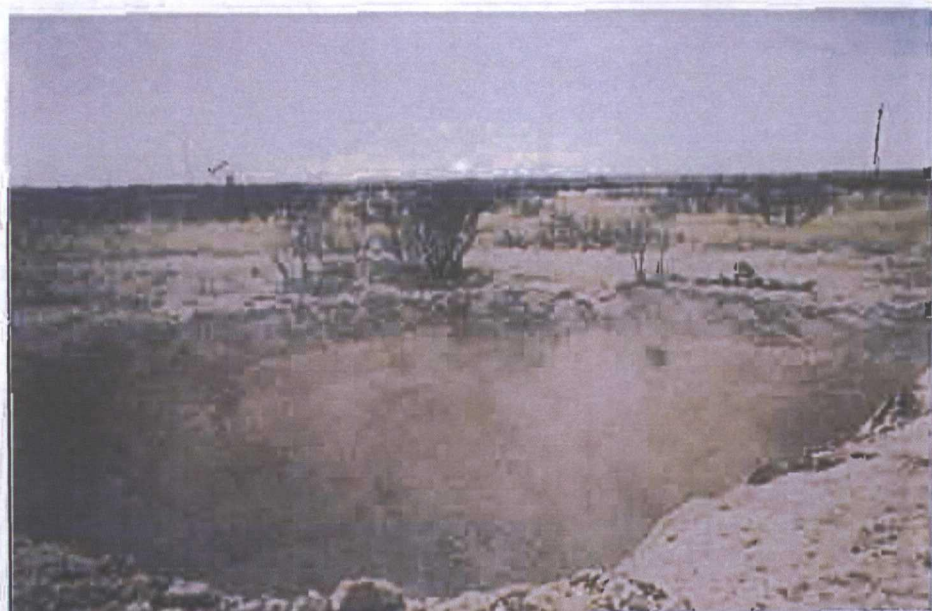
final 25x30x12-ft excavation, facing southeast

General Description of Remedial Action: This junction box was eliminated during the pipeline replacement/upgrade program. After the former junction box was removed, an investigation was conducted using a backhoe to collect soil samples at regular intervals producing a 25x30x12-ft deep excavation. Chloride field tests were performed on each sample yielding generally low concentrations similar to that of the background. Organic vapors were measured using a PID which yielded low concentrations. Representative composite samples were sent to a commercial laboratory for analysis of chloride and TPH which confirmed low concentrations of both. The excavated soil was blended on site and returned to the excavation to ground surface and contoured to the surrounding area. On 3/9/2009, the site was seeded with a blend of native vegetation and is expected to return to a productive capacity at a normal rate.

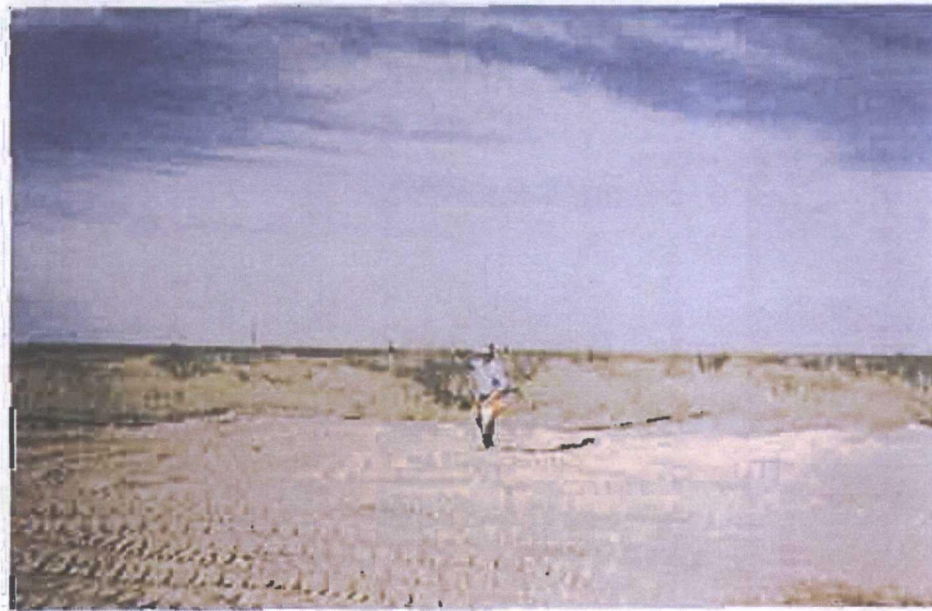
seeding backfilled site, facing west

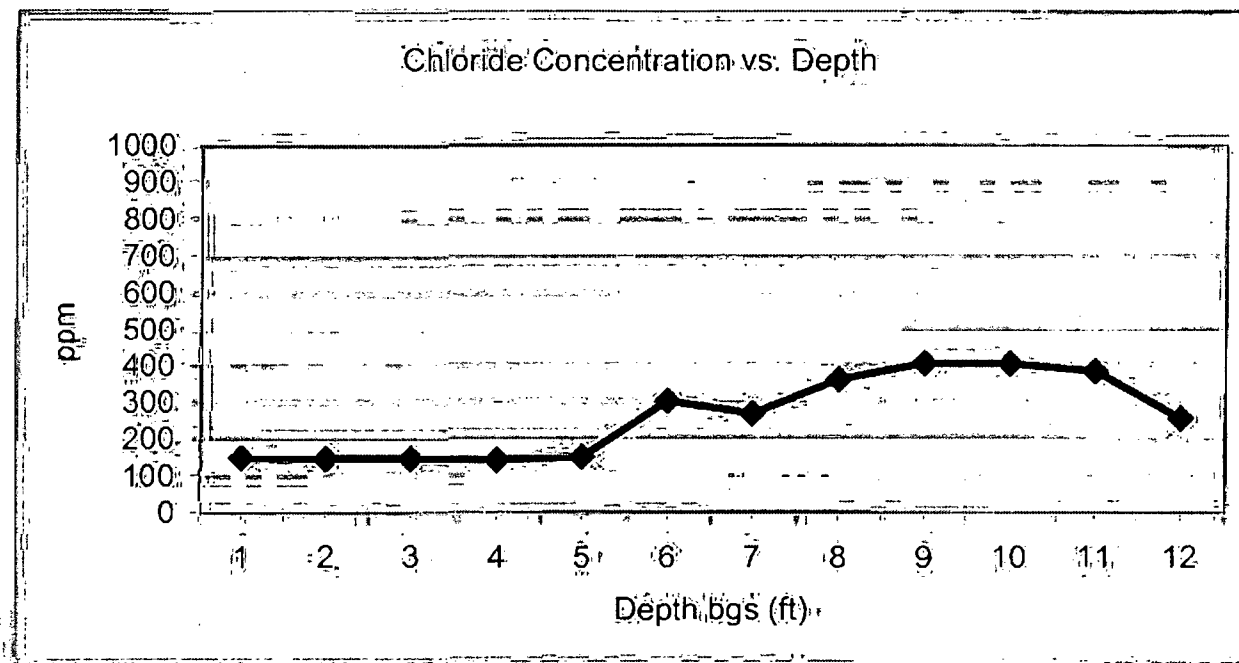
CHLORIDE CONCENTRATION CURVE

Backhoe samples at 10 ft west of the junction (source)

Depth bgs (ft)	[Cl] ppm
1	147
2	144
3	145
4	142
5	151
6	303
7	268
8	361
9	405
10	404
11	384
12	256

Groundwater = 103 ft

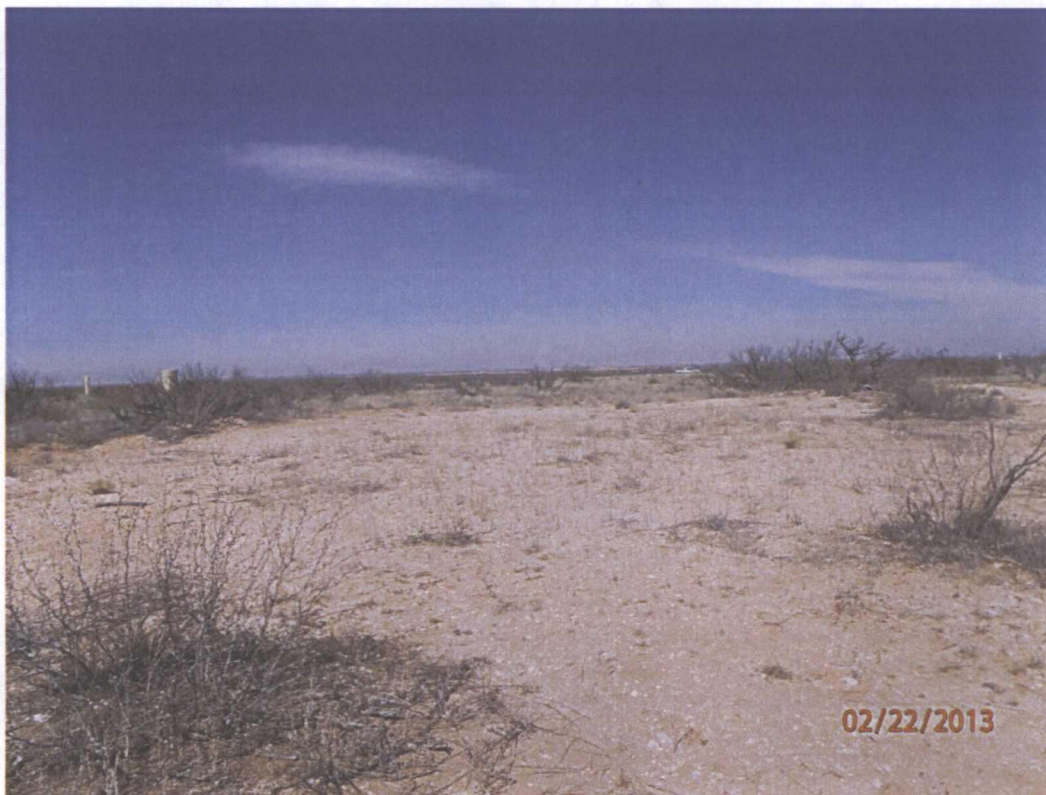
Facing north

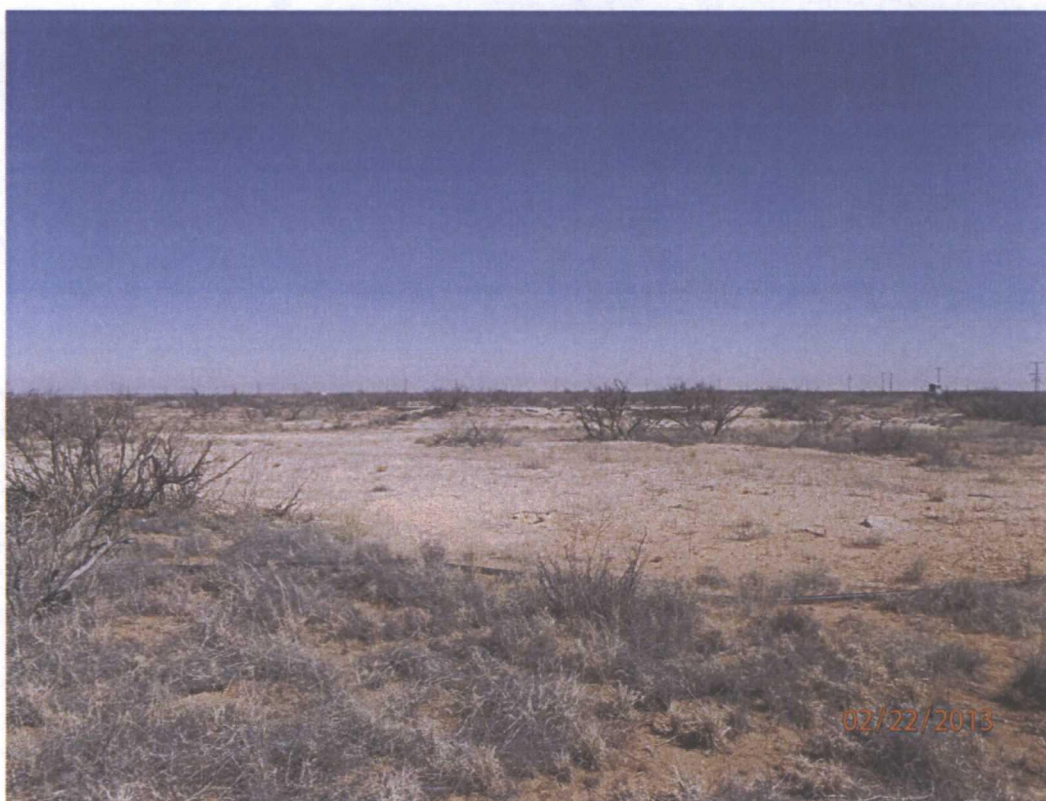
Facing east
