From: Hansen, Edward J., EMNRD
Sent: Thursday, May 02, 2013 1:20 PM
To: Hack Conder (hconder@riceswd.com)
Cc: Leking, Geoffrey R, EMNRD; Laura Pena (lpna@riceswd.com); Katie Jones <kjones@riceswd.com> (kjones@riceswd.com); Scott Curtis (scurtis@riceswd.com)
Subject: Remediation Plan (1R427-342) Termination - ROC EME B-10 EOL Site

RE: Termination Request
EME B-10 EOL (1R427-342): UL/B, Sec. 10, T21S, R36E
RICE Operating Company – Eunice Monument Eumont SWD System

RICE OPERATING COMPANY
JUNCTION BOX FINAL REPORT

EME B-10 EOL

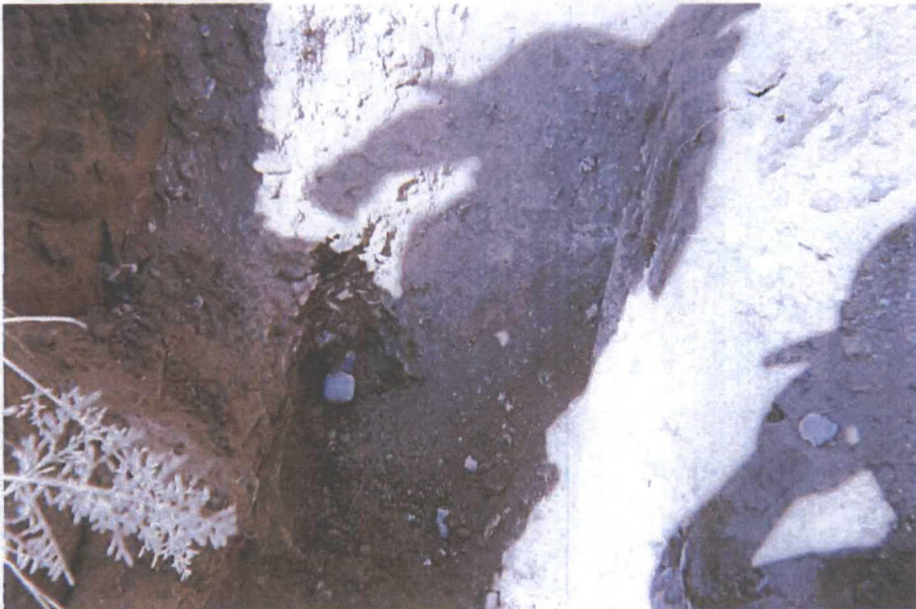
9/15/2010

Site prior to excavation

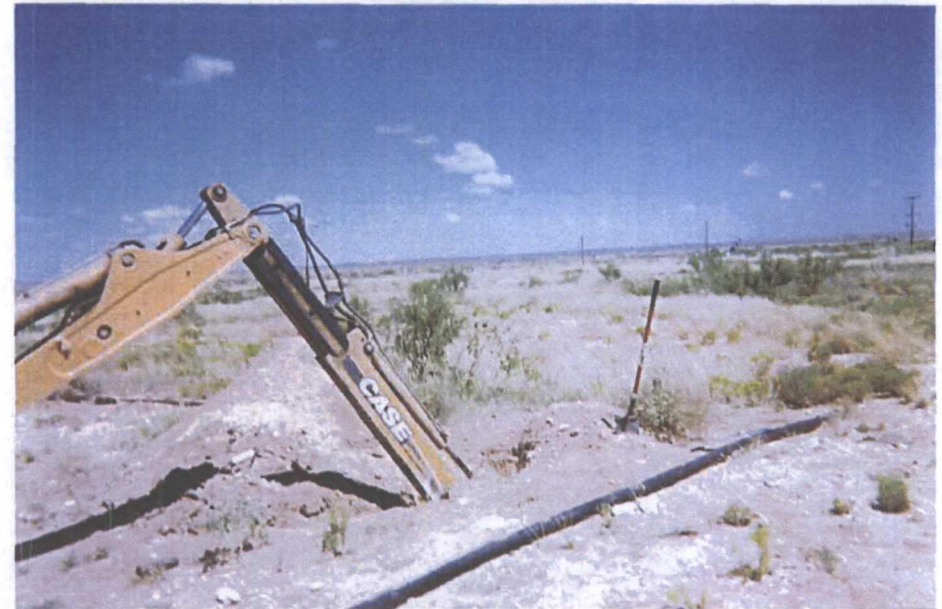
9/15/2010

Delineation Trench being excavated

General Description of Remedial Action: This junction and line were eliminated under the pipeline replacement/upgrade program. After the former junction was removed, an investigation was conducted using a backhoe to collect soil samples at regular intervals. Chloride field tests were performed on each sample, which yielded low concentrations of chloride similar to that of the background sample. Organic vapors were measured using a PID, which also yielded low concentrations. The deepest sample, 10 ft.

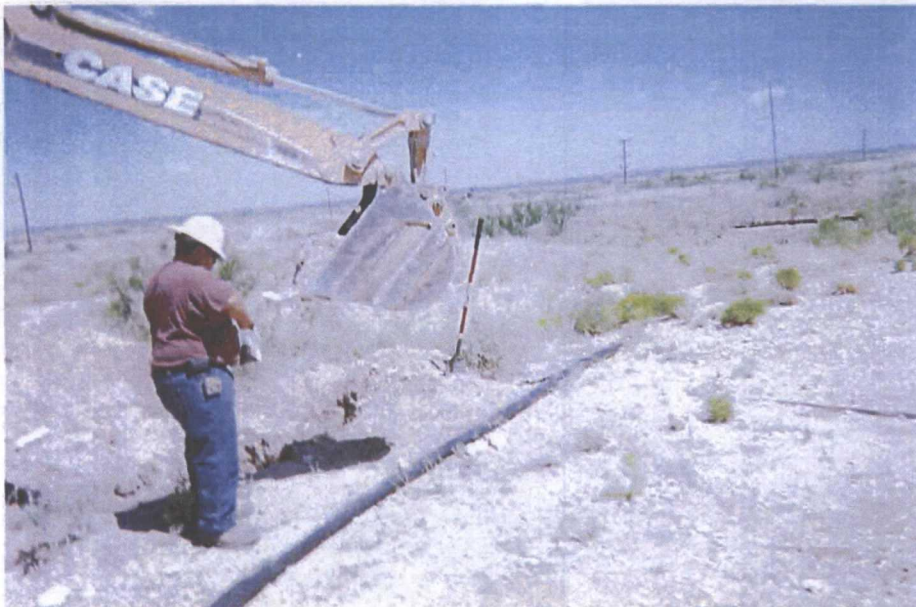
9/15/2010

Collecting sample

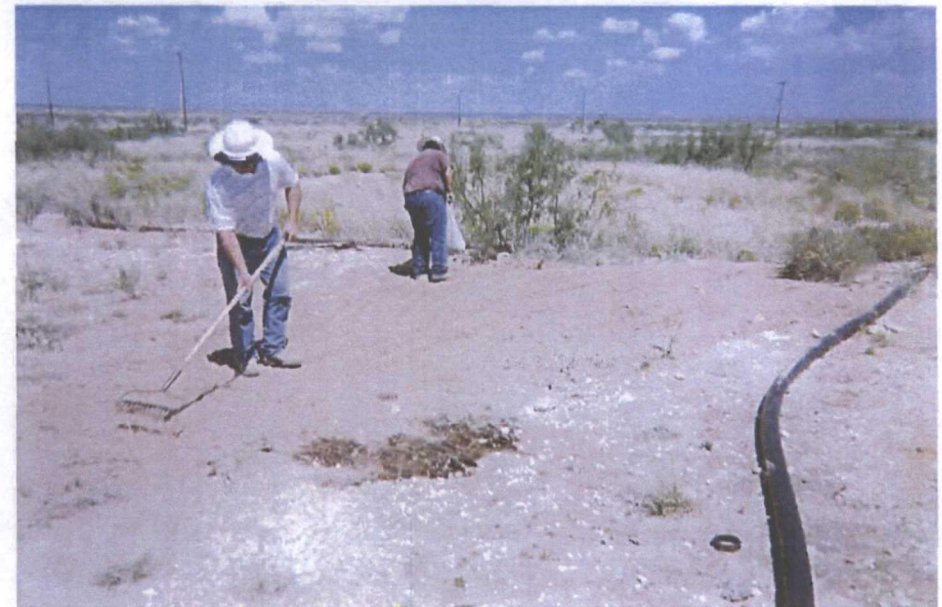
9/15/2010

Seeding excavation

BGS, was sent to a commercial laboratory for analysis, which confirmed low concentrations of chloride and organics. The excavated soil was returned to the excavation to ground surface and contoured to the surrounding area. On 9/15/2010, site was seeded with a blend of native vegetation and is expected to return to a productive capacity at a normal rate.

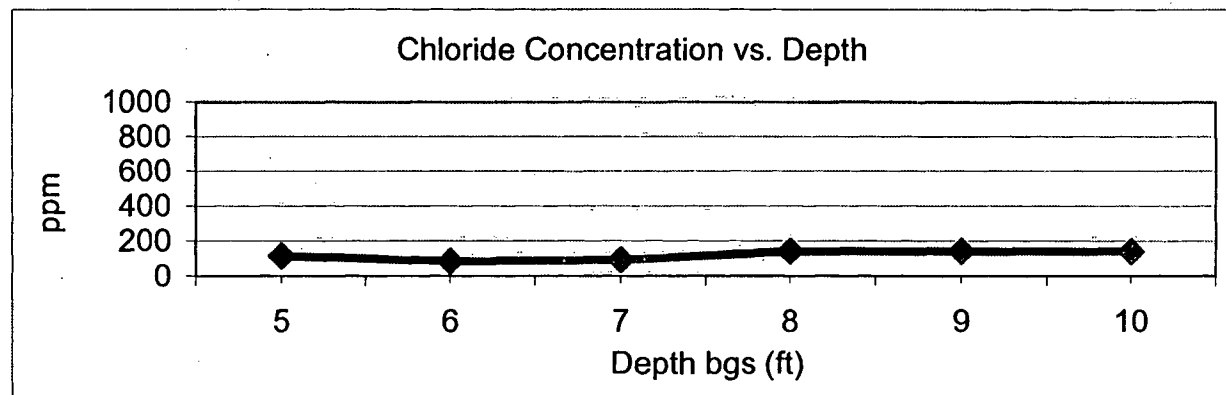
CHLORIDE CONCENTRATION CURVE

Backhoe samples at the junction (source)

Depth bgs (ft)	[Cl] ppm
5	113
6	85
7	91
8	142
9	141
10	139

Groundwater = 200 ft.

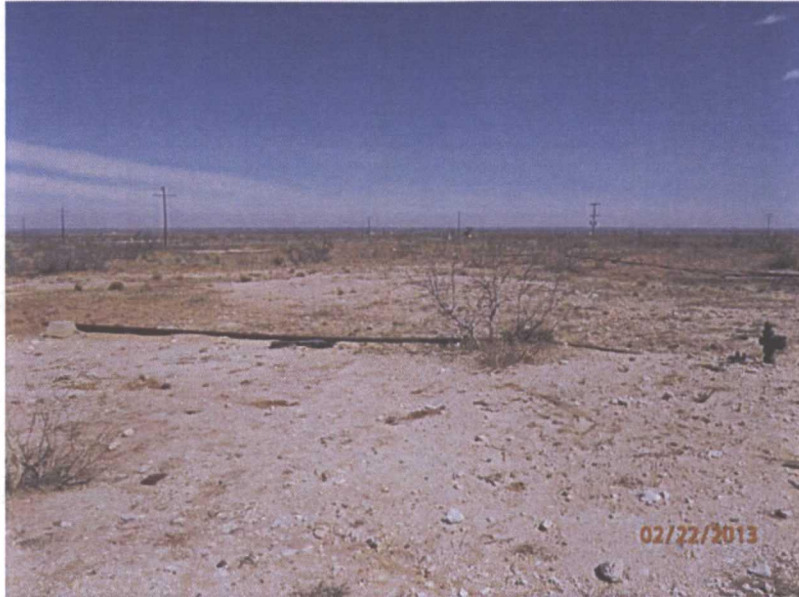
2/22/2013

Site prior to seeding, facing east

Vegetation at the site had not recovered; therefore, RECS personnel were on site to seed the surrounding area on 2/22/2013. The site was seeded with a blend of native vegetation and is expected to return to a productive capacity at a normal rate. Vegetation will act as

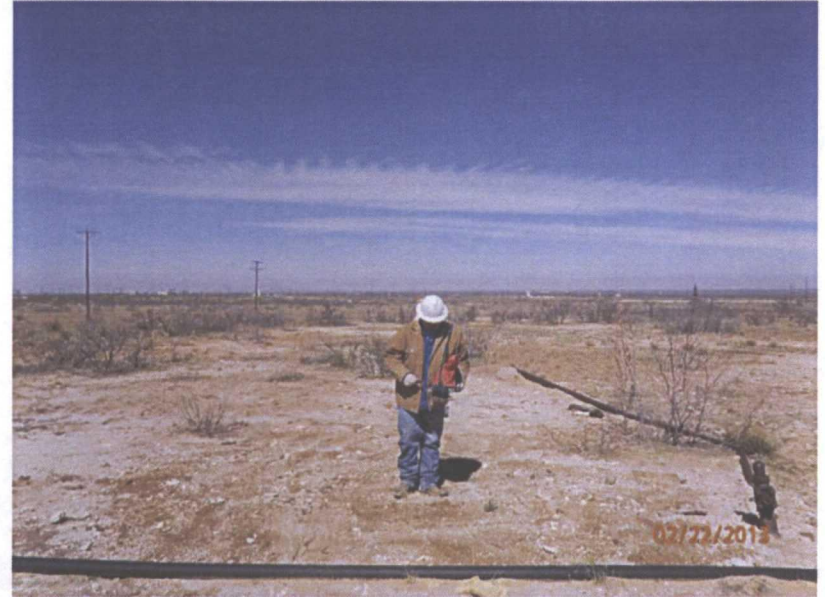
2/22/2013

Seeding site, facing north

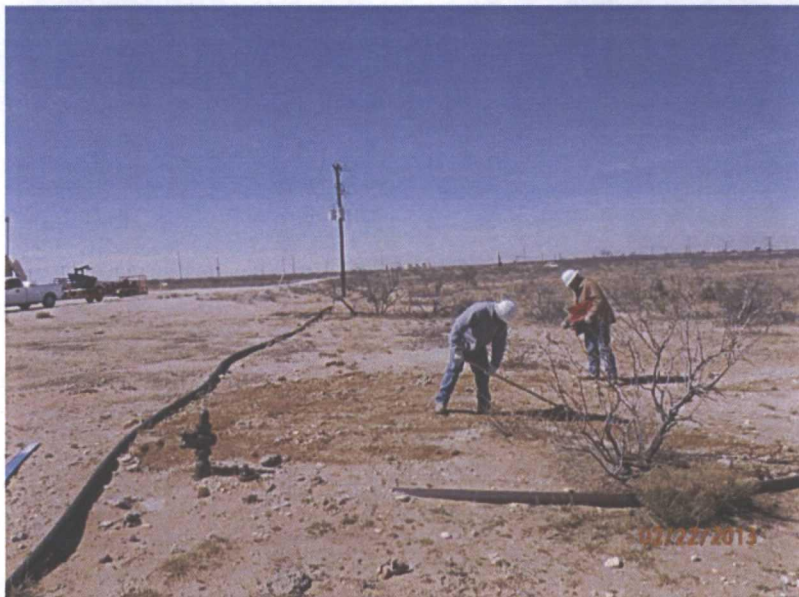
2/22/2013

Raking in seed, facing west

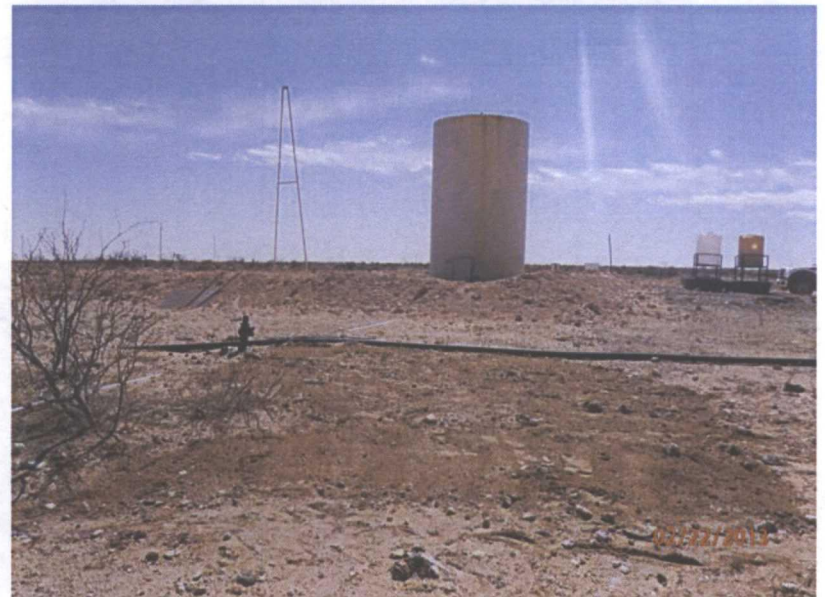
2/22/2013

Site completed, facing south
