**RE: Termination Request
for the Rice Operating Company's
EME Jct F-24 Site
Unit Letter F, Section 24, T20S, R36E, NMPM, Lea County, New Mexico
Remediation Plan (1R427-359) Termination**

RE: Termination Request
EME Jct. F-24 (1R427-359): UL/F, Sec. 24, T20S, R36E
RICE Operating Company – Eunice Monument Eumont SWD System

**RICE OPERATING COMPANY
JUNCTION BOX FINAL REPORT**

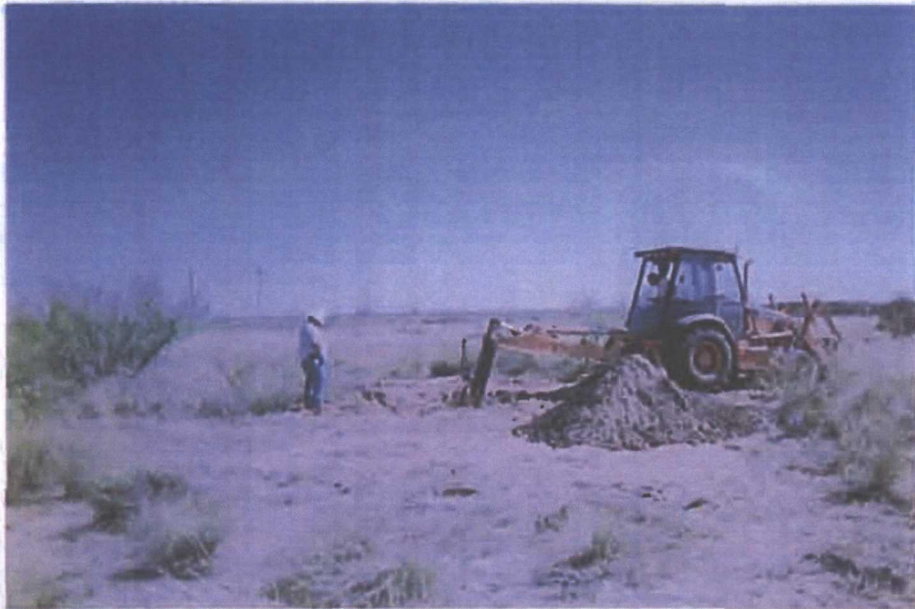
9/15/2010

Delineation trench being excavated

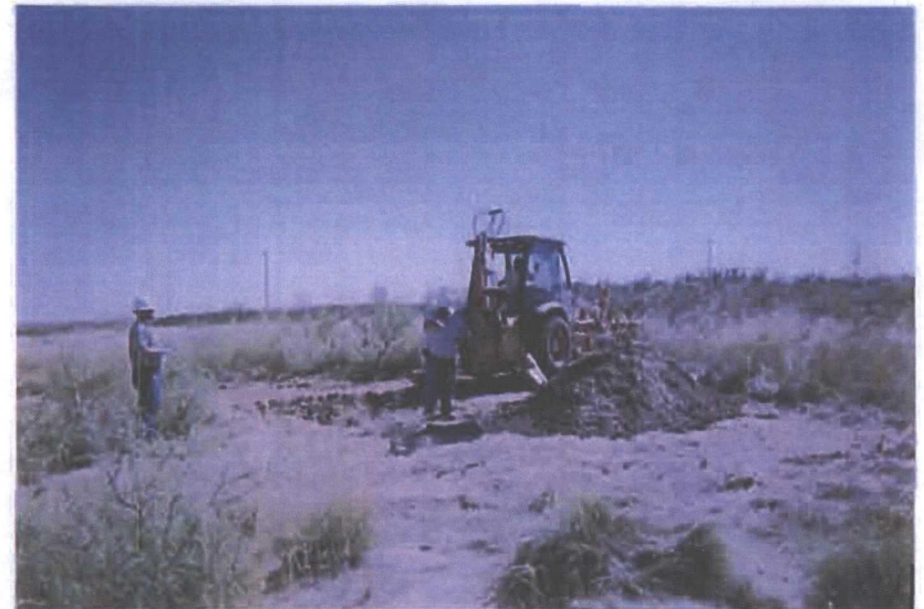
10/12/2010

Samples being collected

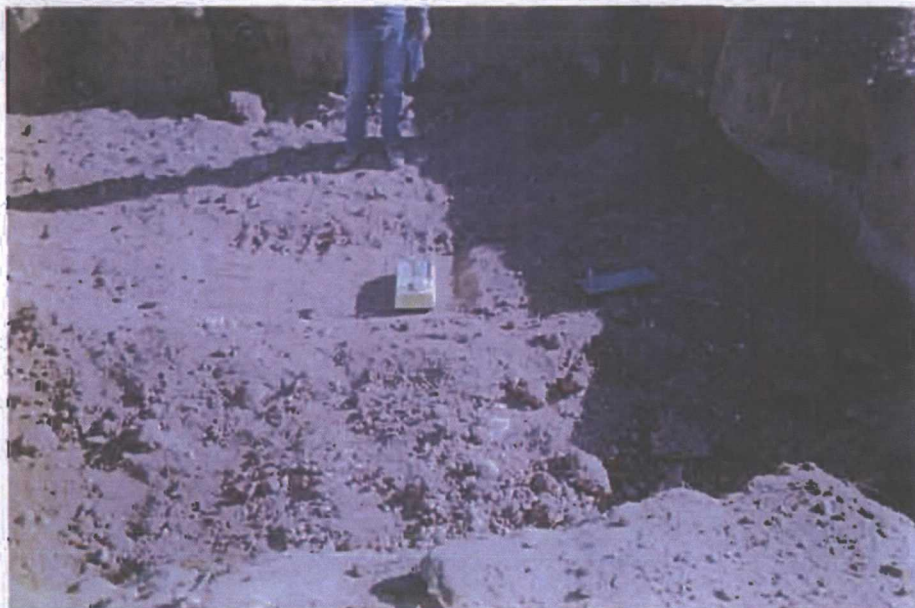
11/23/2010

Performing compaction test

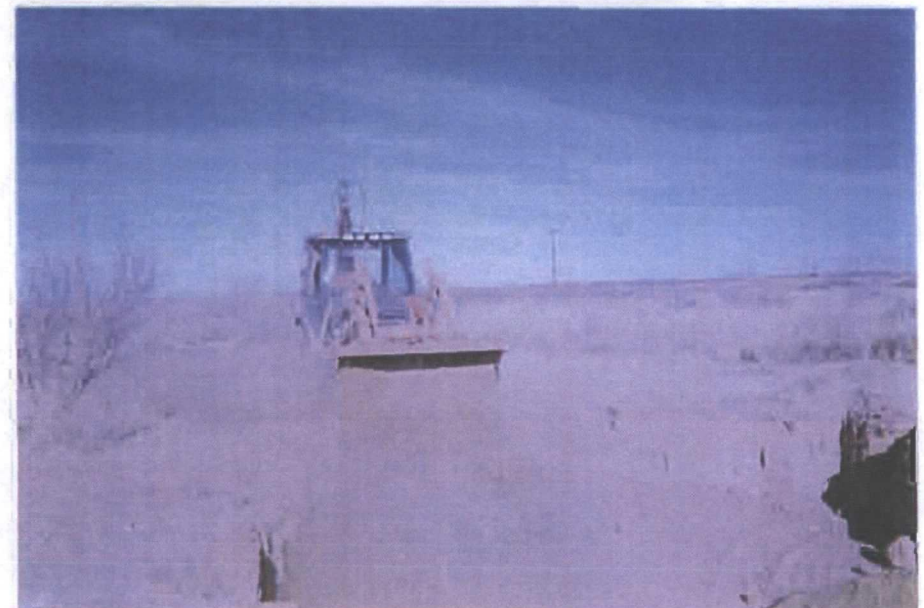
11/23/2010

Backfilling excavation above clay liner

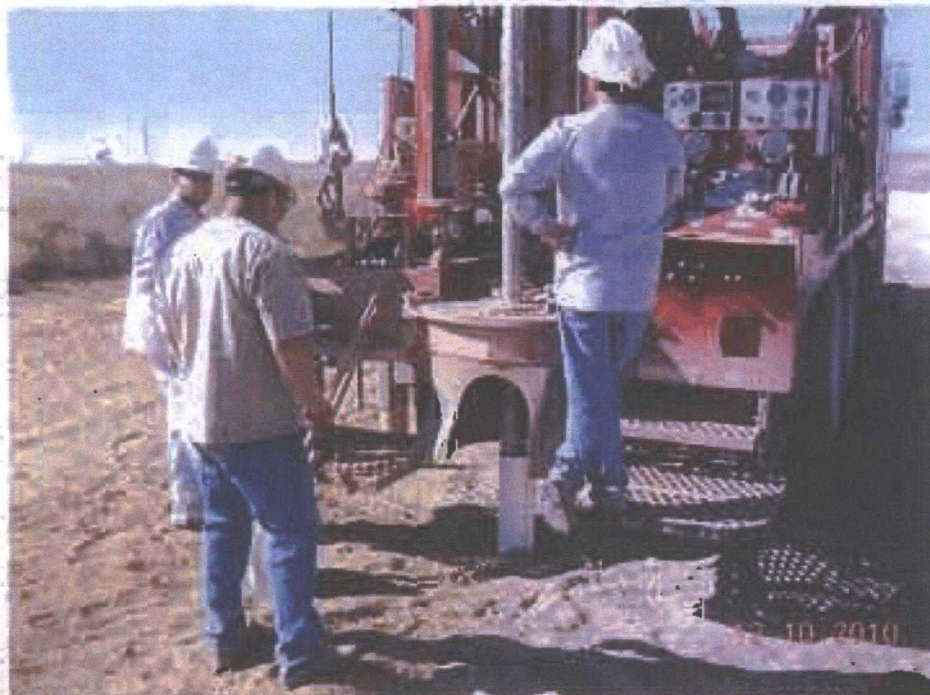
12/10/2010

Drilling the soil bore

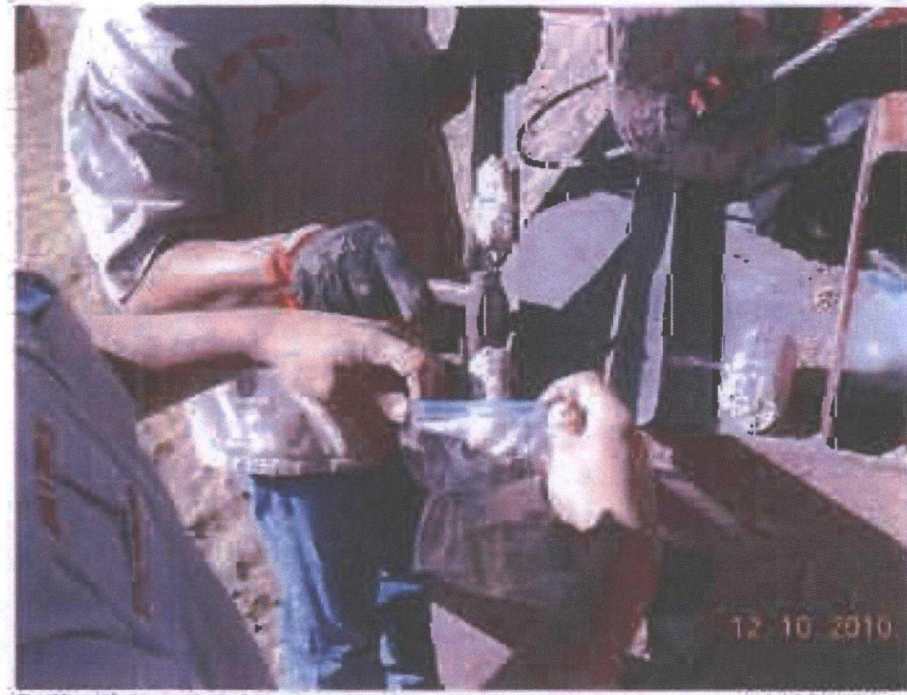
12/10/2010

Collecting sample

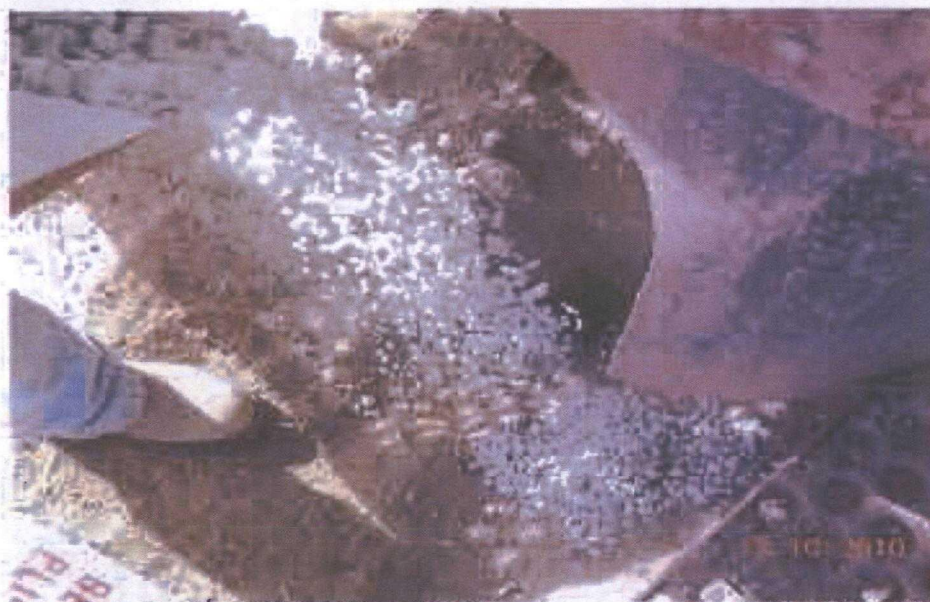
12/10/2010

Plugging bore hole with bentonite

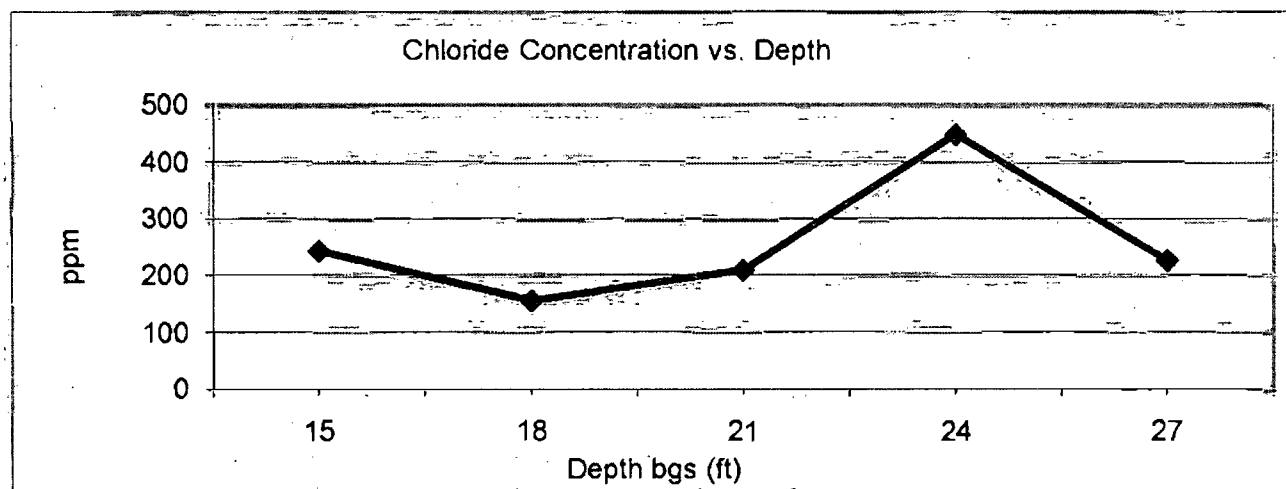
Depth bgs (ft)	[Cl] ppm
15	243
18	155
21	209
24	448
27	226

Groundwater = 28 ft

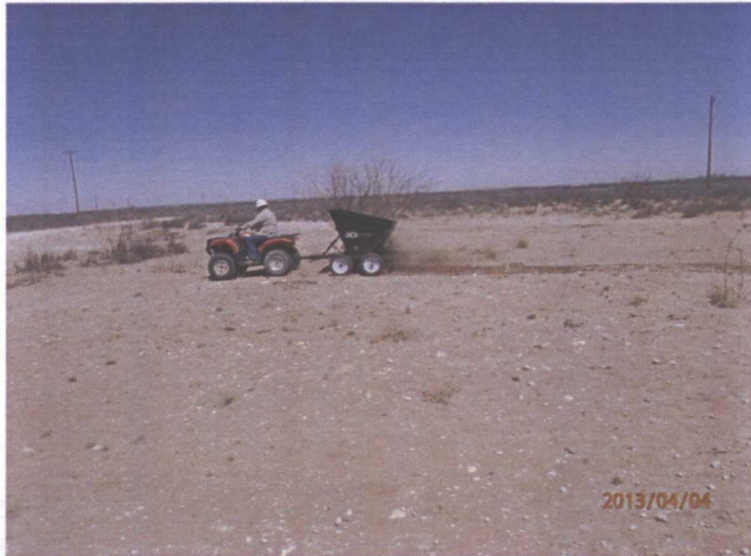
4/4/2013

Spreading amendments, facing north

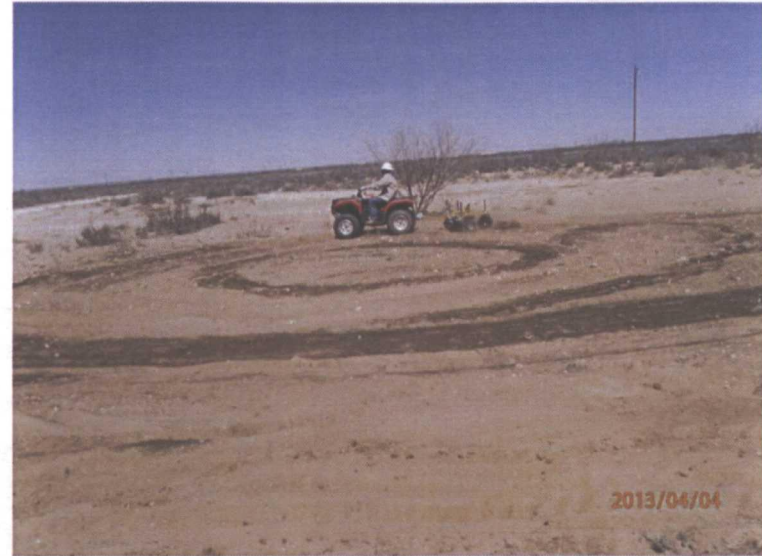
4/4/2013

Tilling site, facing north

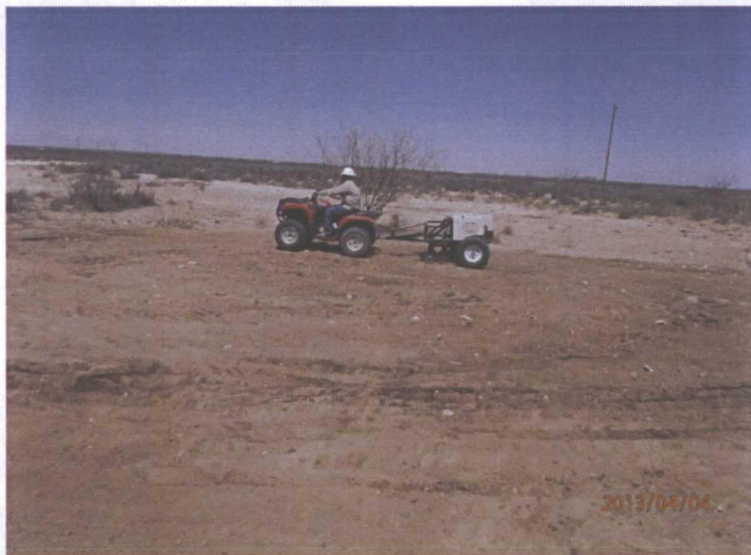
4/4/2013

Seeding site, facing north

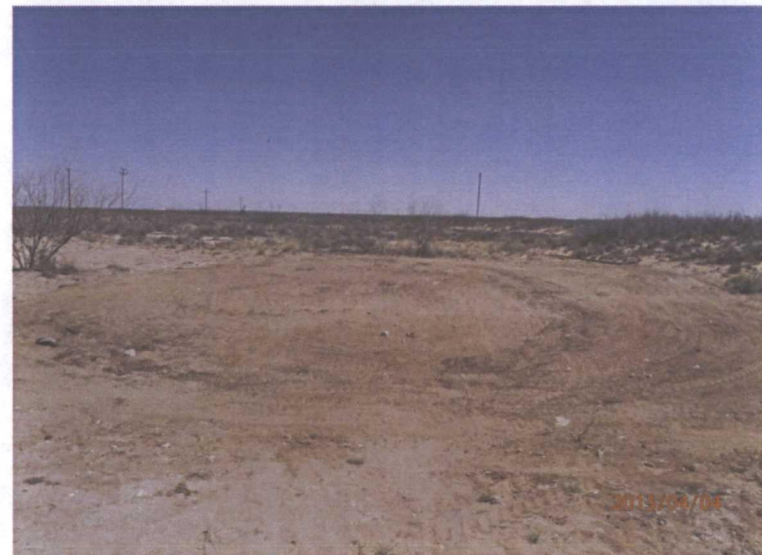
4/4/2013

Site complete, facing east
