From: Hansen, Edward J., EMNRD
Sent: Wednesday, May 29, 2013 2:31 PM
To: Hack Conder (hconder@riceswd.com)
Cc: Leking, Geoffrey R, EMNRD; Laura Pena (lpna@riceswd.com); Katie Jones <kjones@riceswd.com> (kjones@riceswd.com); Scott Curtis (scurtis@riceswd.com)
Subject: Remediation Plan (1R427-357) Termination - ROC EME C-10-1 EOL Site

RE: Termination Request
EME C-10-1 EOL (1R427-357): UL/C, Sec. 10, T21S, R36E
RICE Operating Company – Eunice Monument Eumont SWD System

EME C-10-1 EOL

**RICE OPERATING COMPANY
JUNCTION BOX FINAL REPORT**

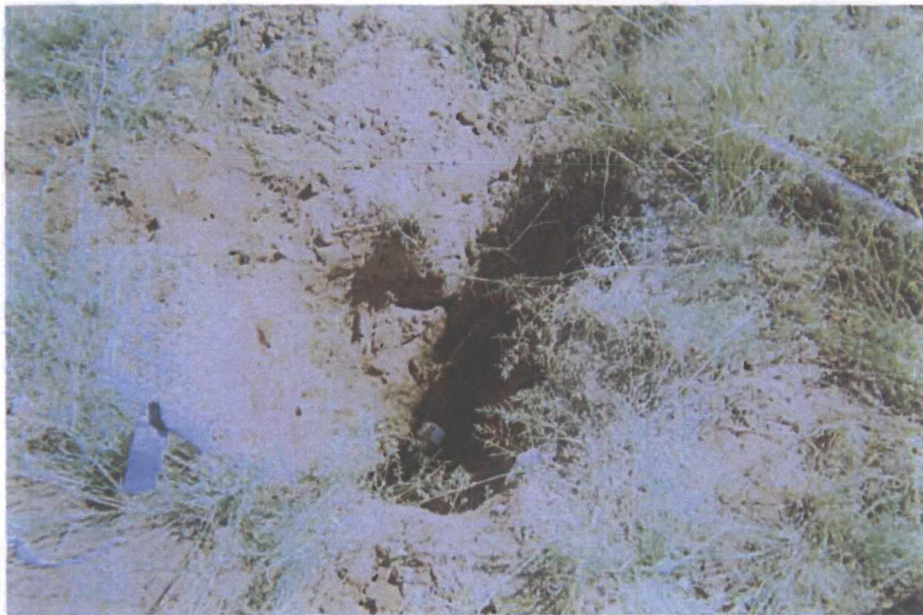
9/14/2010

Site prior to excavation

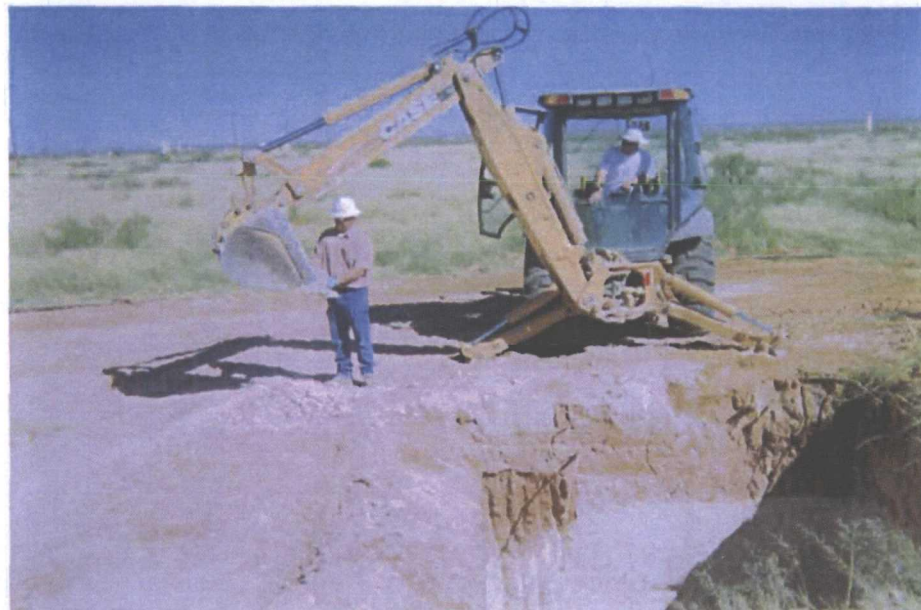
9/29/2010

Collecting Sample

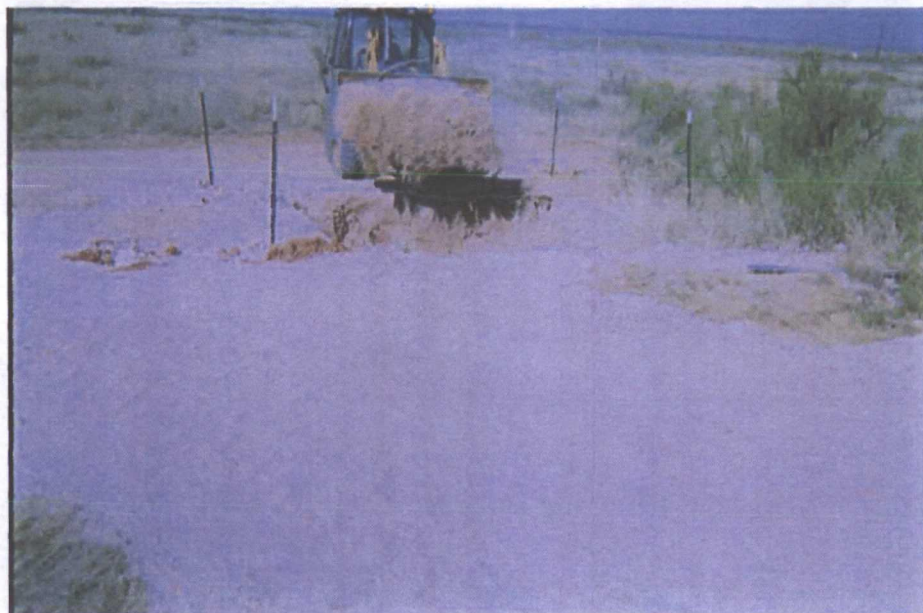
10/27/2010

Backfilling site

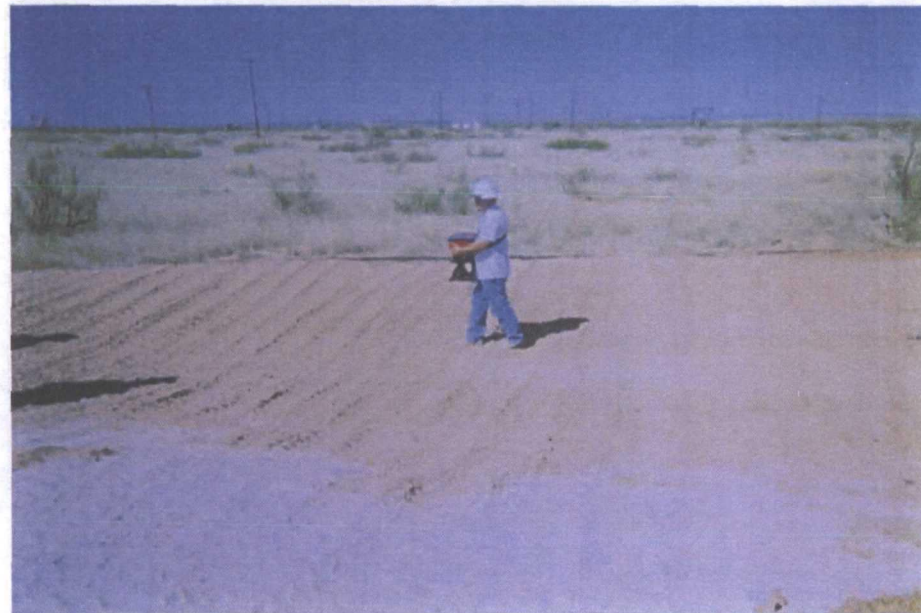
10/27/2010

Seeding site

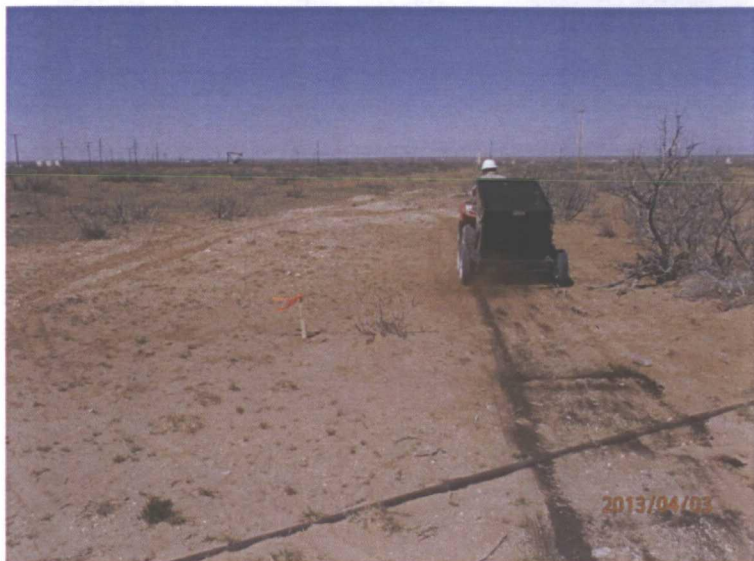
4/3/2013

Spreading amendments, facing north

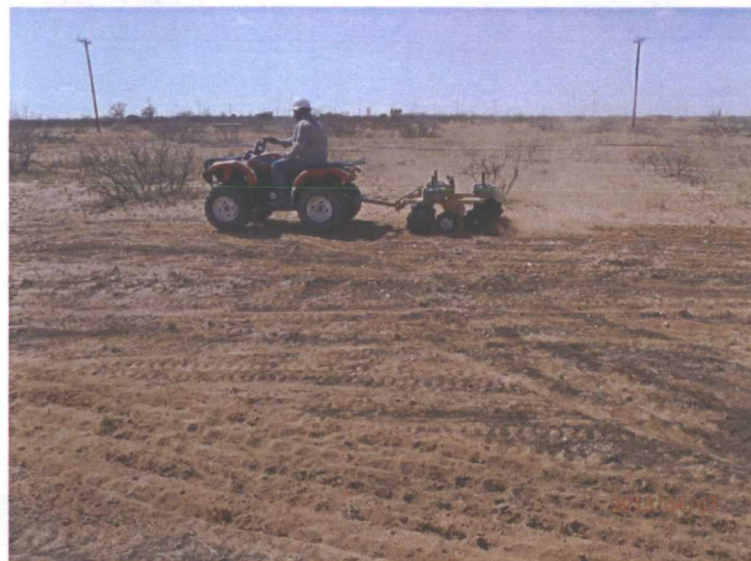
4/3/2013

Tilling site, facing west

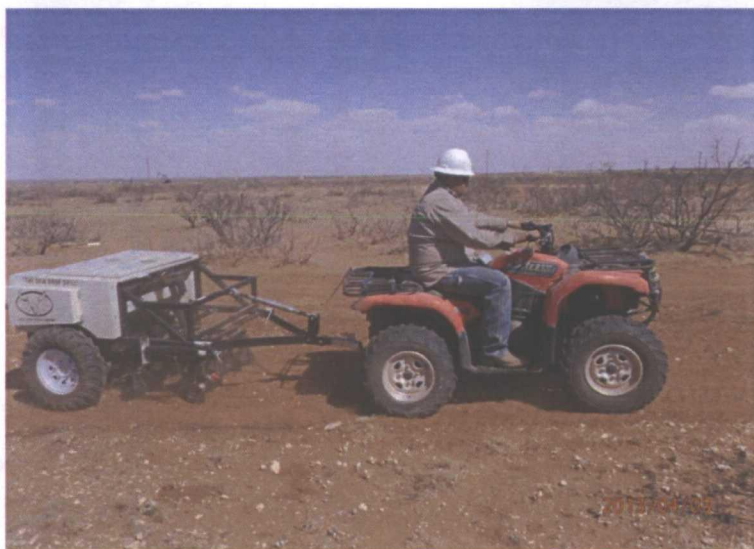
4/3/2013

Seeding site, facing east

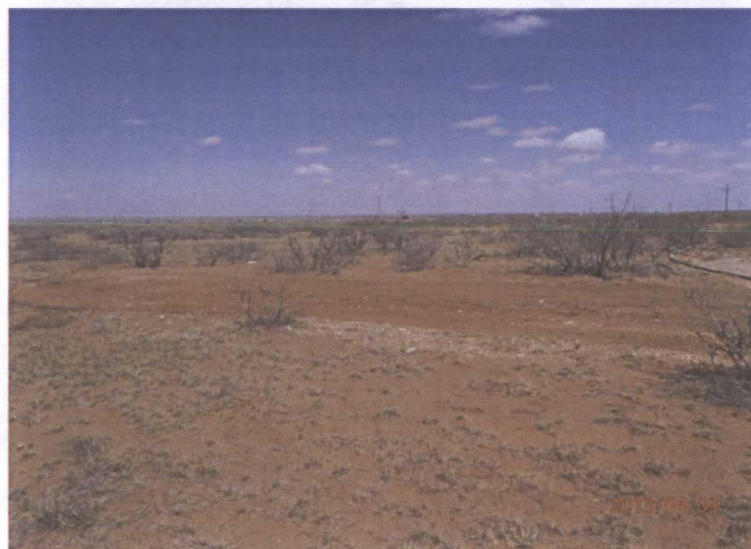
4/3/2013

Site complete, facing east
