**RE: Termination Request
for the Rice Operating Company's
EME I-9-1 Site
Unit Letter I, Section 9, T21S, R36E, NMPM, Lea County, New Mexico
Remediation Plan (1R427-34) Termination**

RE: Termination Request
EME I-9-1 (1R427-34): UL/I, Sec. 9, T21S, R36E
RICE Operating Company – Eunice Monument Eumont SWD System

**EME Jct. I-9-1
(1R427-34)**

**RICE OPERATING COMPANY
JUNCTION BOX FINAL REPORT**

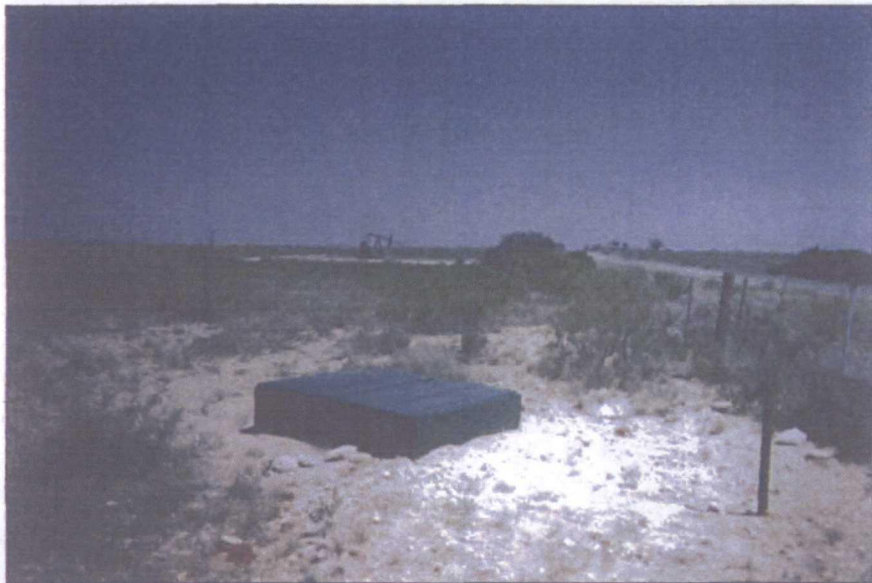
Undisturbed junction box

7/23/2003

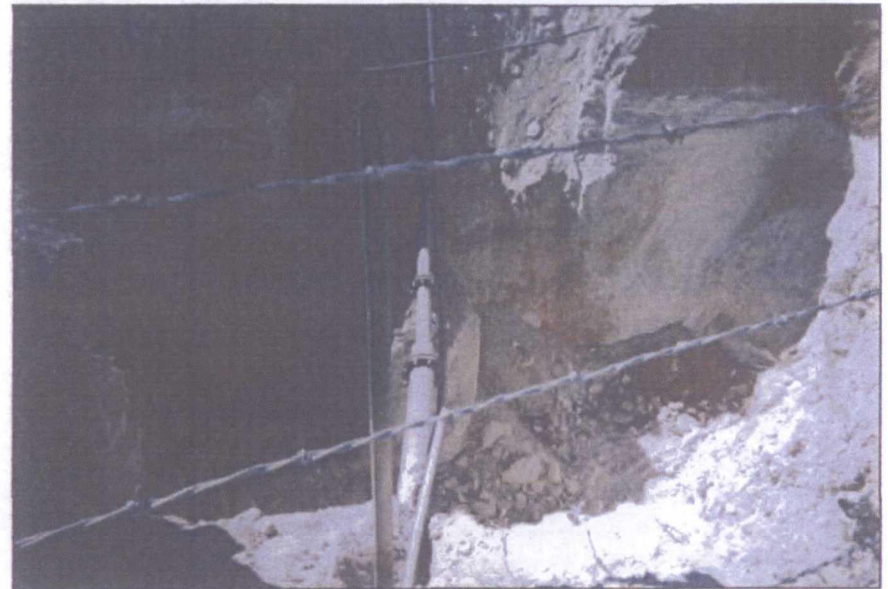
30 x 14 x 12-ft-deep Excavation

9/15/2003

The excavated soil was land farmed on-site and then backfilled into the hole. The junction has been re-plumbed with a new poly pipeline and a new water-tight junction box has been built over it. The disturbed surface was re-seeded with a blend of native vegetation on 12/12/2003 and will be monitored for growth.

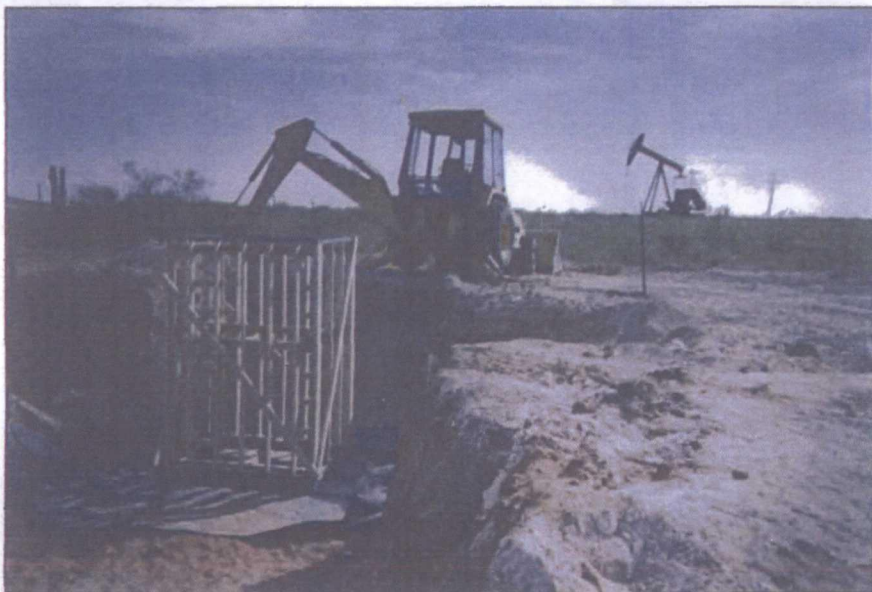
Construction of New Junction Box

10/2/2003

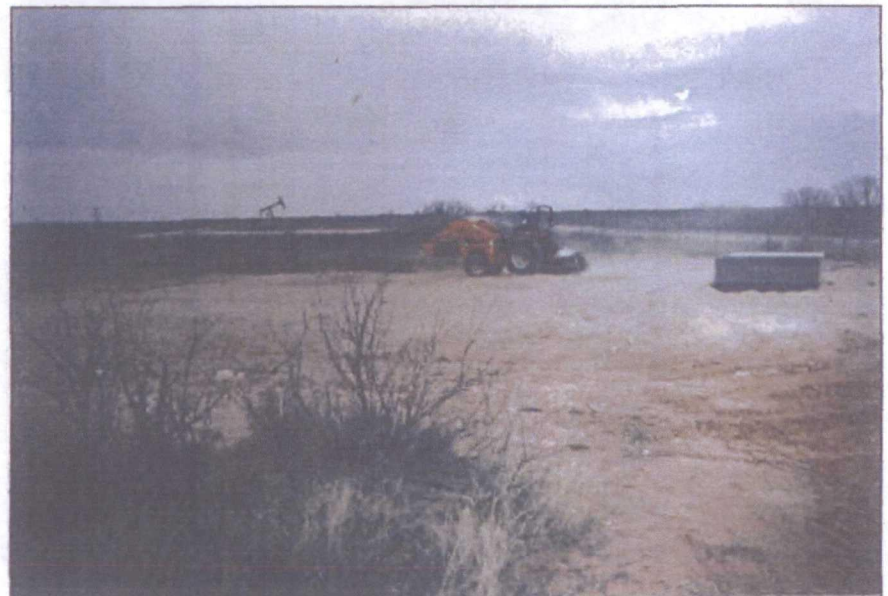
Seeding Disturbed Surface

12/12/2003

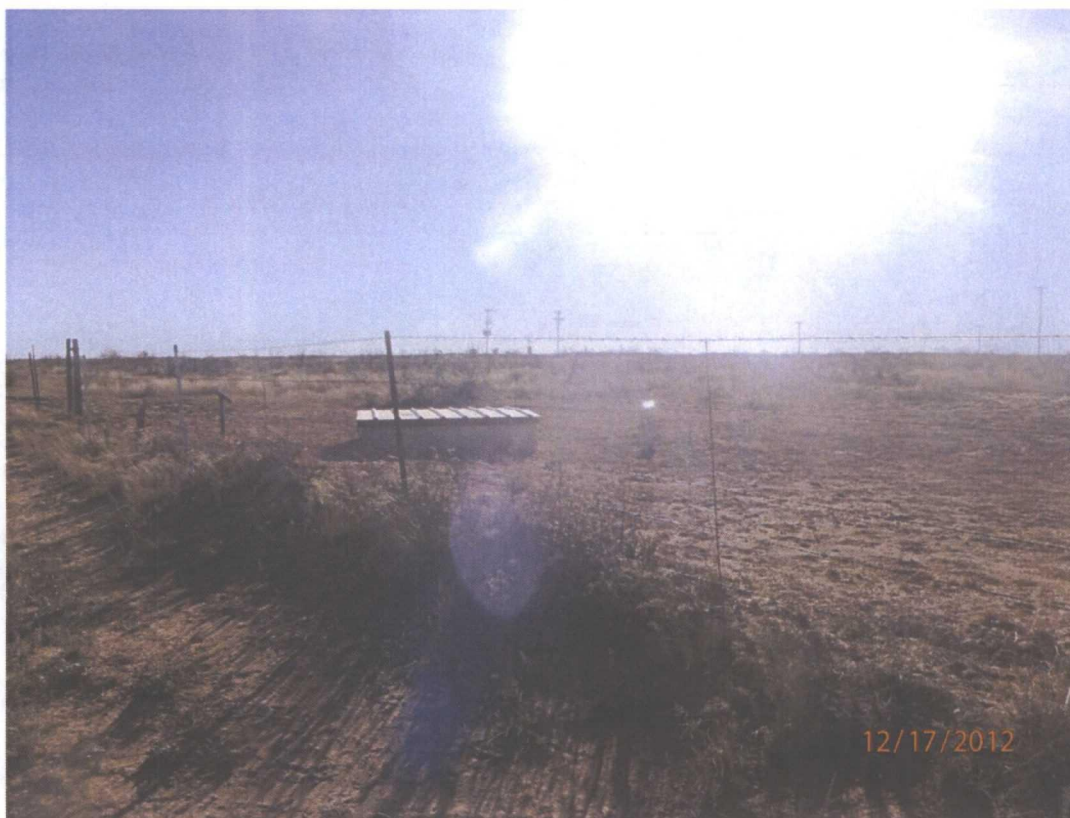
Facing Southwest

12/17/2012

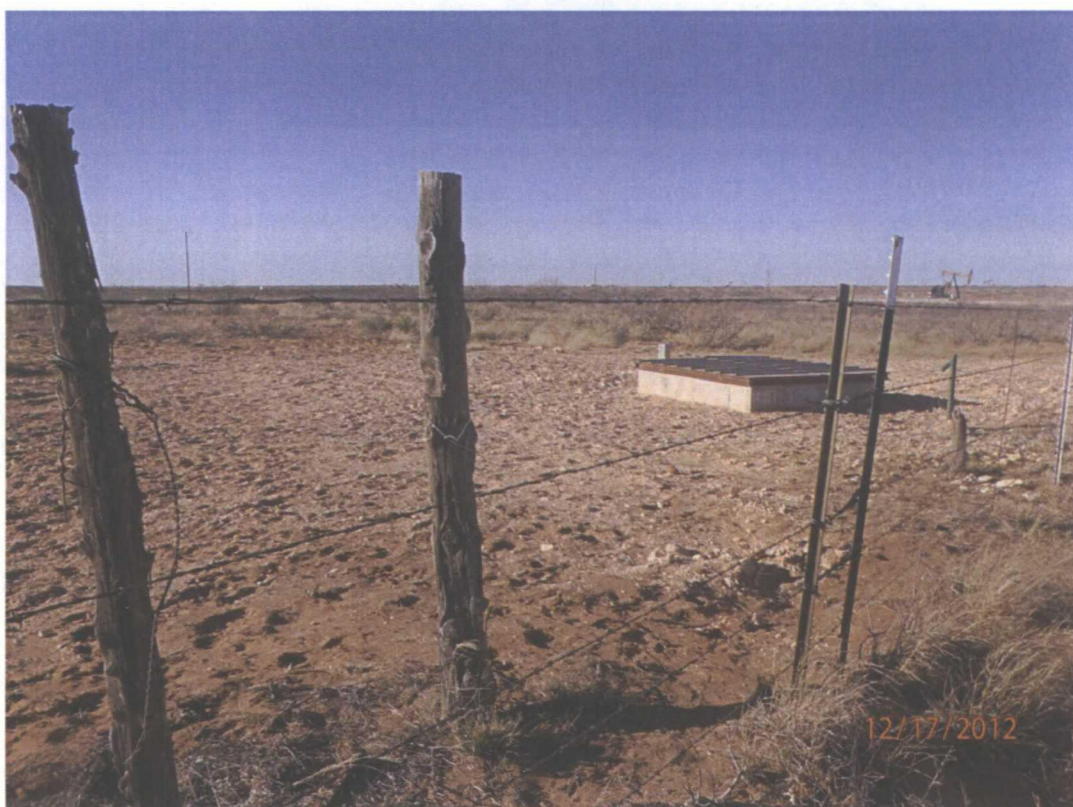
Facing Northwest

12/17/2012
