1R-427-76

RE: Termination Request EME M-9-1 (1R427-76): UL/M, Sec. 9, T20S, R37E RICE Operating Company – Eunice Monument Eumont SWD System

RICE OPERATING COMPANY JUNCTION BOX FINAL REPORT

EME M-9-1 (1R427-76) UL/M, Section 9, T20S, R37E

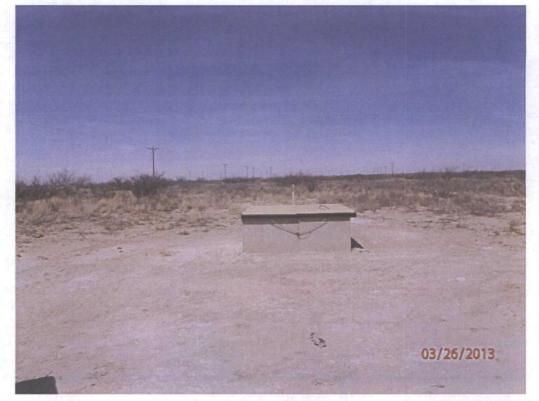
Facing north

ground surface (BGS) where a compacted red-bed clay layer was installed and density tested. The clay layer will provide a barrier that will inhibit the downward migration of chlorides to groundwater. The excavation was backfilled with remediated soil to ground surface and contoured to the surrounding area. The remediated soil was tested in 3 ft lifts, resulting in low concentrations of chloride. A new, water-tight junction box was built over the same location within an active facility; therefore, seeding is not necessary.
