**RE: Termination Request
for the Rice Operating Company's
EME Jct K-15 Site
Unit Letter K, Section 15, T21S, R36E, NMPM, Lea County, New Mexico
Remediation Plan (1R427-294) Termination**

RE: Termination Request
EME Jct. K-15 (1R427-294): UL/K, Sec. 15, T21S, R36E
RICE Operating Company – Eunice Monument Eumont SWD System

EME Jct. K-15

**RICE OPERATING COMPANY
JUNCTION BOX FINAL REPORT**

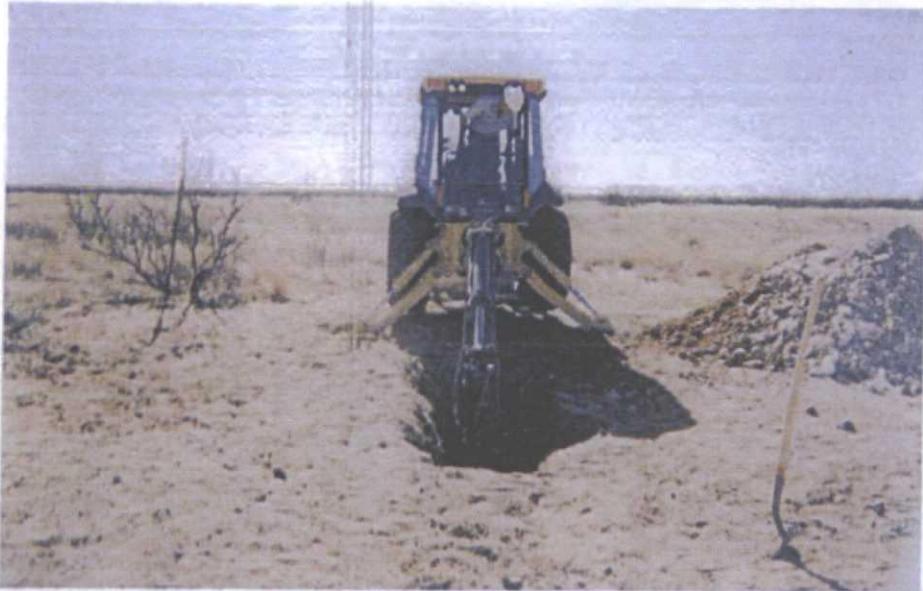
1/13/2009

excavating the source, facing south

General Description of Remedial Action: This junction box was eliminated during the pipeline replacement/upgrade program. After the former junction box was removed, an investigation was conducted using a backhoe to collect soil samples at regular intervals producing a 5x3x9-ft-deep excavation. Field data suggests low concentrations of organic vapors and chloride concentrations similar to that of the background. The deepest sample, 9 ft BGS, was sent to a commercial laboratory for analysis of chloride and TPH which confirmed low concentrations. The excavated soil was returned to the excavation to ground surface and contoured to the surrounding area. On 2/25/2009, the site was seeded with a blend of native vegetation and is expected to return to a productive capacity at a normal rate.

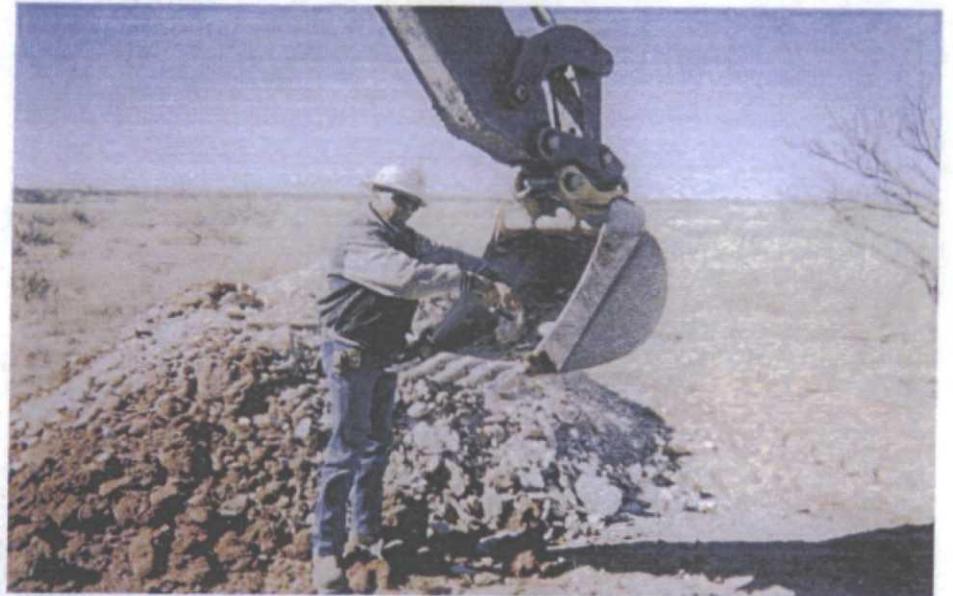
1/13/2009

collecting a soil sample, facing south

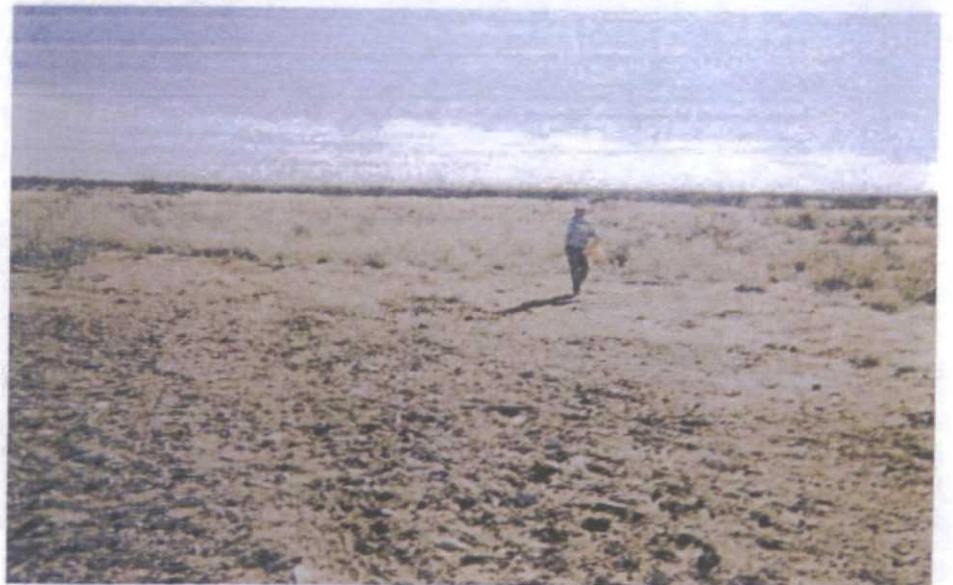
2/25/2009

seeding backfilled site, facing south

below detectable limits. On 5/16/2013, soil amendments were added to the site and the site was seeded with a blend of native vegetation. Vegetation will act as an evapotranspiration barrier that will also inhibit the downward migration of chlorides and hydrocarbons. Plants capture water through their roots and so reduce the amount of water infiltrating below the root zone.

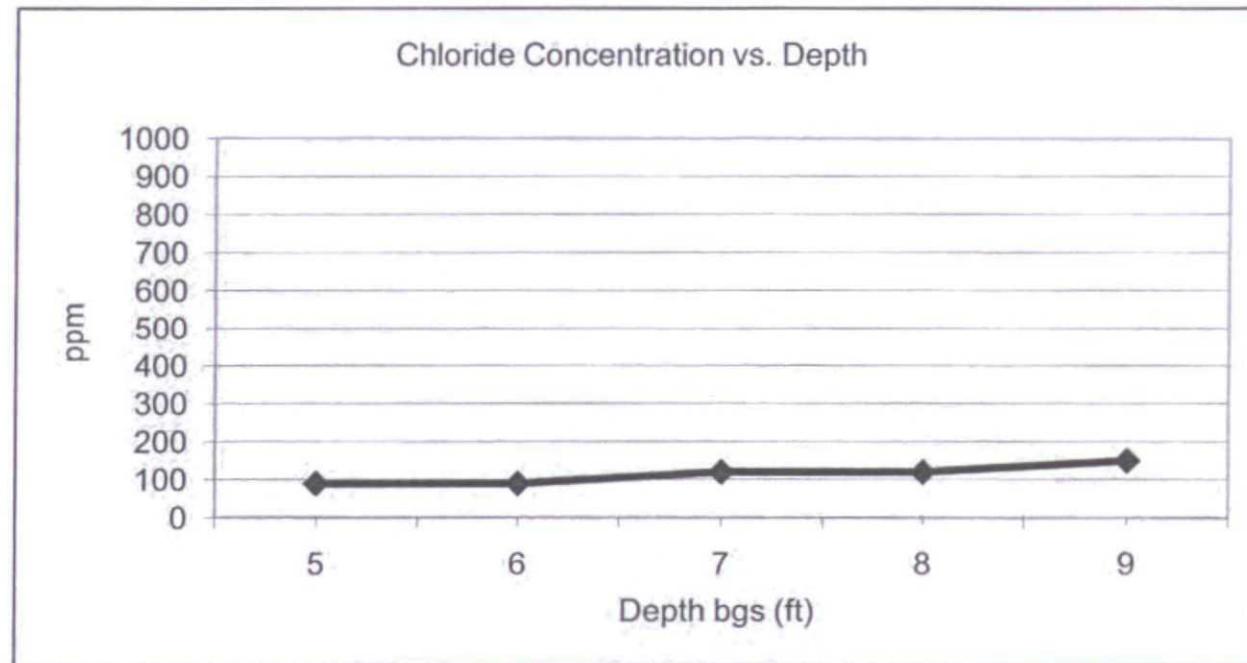
Backhoe samples at the junction (source)

Depth bgs (ft)	[Cl] ppm
5	90
6	90
7	120
8	120
9	150

Groundwater = 175 ft
