From: Hansen, Edward J., EMNRD
Sent: Thursday, July 18, 2013 8:30 AM
To: Hack Conder (hconder@riceswd.com)
Cc: Leking, Geoffrey R, EMNRD; Laura Pena (lpena@riceswd.com); Katie Jones <kjones@riceswd.com> (kjones@riceswd.com); Scott Curtis (scurtis@riceswd.com)
Subject: Remediation Plan (1R427-143) Termination - ROC EME Phillips St. A EOL Site

RE: Termination Request
EME Phillips St. A EOL (1R427-143): UL/N, Sec. 31, T19S, R37E
RICE Operating Company – Eunice Monument Eumont SWD System

**RICE OPERATING COMPANY
JUNCTION BOX FINAL REPORT**

EME Phillips St. 'A' EOL

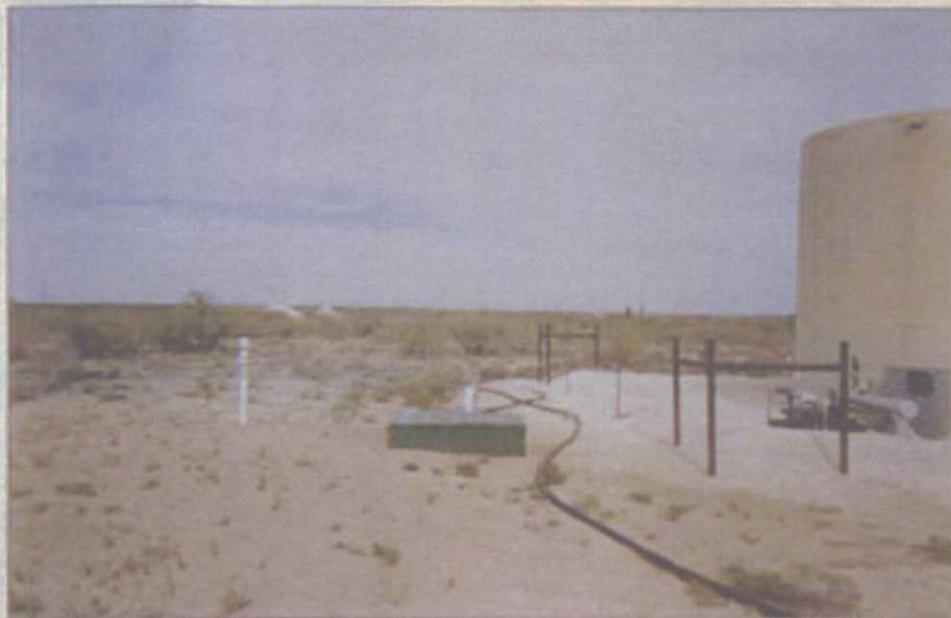
11/10/2003

undisturbed junction box

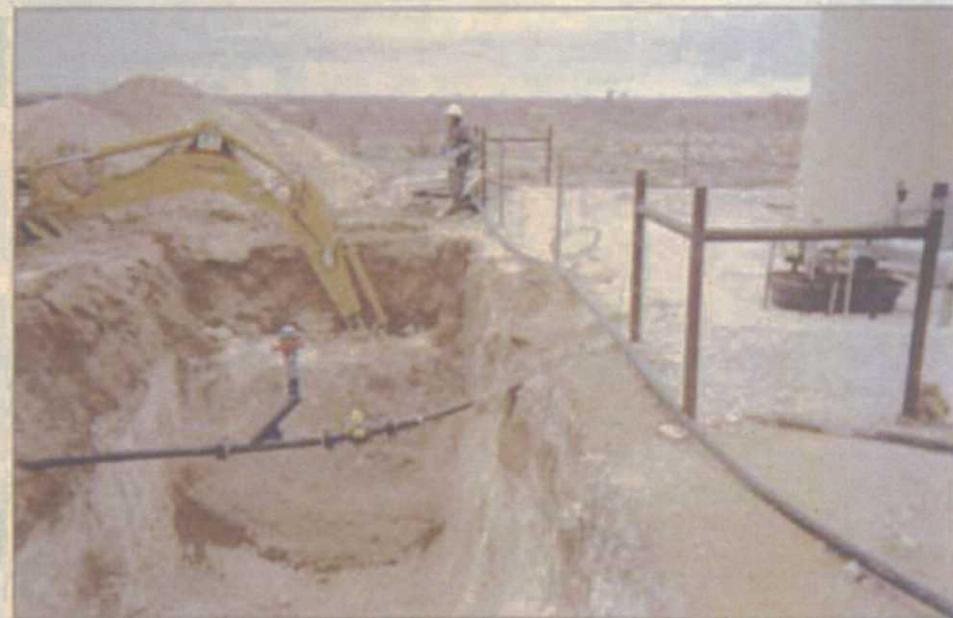
3/11/2004

delineation & excavation

The site was delineated using a backhoe to form a 30x30x12-ft deep excavation and soil samples were screened at regular intervals for both hydrocarbons and chlorides. Each sample was field titrated for chlorides and field screened using a PID for hydrocarbons, resulting in chloride concentrations that decreased laterally but increased with depth. The excavated soil was blended on site and representative composite samples of the excavation walls, bottom and remediated backfill were sent to a commercial for analysis of chloride and TPH, resulting in a 4-wall chloride concentration of 208 mg/kg and concentrations of gasoline range organics (GRO) concentration and diesel range organics (DRO) below detectable limits. The bottom composite resulted in a chloride concentration of 784 mg/kg and concentrations of GRO and DRO below detectable

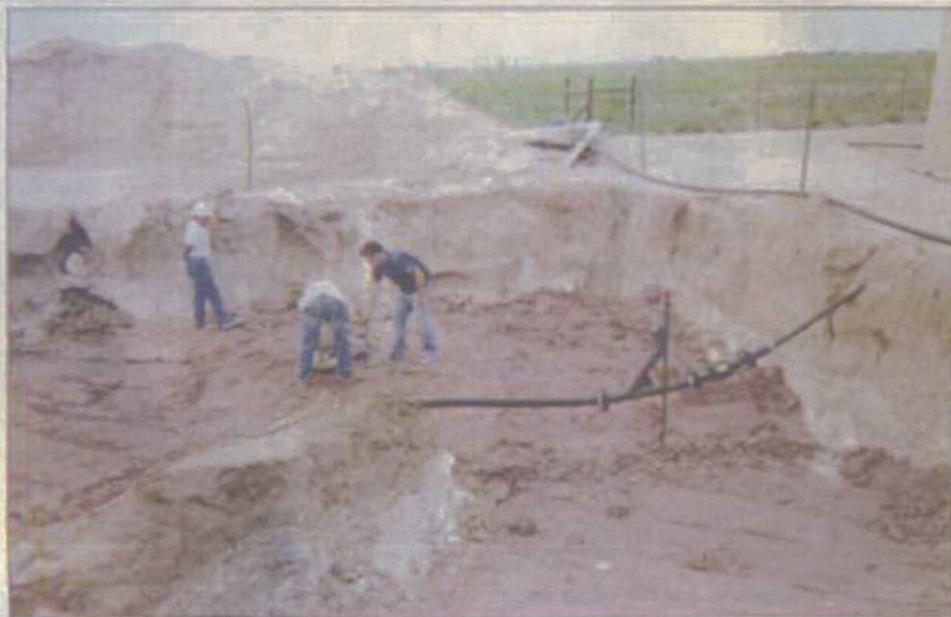
5/14/2004

testing clay barrier at 6 ft BGS

limits. The remediated backfill resulted in a chloride concentration of 224 mg/kg and concentrations of GRO and DRO below detectable limits. The excavation was backfilled with the excavated soil to 6 ft BGS. From 6 – 5 ft BGS, a one foot thick clay layer was installed. The clay layer will provide a barrier that will inhibit the downward migration of chlorides to groundwater. The remaining excavation was backfilled with the remediated backfill to ground surface and contoured to the surrounding area. A new watertight junction box was built on the site.

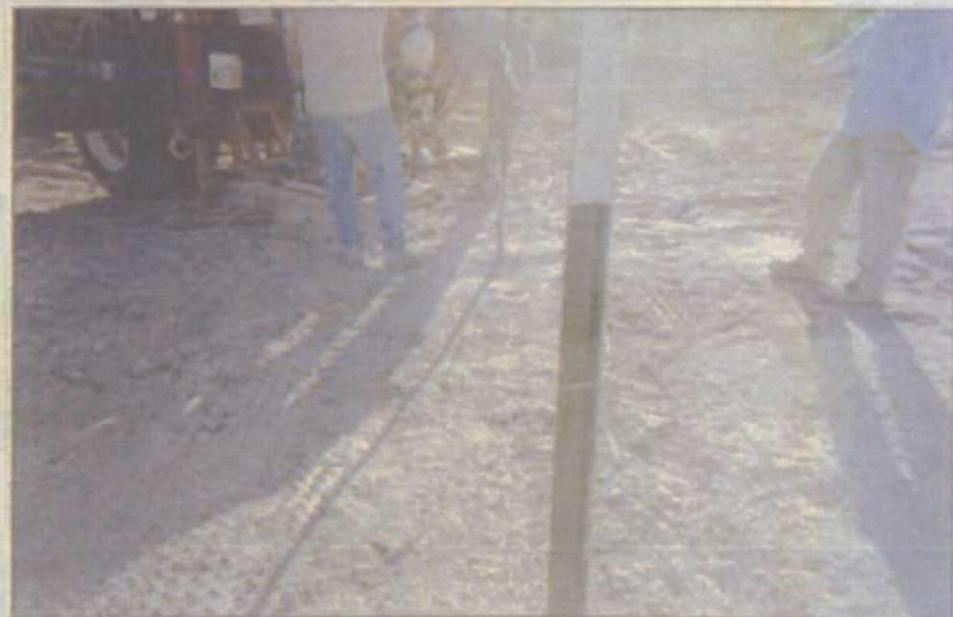
soil bore delineation drilling at backfilled site

To further investigate the depth of the chloride and TPH presence, a soil boring was initiated on 6/1/2004 at 15 ft southeast of the former junction box. Each sample was field titrated for chlorides and field screened using a PID for hydrocarbons, resulting in low concentrations of both. The 30 ft sample was taken to a commercial laboratory for analysis of chloride and TPH, resulting in a chloride concentration of 304 mg/kg and concentrations of GRO and DRO below detectable limits. The entire bore hole was plugged with bentonite to ground surface.

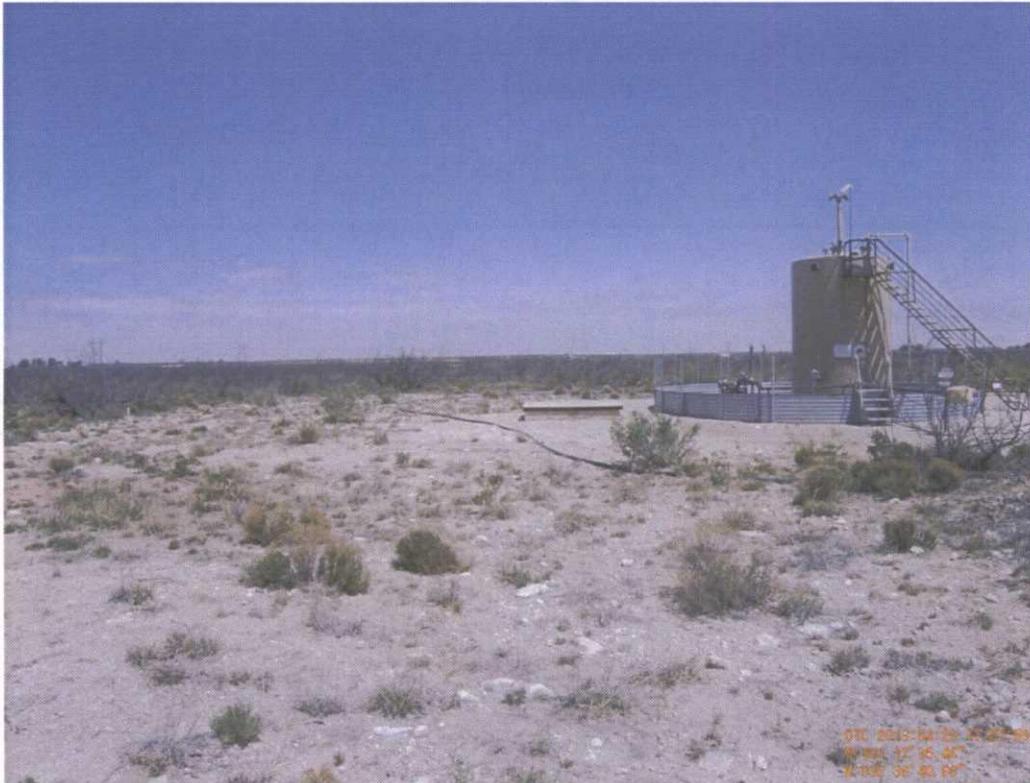
4/23/2013

Facing north

The site is located next to a lease pad and a new watertight junction box was installed; therefore, reseeding of the site is not necessary.
