# Turner B North Tank Battery

## CLOSURE REPORT

2RP-1733 2RP-1734 2RP-1896

**November 14, 2013**

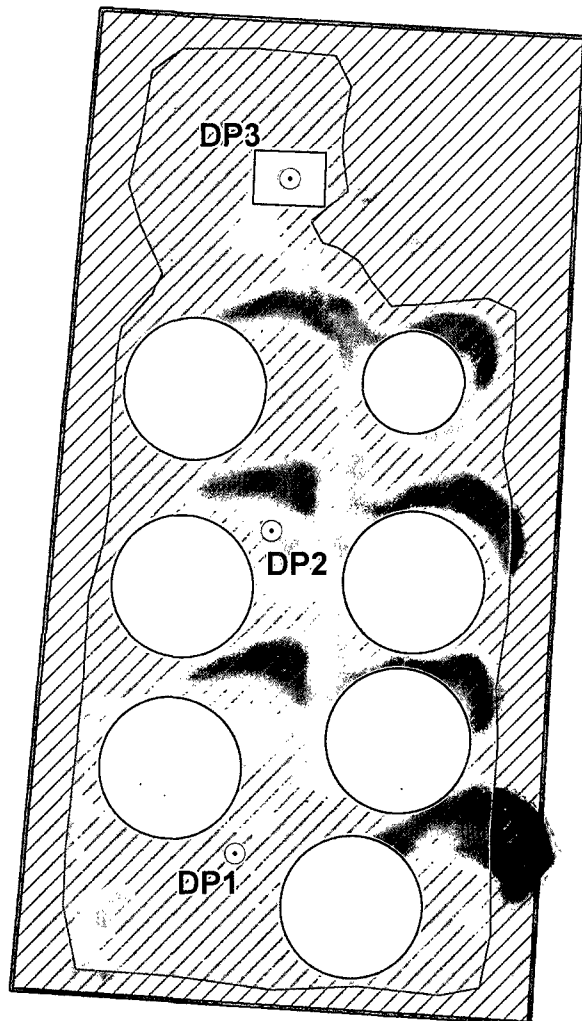
# FIGURE - Site Diagram

DP3					
Depth	Cl- ppm	Lab Cl-	GRO	DRO	Total BTEX
9'	1249	864	<10	<10	<0.300
14'	1199				
19'	674				
24'	499				
29'	474	224	<10	<10	<0.300
34'	324	32	<10	<10	<0.300

DP2					
Depth	Cl- ppm	Lab Cl-	GRO	DRO	Total BTEX
9'	1125	1130	<10	10.6	<0.300
14'	1174				
19'	899				
24'	999				
29'	649	656	<10	<10	<0.300
34'	624	32	<10	<10	<0.300

DP1					
Depth	Cl- ppm	Lab Cl-	GRO	DRO	Total BTEX
9'	1499	192	<10	<10	<0.300
14'	1699				
19'	1249				
24'	1124				
29'	999				
34'	674				
39'	999				
44'	874				
49'	724	16	<10	<10	<0.300
54'	674	448	<10	13.1	<0.300

On September 16, 2013 a drill rig was used to collect soil samples from 3 locations centrally placed within the excavation (Figure). At each soil bore, sampling commenced at 5 ft. below the excavation floor. Samples were collected in 5 ft. intervals, and were field screened for chloride and visual staining. Sampling continued at each soil bore until two consecutive samples with low chloride were obtained. Samples from each soil bore were submitted to a commercial laboratory for chloride, TPH (GRO/DRO), and BTEX (Benzene, Toluene, Ethyl benzene, Xylene) analyses (Appendix IV).

At DP1 (drill point), chloride at 54 ft. bgs was 448 mg/kg, GRO was less than 10 mg/kg, DRO was 13.1 mg/kg, and Total BTEX showed less than 0.300 mg/kg. Chloride in both DP2 and DP3 at 34

ft. bgs was 32 mg/kg, GRO/DRO were each less than 10 mg/kg, and Total BTEX showed less than 0.300 mg/kg. The soil bores were backfilled with clean soil and capped with bentonite.

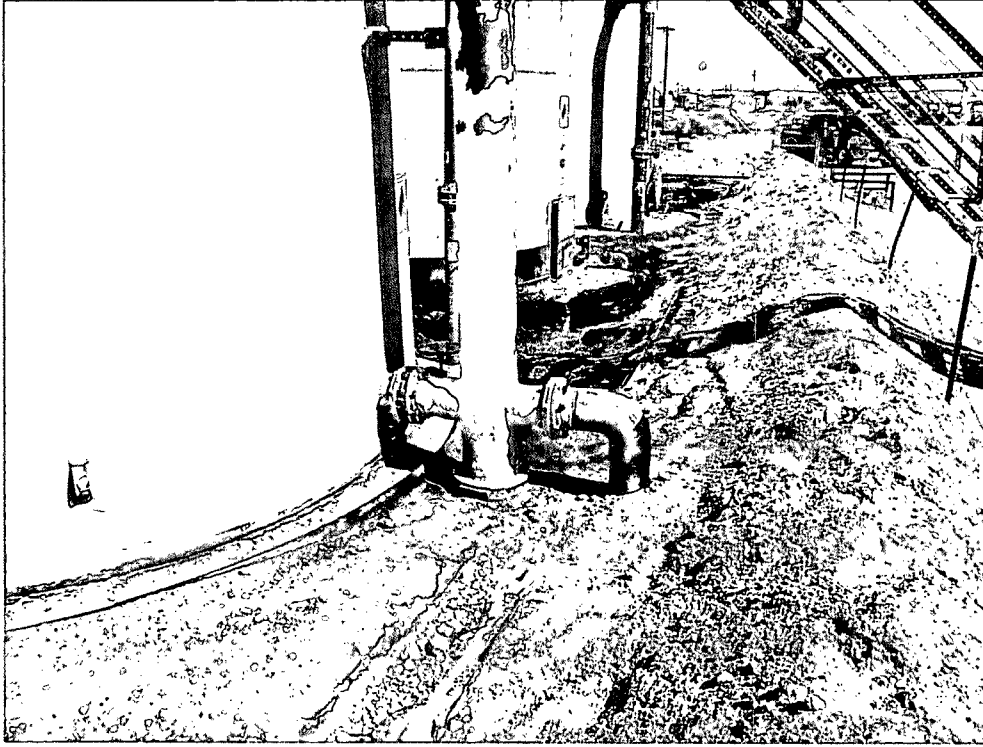
Impacted area, east side, facing north 08/23/13

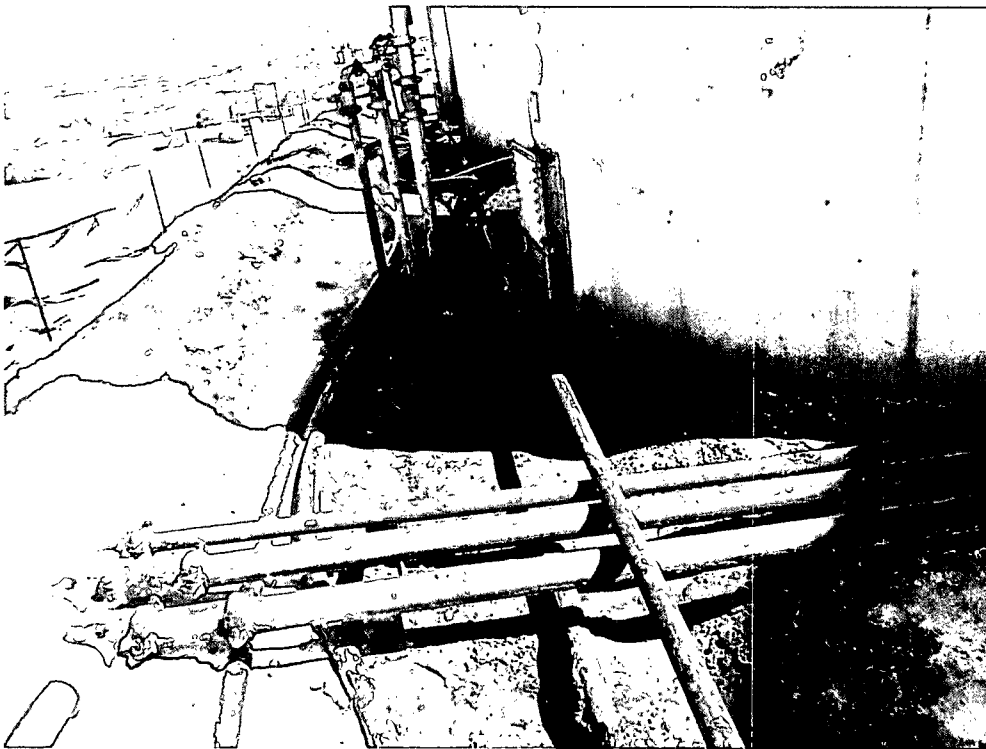
Impacted area, west side, facing north 08/23/13

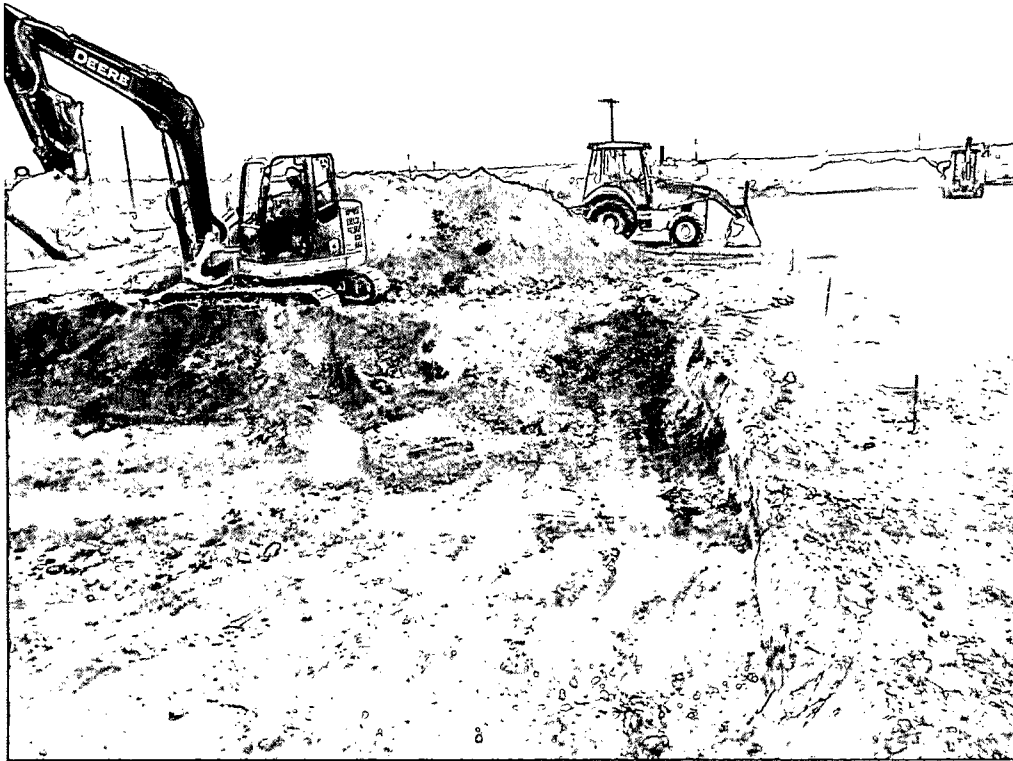
Excavation, facing north 9/10/13

The entire area was excavated to 4 ft. below ground surface (bgs). The excavated soils were removed to a NMOCD approved disposal facility. Due to a rain event, the excavation bottom was dressed with a layer of clean imported caliche for ease of access by a drill rig.

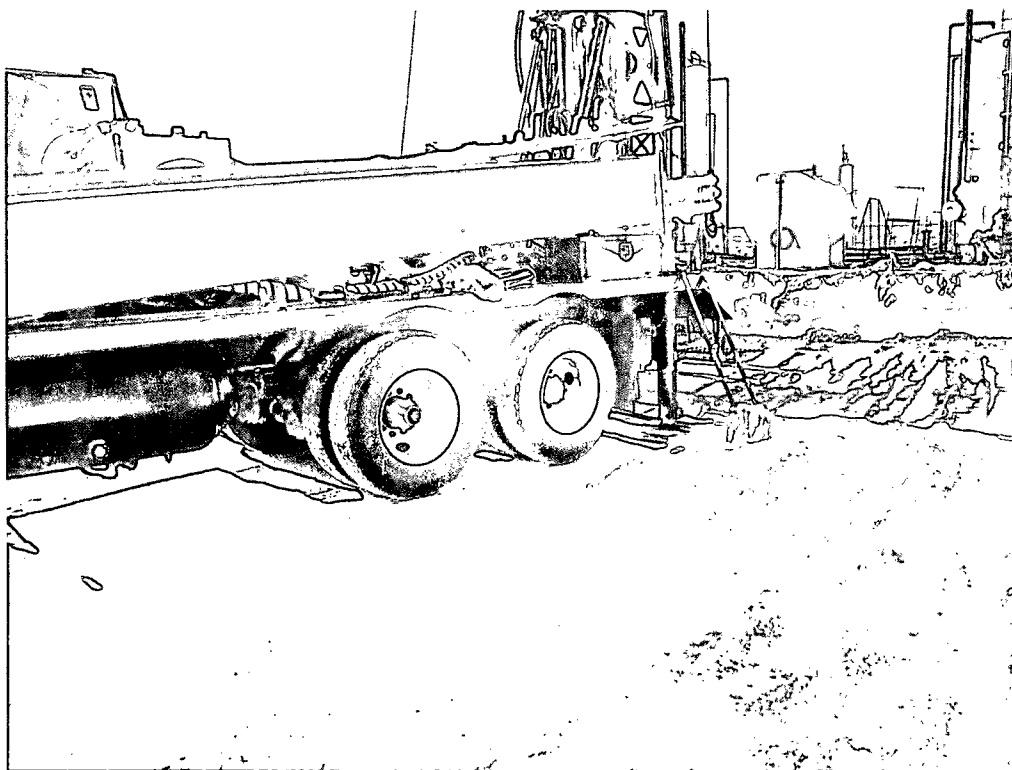
Installation of soil bore, facing south 09/16/13

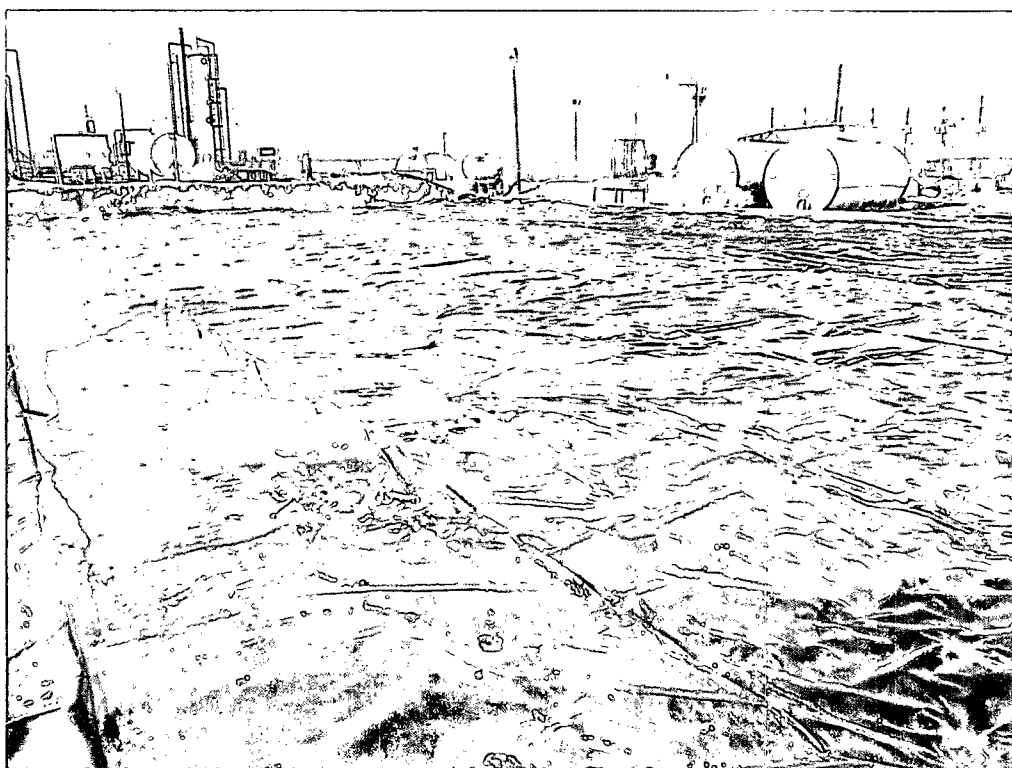
Installation of liner at 4' bgs, facing southwest 09/17/13

On September 17, 2013 a 20 mil reinforced plastic liner was installed in the excavation floor. The excavation was backfilled with clean soil and caliche to ground surface, leveled, and compacted. A secondary containment system with steel sidewalls and a polyethylene liner was constructed above the compacted backfill. The new facility was assembled within the secondary containment.

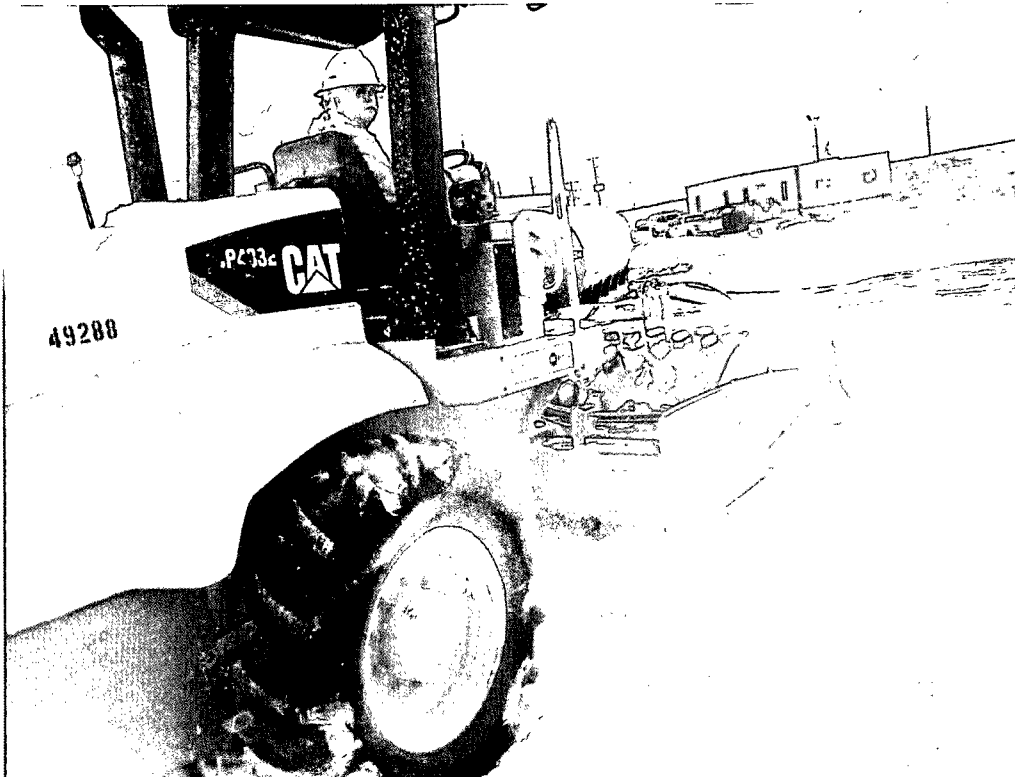
Compaction of caliche backfill, facing west 9/18/13

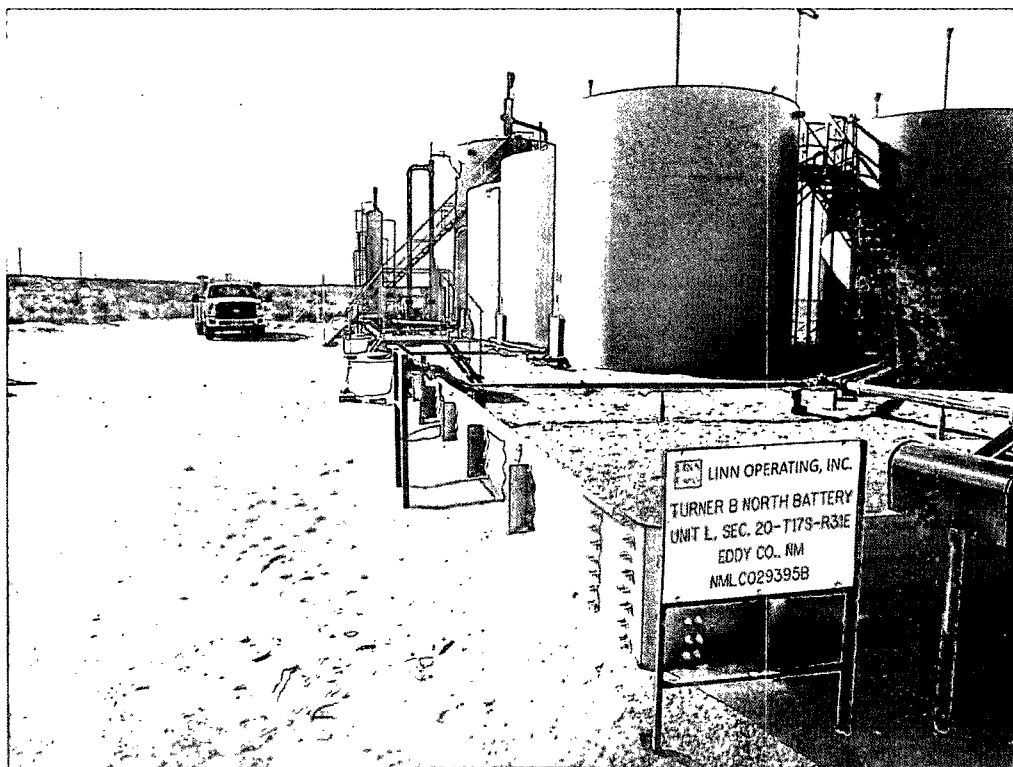
Final battery inside secondary containment, facing south 11/15/13

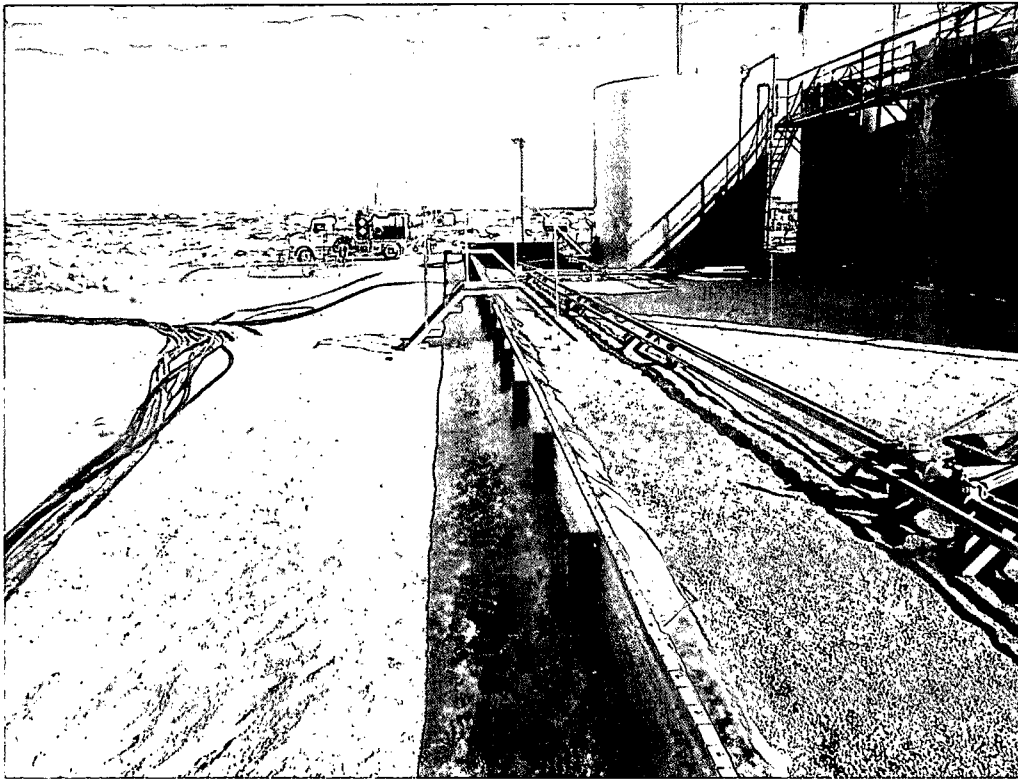
Final battery inside secondary containment, facing north 11/15/13

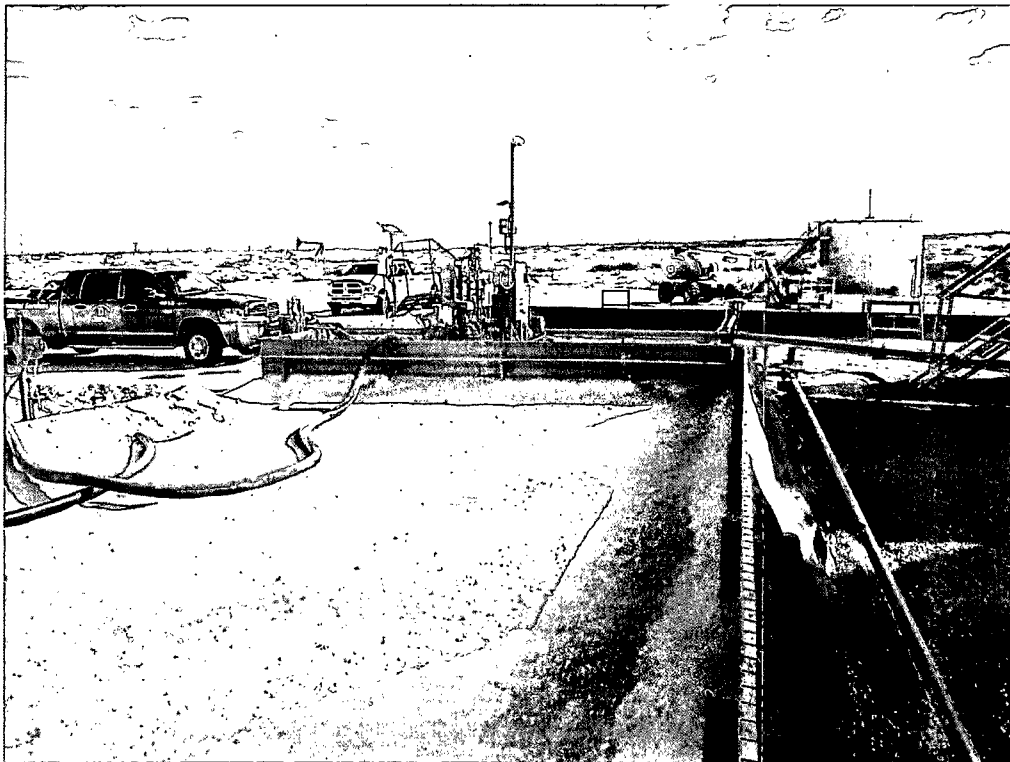
Lact unit inside secondary containment, facing east 11/15/13
