# **Max Friess Supply Line**

**2RP-1877**

# **CAP Report and Termination Request**

**RE: CAP Report and Termination Request  
Linn Energy – Max Friess Supply Line (2RP-1877)  
UL/P sec. 19 T17S R31E  
API No. 3001528822**

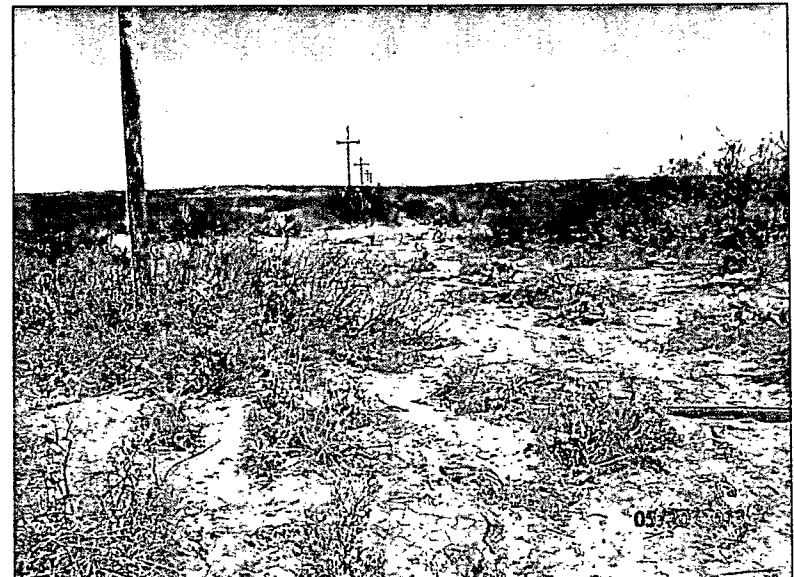
Initial release area, facing east

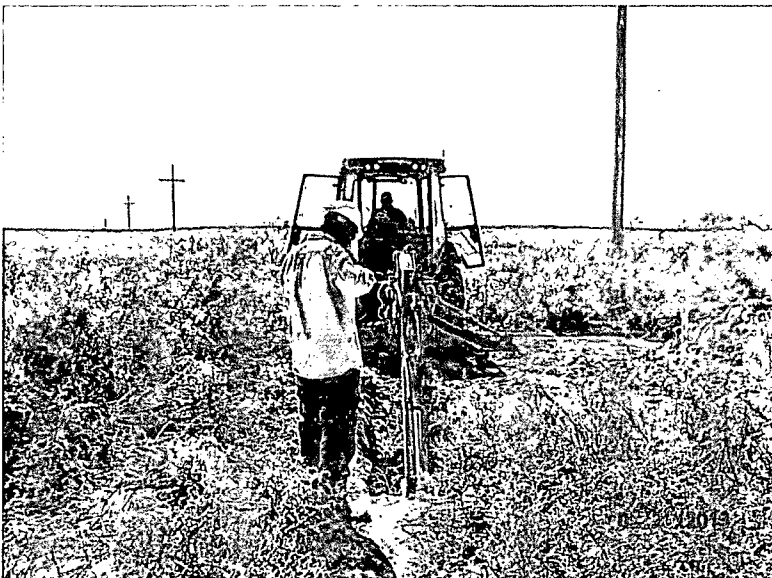
Installing verticals, facing east

Based on the surface data, RECS installed six verticals at each surface sample point. BLM approved vertical installation on July 23<sup>rd</sup>, 2013. As the verticals were installed, samples were taken at regular intervals and field tested for chlorides and hydrocarbons. Representative samples from each vertical were taken to a commercial laboratory for analysis. Verticals #1 and #2 were installed to a depth of 15 ft bgs and showed elevated laboratory chloride readings at that depth. However, GRO, DRO and BTEX readings were non-detect, except for in Vertical #1 where the toluene reading was 0.086 mg/kg at 1.5 ft and in Vertical #2 where the DRO reading was 11.3 mg/kg. Vertical #3 was installed to a depth of 13 ft bgs and Vertical #4 was installed to a depth of 4 ft bgs where laboratory chlorides, GRO, DRO and BTEX readings were low in the bottom most sample of each vertical. Vertical #5 was installed to a depth of 15 ft bgs where the

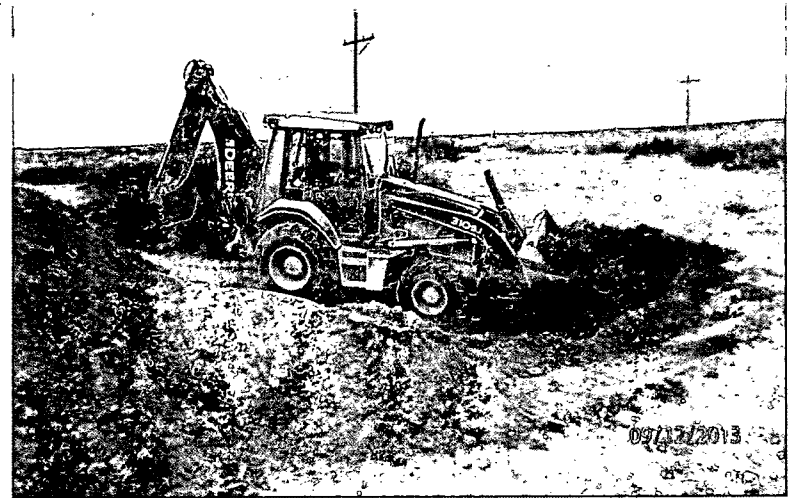
Excavating for liner installation, facing east

On September 12<sup>th</sup>, 2013, RECS personnel were on site to begin the excavation for liner installation. The site was excavated to a depth of 4 ft bgs and samples were taken along the walls and field tested for chlorides and hydrocarbons. The walls of the excavation were extended until field tests concluded that the walls had field chloride values less than 1,000 mg/kg. The excavation was completed on October 9<sup>th</sup>, 2013 and final wall samples were taken on October 10<sup>th</sup>, 2013 (Figure 2). The wall samples were field tested for chlorides and hydrocarbons and representative samples were taken to a commercial laboratory for analysis (Appendix B). A 2 foot trench was installed along the edge of the base of the excavation to prepare to key set the liner. A 20-mil reinforced poly liner was installed and key set into the excavation. The excavation was then backfill to 2 ft bgs

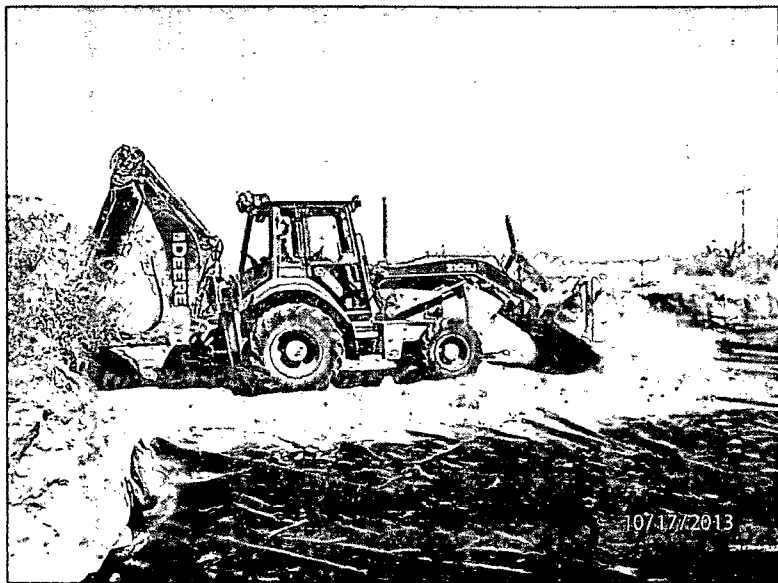
Backfilling over liner, facing east
