# RICE Operating Company

RE: Corrective Action Plan (CAP)  
BD Jct. N-31-1 Accidental Discharge: Unit N, Section 31, T21S, R37E  
API No. 30-025-38528  
RICE Operating Company – Blinbery Drinkard SWD System

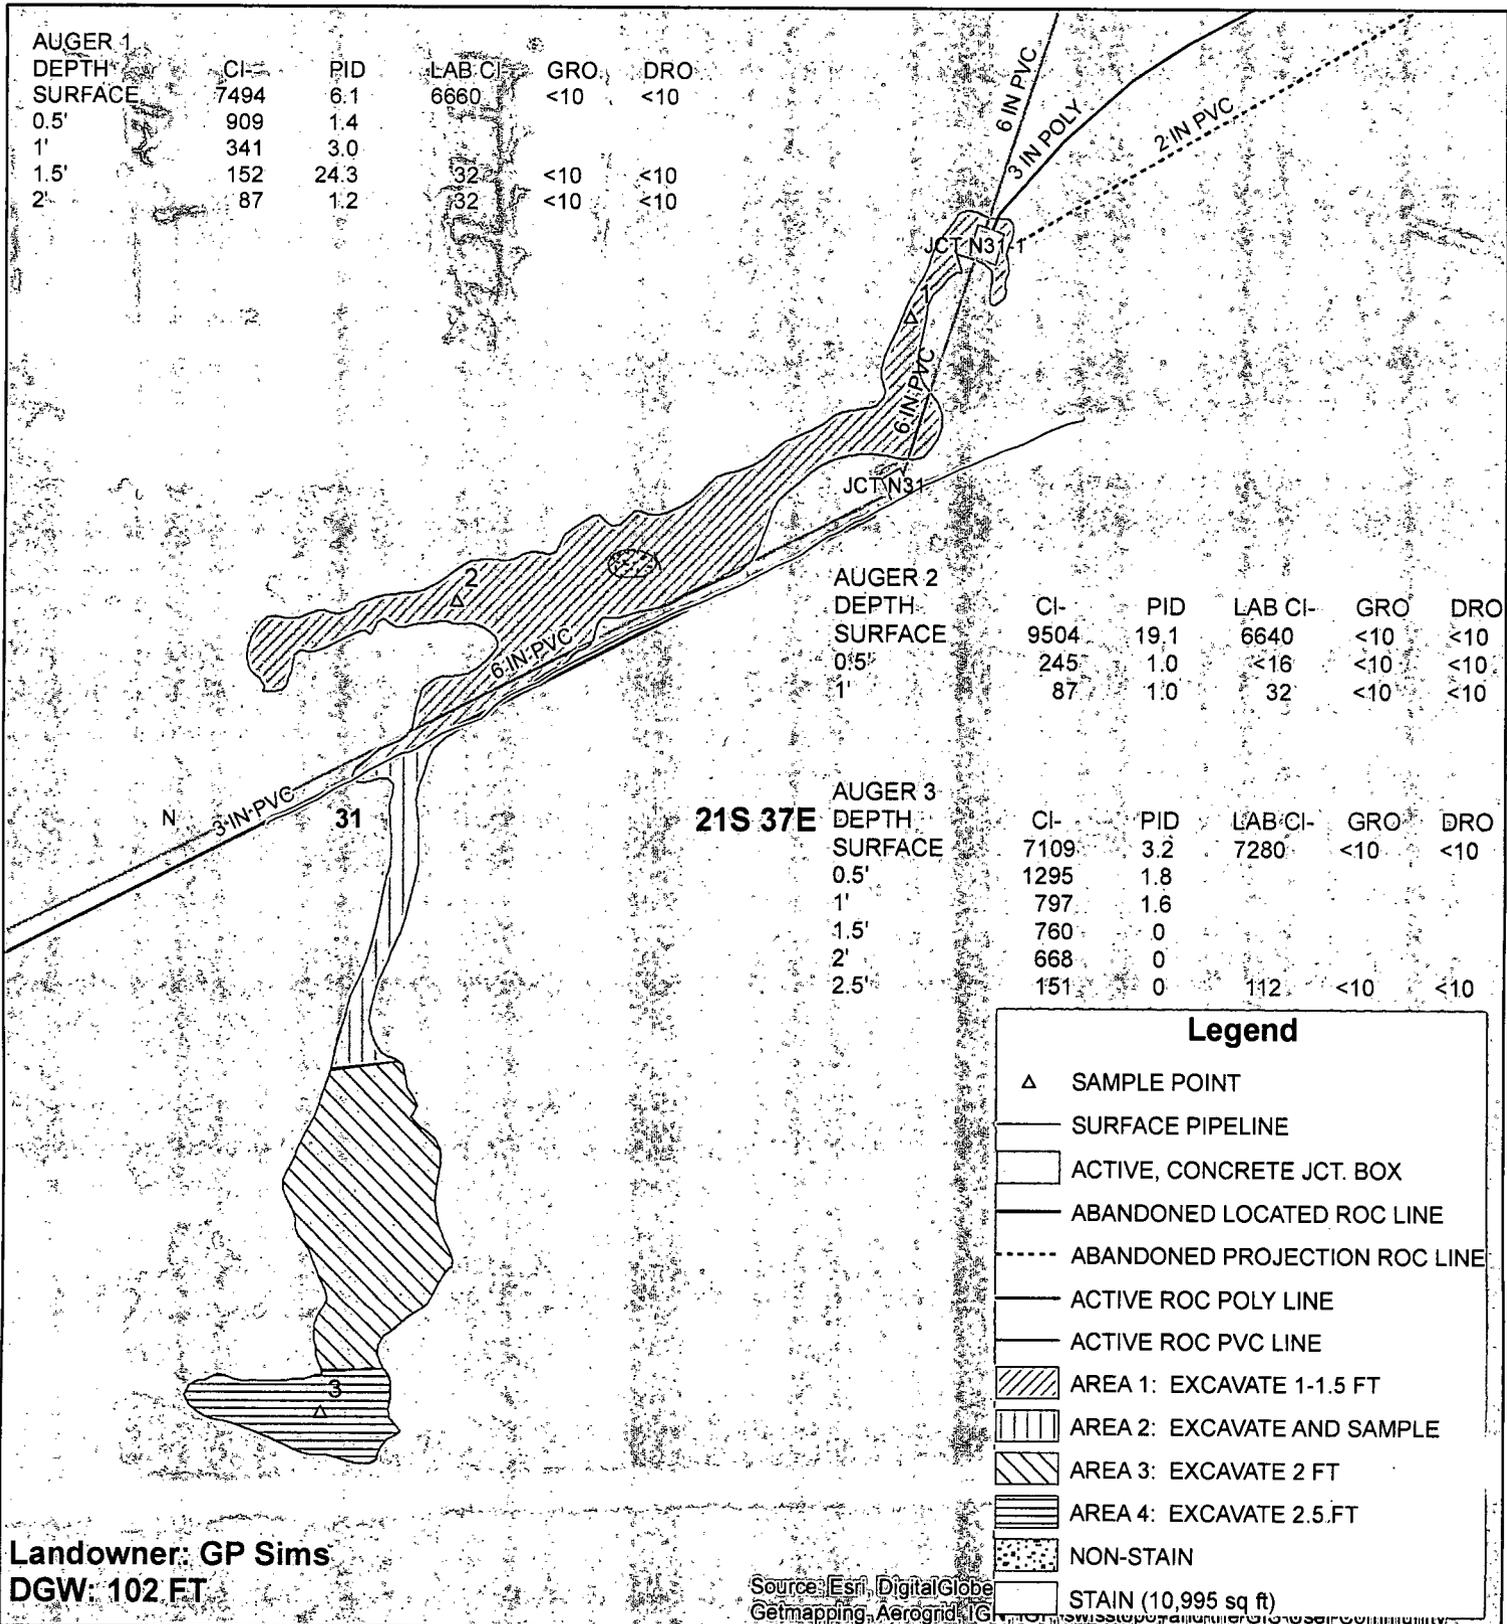
**Figure 2**

On January 2, 2014, RECS personnel were onsite to collect hand auger soil samples at regular intervals in three separate areas. Each sample was field titrated for chloride and screen for hydrocarbons using a PID. Auger point 1 was collected near the source of the AD to a depth of 2 ft bgs. Chloride concentrations decreased from 7,494 mg/kg at the surface to a concentration of 152 mg/kg at 1.5 ft bgs and 87 mg/kg at 2 ft bgs. Auger point 2 was collected near the center of the AD to a depth of 1 ft bgs. Chloride concentrations decreased from 9,504 mg/kg at the surface to 245 mg/kg at 0.5 ft to 87 mg/kg at 1 ft bgs. Auger point 3 was collected from the southern part of the AD to a depth of 2.5 ft bgs. Chloride concentrations decreased from 7,109 mg/kg at the surface to 151 mg/kg at 2.5 ft bgs. Laboratory analysis confirmed chloride concentrations that decreased with depth and TPH concentrations below detectable limits. This data and the AD boundary is shown in Figure 2. The lab result is included in Appendix B.

During a meeting with the District 1 NMOCD office on January 3, 2013, the following corrective actions were discussed. The AD will be separated into four different sections, based on chloride concentration. Area 1 is the soil surrounding auger points 1 and 2, Area 2 is the ravine section, Area 3 is the soil surrounding historical over flow pit, and Area 4 is the soil surrounding auger point 3. To protect groundwater quality, ROC proposes to excavate Area 1 to a depth of 1-1.5 ft bgs. Area 2 is proposed to be excavated and sampled to verify chloride concentrations. Area 3 is proposed to be excavated to a depth of 2 ft bgs, and Area 4 is proposed to be excavated to a depth of 2.5 ft bgs. The specified excavation depths will remove the highest chloride concentrations. The excavation boundaries are summarized in Figure 2. Figure 3 is a detailed plat that shows surrounding features and non-ROC pipelines.

# Proposed Excavation

Each excavated area will then be backfilled with soil containing a chloride concentration below 500 mg/kg and a field PID reading below 100 ppm. Any soil requiring disposal will be properly disposed of at a NMOCD approved facility. The backfilled excavation will then be seeded with a blend of native vegetation. Vegetation provides a natural infiltration barrier, since plants capture water through their roots thereby reducing the amount of water traveling through the vadose zone.

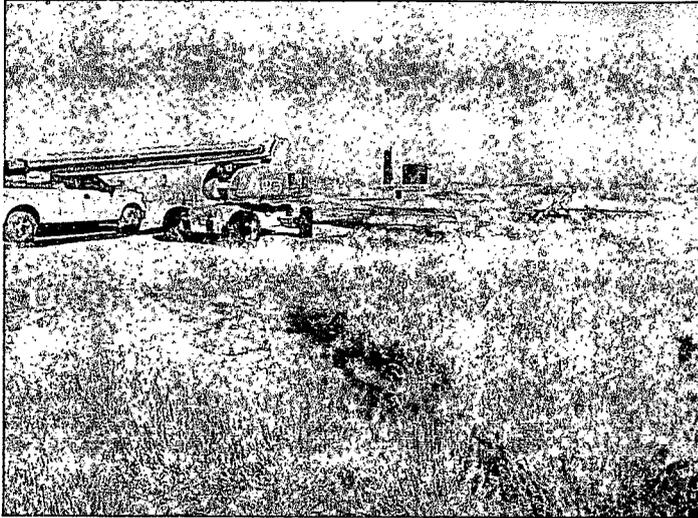
An accidental discharge of produced water was discovered on December 31, 2013. The NMOC D District 1 office was notified that day, and an initial C-141 was submitted to the District 1 office on January 2, 2014. According to the initial C-141, a PVC flange in the junction box cracked, releasing the 60 bbls of produced water, which affected a total of 10,995 ft<sup>2</sup> of pasture and lease road. After the AD was discovered, the line was shut in and a vacuum truck was used to recover 20 bbls of the produced water, then the flange was permanently repaired. The initial C-141 and photos of the leak are included in Appendix A.

Facing northeast

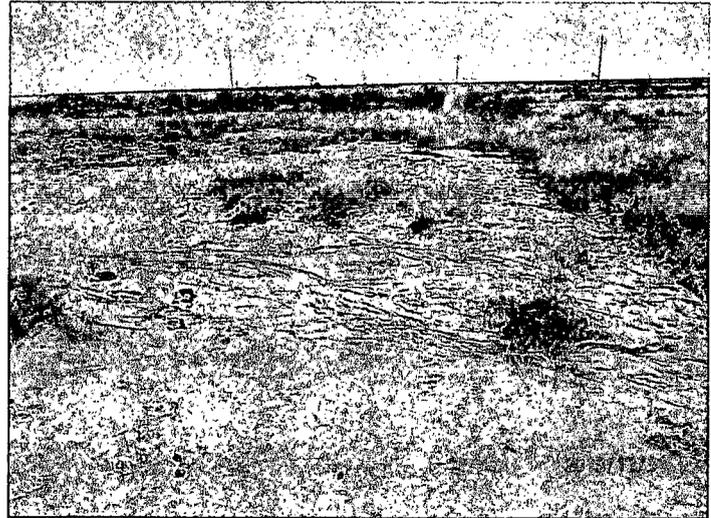
Facing south
