RICE *Operating Company*

RE: UPDATED Corrective Action Plan (CAP)
BD Jct. N-31-1 Accidental Discharge: Unit N, Section 31, T21S, R37E
API No. 30-025-38528
RICE Operating Company – Blinbry Drinkard SWD System

ROC submits the following Corrective Action Plan (CAP) for the BD Jct. N-31-1 Accidental Discharge (AD). The AD was located in unit letter N, section 31, T21S, R37E, as shown in Figure 1. ROC is the service provider (agent) for the BD SWD System and has no ownership of any portion of the pipeline, well, or facility. The system is owned by a consortium of oil producers, System Parties, who provide all operating capital on a percentage ownership/usage basis.

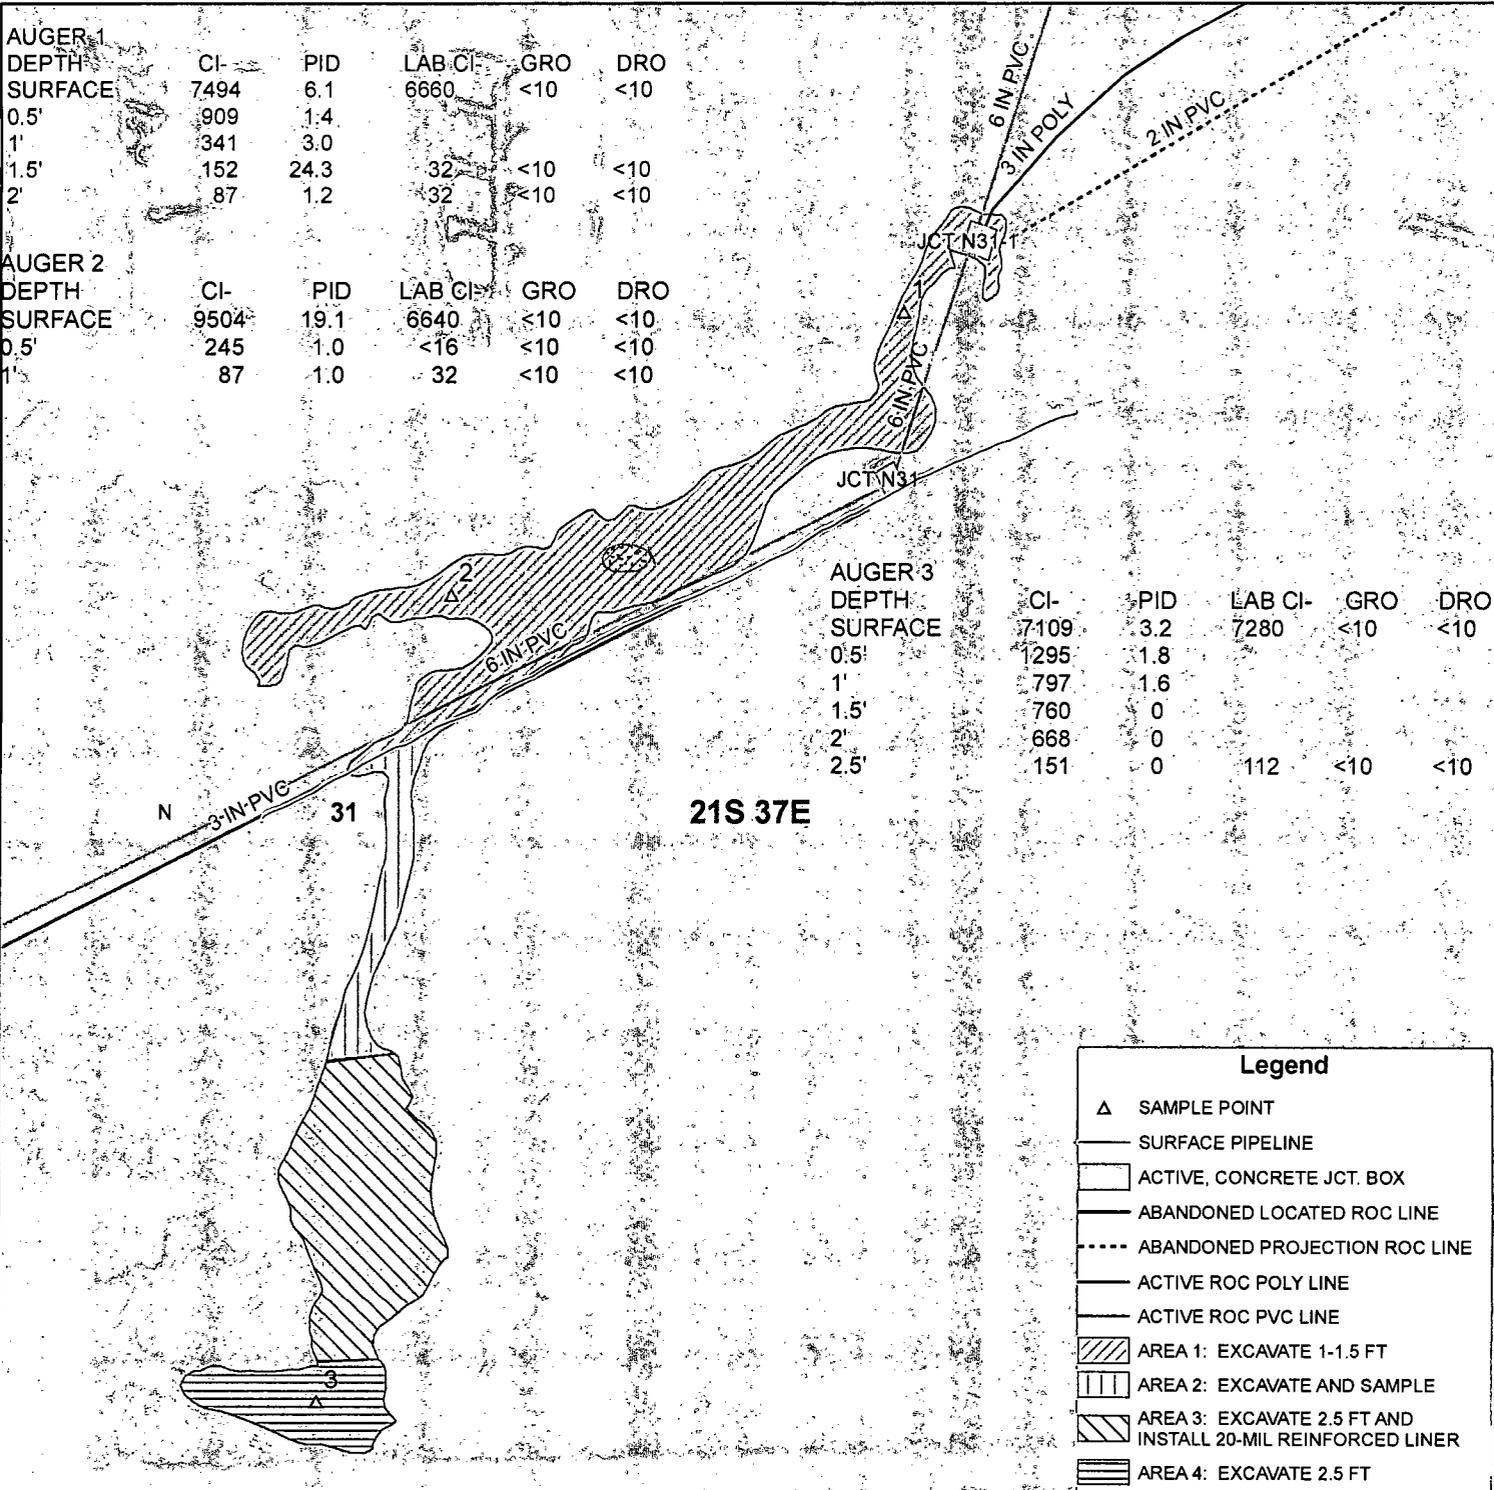
Figure 2

On January 2, 2014, RECS personnel were onsite to collect hand auger soil samples at regular intervals in three separate areas. Each sample was field titrated for chloride and screen for hydrocarbons using a PID. Auger point 1 was collected near the source of the AD to a depth of 2 ft bgs. Chloride concentrations decreased from 7,494 mg/kg at the surface to a concentration of 152 mg/kg at 1.5 ft bgs and 87 mg/kg at 2 ft bgs. Auger point 2 was collected near the center of the AD to a depth of 1 ft bgs. Chloride concentrations decreased from 9,504 mg/kg at the surface to 245 mg/kg at 0.5 ft to 87 mg/kg at 1 ft bgs. Auger point 3 was collected from the southern part of the AD to a depth of 2.5 ft bgs. Chloride concentrations decreased from 7,109 mg/kg at the surface to 151 mg/kg at 2.5 ft bgs. Laboratory analysis confirmed chloride concentrations that decreased with depth and TPH concentrations below detectable limits. This data and the AD boundary is shown in Figure 2. The lab result is included in Appendix B.

During a meeting with the District 1 NMOCD office on January 3, 2013, the following corrective actions were discussed. The AD will be separated into four different sections, based on chloride concentration. Area 1 is the soil surrounding auger points 1 and 2, Area 2 is the ravine section, Area 3 is the soil surrounding a former drill pit, and Area 4 is the soil surrounding auger point 3. To protect groundwater quality, ROC proposes to excavate Area 1 to a depth of 1-1.5 ft bgs. Area 2 is proposed to be excavated and sampled to verify chloride concentrations. Area 3 is proposed to be excavated to a depth of 2.5 ft bgs with a 20-mil reinforced liner being installed and properly seated at that depth. Area 4 is proposed to be excavated to a depth of 2.5 ft bgs. The specified excavation depths will remove the highest chloride concentrations. The excavation boundaries are summarized in Figure 2. Figure 3 is a detailed plat that shows surrounding features and non-ROC pipelines.

AUGER 1 DEPTH	CI-	PID	LAB CI-	GRO	DRO
SURFACE	7494	6.1	6660	<10	<10
0.5'	909	1.4			
1'	341	3.0			
1.5'	152	24.3	32	<10	<10
2'	87	1.2	32	<10	<10

AUGER 2 DEPTH	CI-	PID	LAB CI-	GRO	DRO
SURFACE	9504	19.1	6640	<10	<10
0.5'	245	1.0	<16	<10	<10
1'	87	1.0	32	<10	<10

AUGER 3 DEPTH	CI-	PID	LAB CI-	GRO	DRO
SURFACE	7109	3.2	7280	<10	<10
0.5'	1295	1.8			
1'	797	1.6			
1.5'	760	0			
2'	668	0			
2.5'	151	0	112	<10	<10

Legend	
△	SAMPLE POINT
—	SURFACE PIPELINE
□	ACTIVE, CONCRETE JCT. BOX
—	ABANDONED LOCATED ROC LINE
---	ABANDONED PROJECTION ROC LINE
—	ACTIVE ROC POLY LINE
—	ACTIVE ROC PVC LINE
▨	AREA 1: EXCAVATE 1-1.5 FT
▧	AREA 2: EXCAVATE AND SAMPLE
▩	AREA 3: EXCAVATE 2.5 FT AND INSTALL 20-MIL REINFORCED LINER
▪	AREA 4: EXCAVATE 2.5 FT
▫	NON-STAIN
□	STAIN (10,995 sq ft)

Each excavated area will then be backfilled with soil containing a chloride concentration below 500 mg/kg and a field PID reading below 100 ppm. Any soil requiring disposal will be properly disposed of at a NMOCD approved facility. The backfilled excavation will then be seeded with a blend of native vegetation. Vegetation provides a natural infiltration barrier, since plants capture water through their roots thereby reducing the amount of water traveling through the vadose zone.

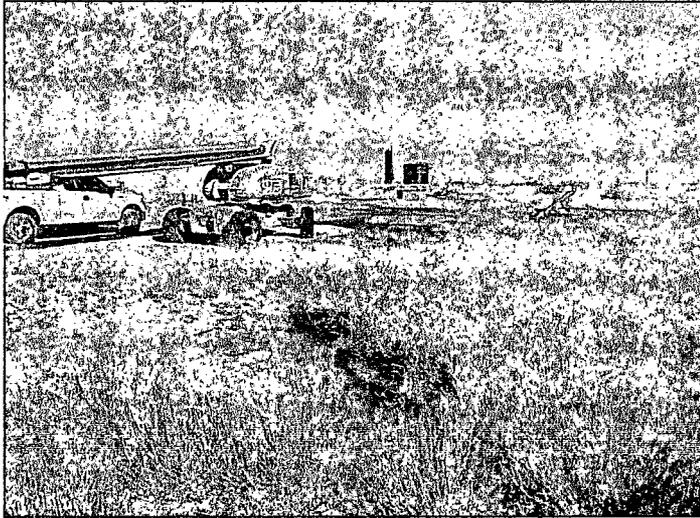
An accidental discharge of produced water was discovered on December 31, 2013. The NMOCD District 1 office was notified that day, and an initial C-141 was submitted to the District 1 office on January 2, 2014. According to the initial C-141, a PVC flange in the junction box cracked, releasing the 60 bbls of produced water, which affected a total of 10,995 ft² of pasture and lease road. After the AD was discovered, the line was shut in and a vacuum truck was used to recover 20 bbls of the produced water, then the flange was permanently repaired. The initial C-141 and photos of the leak are included in Appendix A.

Describe Cause of Problem and Remedial Action Taken.*
The PVC flange in the junction box cracked releasing 60 barrels of produced water. The line was shut in and isolated. A vacuum truck was called to the site and recovered 20 barrels of produced water. The flange will be repaired on 1/2/14.

Facing northeast

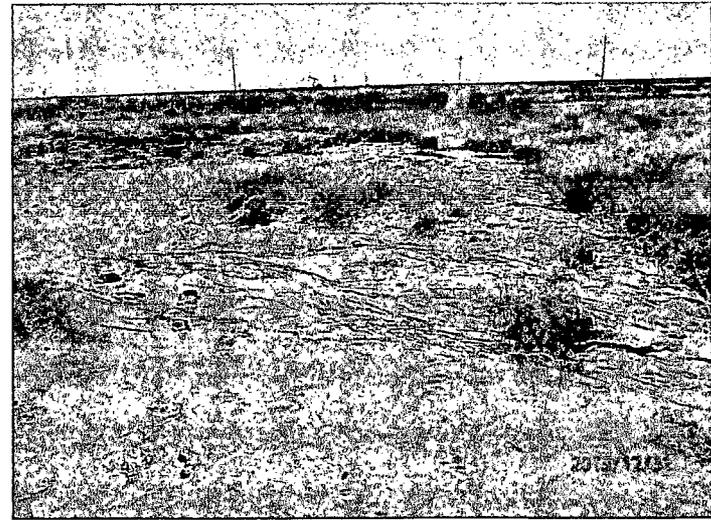
Facing south
