## **REMEDIATION SUMMARY AND SITE CLOSURE REQUEST**

**BOPCO, LP**  
**PLU PIERCE CANYON 17-24-30 USA #1H**  
**Eddy County, New Mexico**  
**Unit Letter "N" (SE/SW), Section 17 Township 24 South, Range 30 East**  
**Latitude 32.211095° North, Longitude 103.905918° West**  
**NMOCD Reference #2RP- 2199**

**March 2014**

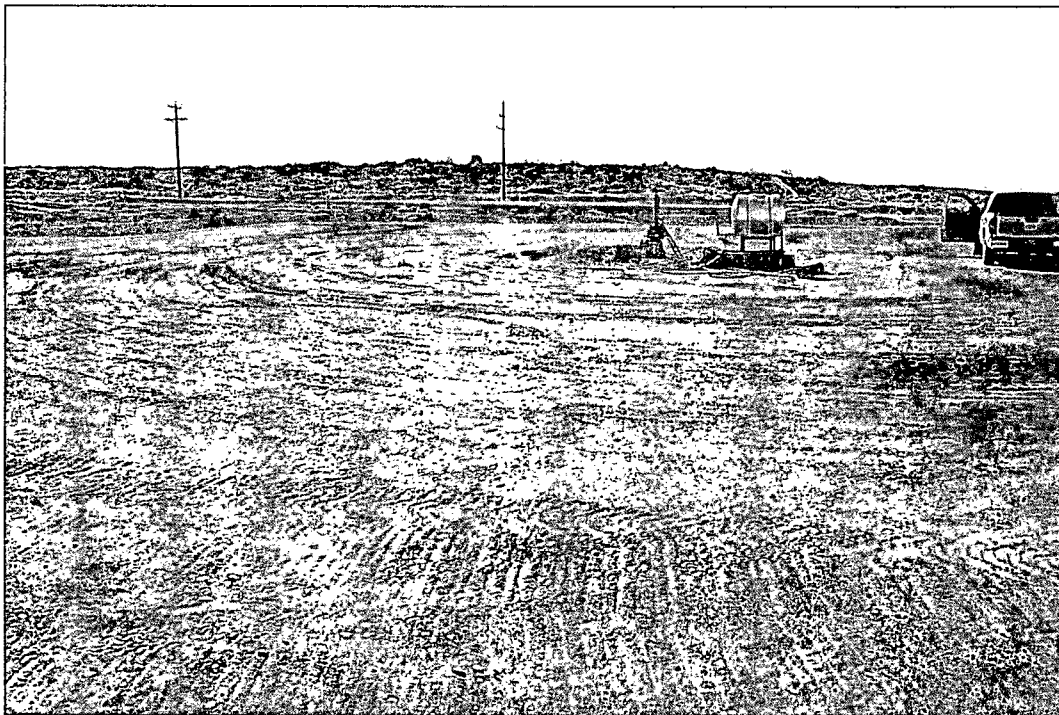
Photograph of the initial release and surface staining at the Pierce Canyon 17-24-30 USA #1H Release Site.

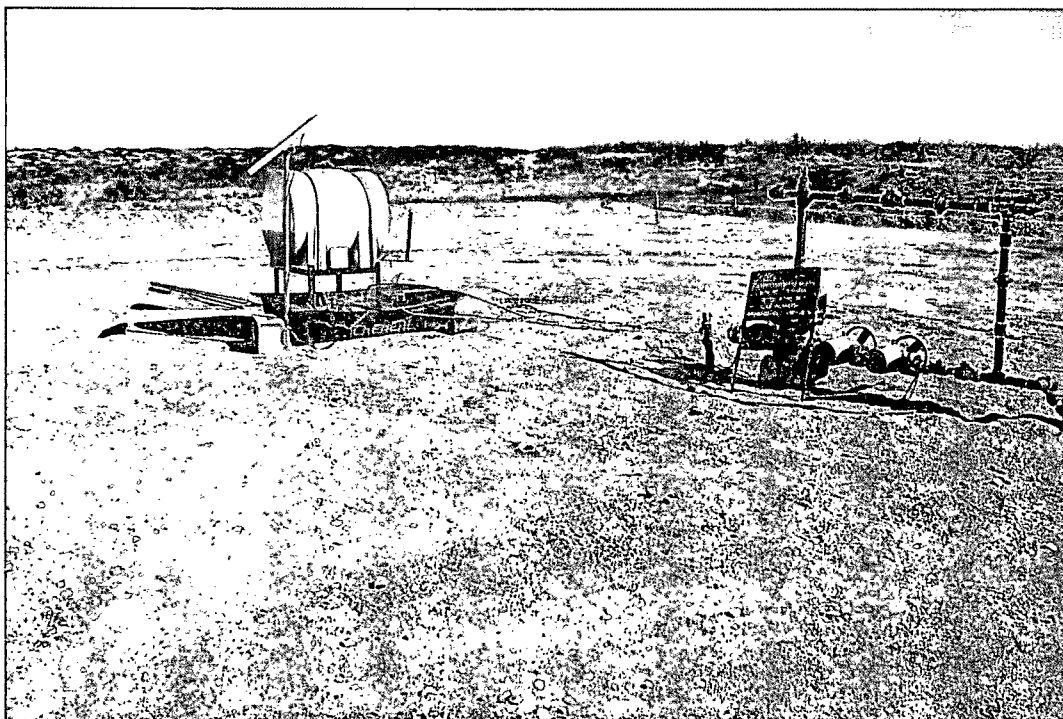
Photograph of the initial release and surface staining at the Pierce Canyon 17-24-30 USA #1H Release Site.

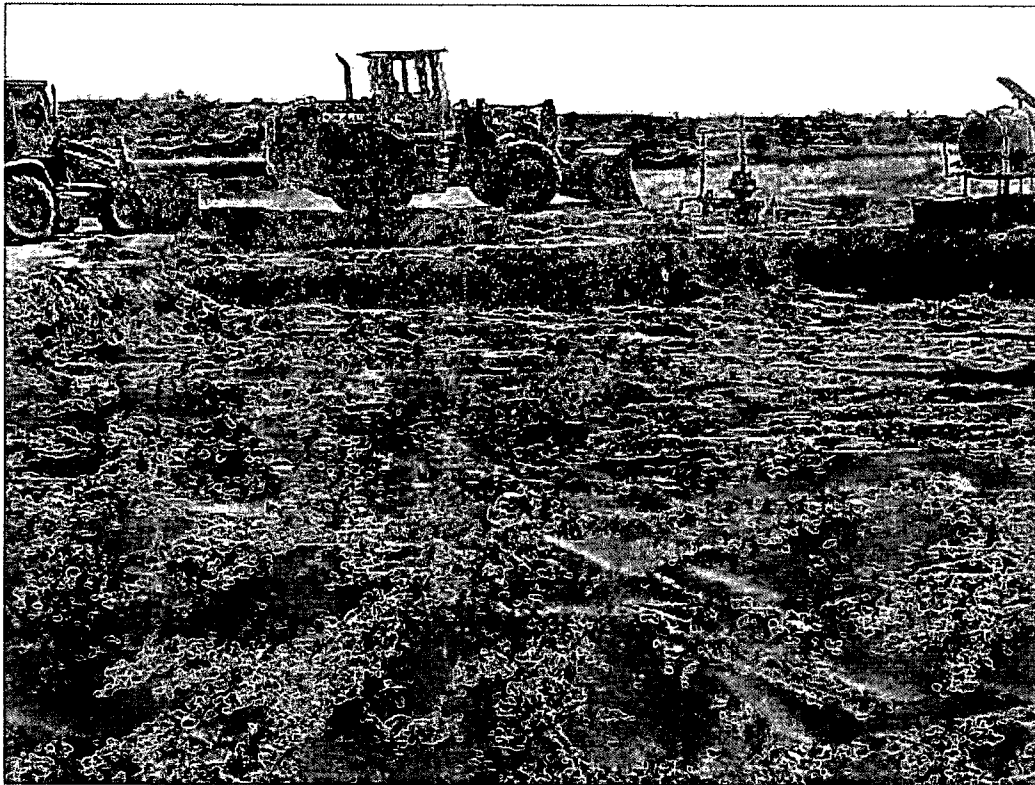
Photograph of excavation activities at the Pierce Canyon 17-24-30 USA #1H Release Site.

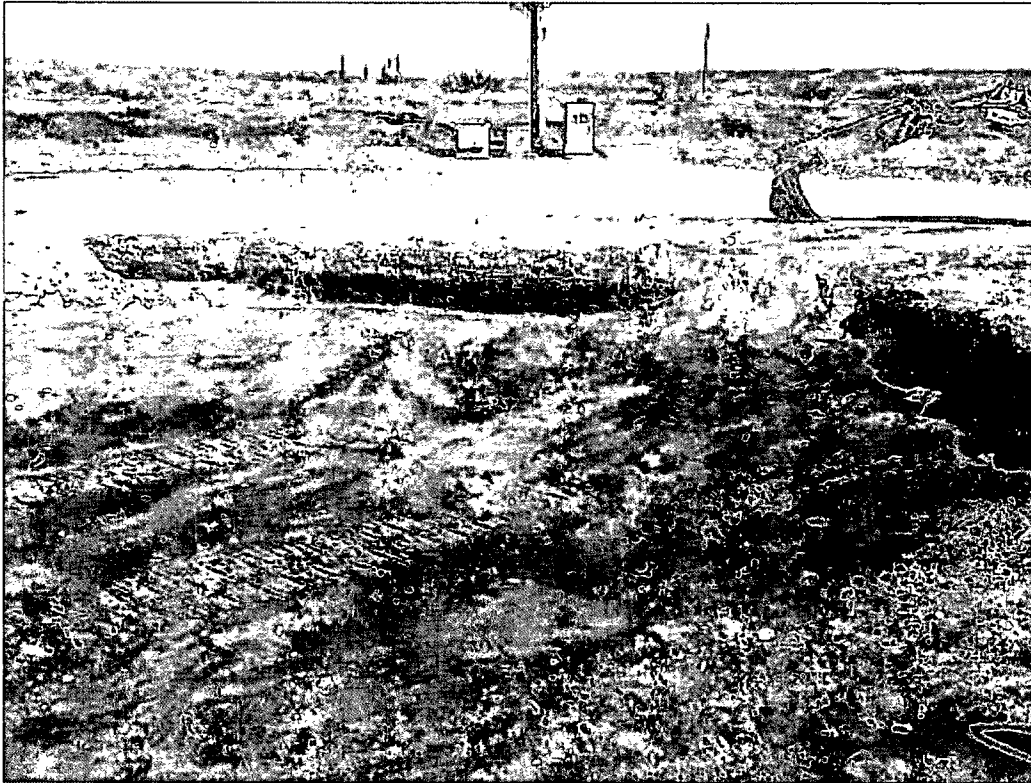
Photograph of excavation activities at the Pierce Canyon 17-24-30 USA #1H Release Site.

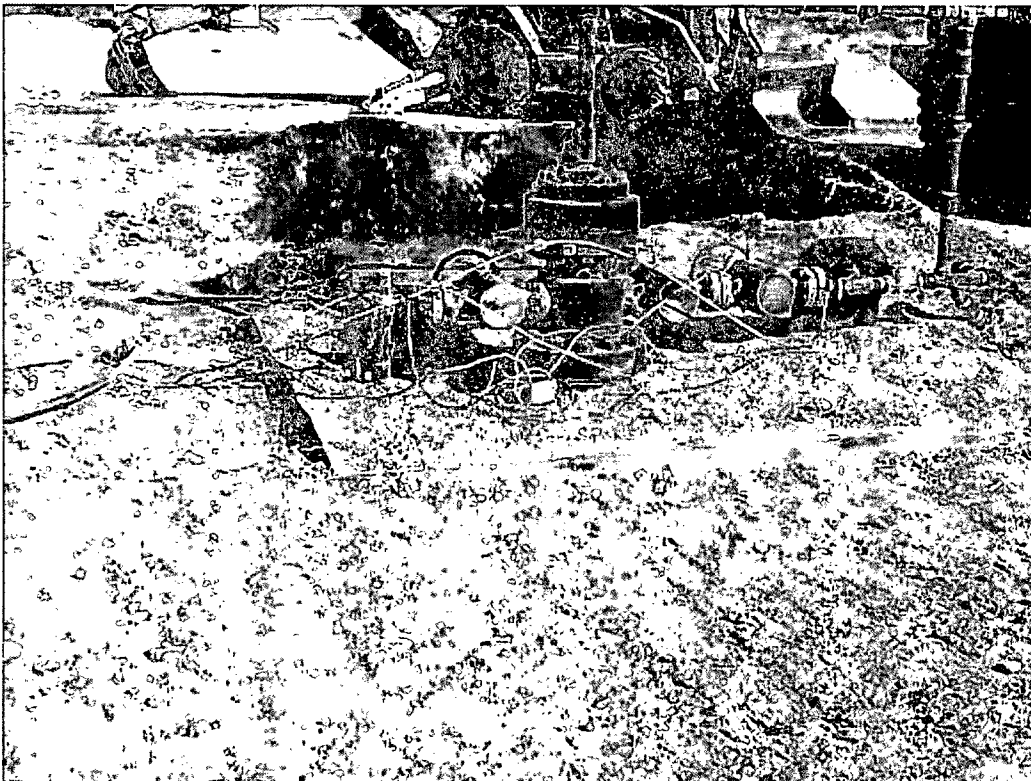
Photograph of excavation activities at the Pierce Canyon 17-24-30 USA #1H Release Site.

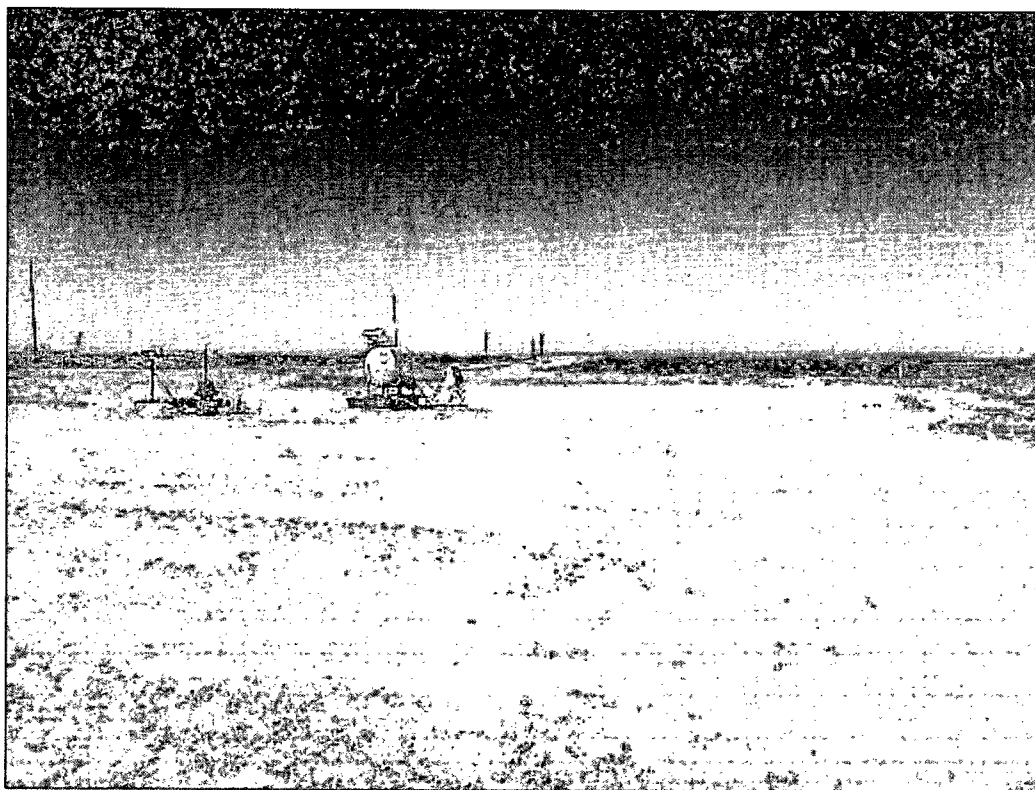
Photograph of the Pierce Canyon 17-24-30 USA #1H Release Site after remediation activities.
