H.E. West B #41
2RP-1863

Termination Request

RE: Termination Request

Linn Energy – H.E. West B #41 (2RP-1863)

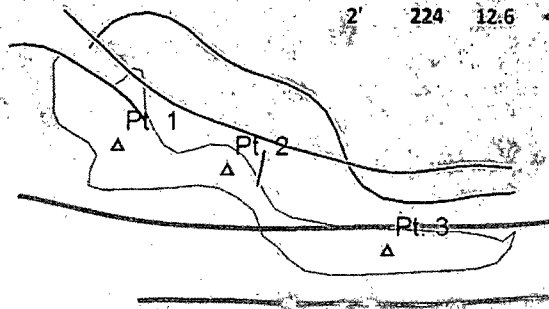
Figure 1

RECS personnel were on site beginning on August 23rd, 2013 to assess the site. Samples were taken from the surface and with depth at three locations throughout the release (Figure 1). The samples were field tested for chlorides and hydrocarbons and representative samples were taken to a commercial laboratory for analyses (Appendix B). The surface samples at the three points showed elevated laboratory chloride levels, Gasoline Range Organics (GRO) readings of non-detect and elevated Diesel Range Organics (DRO) readings. At Point 2, the laboratory chloride levels dropped to below 250 mg/kg at 2 ft bgs and at Point 3, the laboratory chloride levels dropped to below 250 mg/kg at 3 ft bgs. DRO levels in Point 2 dropped to 10.8 mg/kg at 2 ft bgs and in Point 3 to non-detect at 3 ft bgs.

Initial Sampling Data

Point 1	CI-	PID	GRO	DRO	B	T	E	X	BTEX
SS	5520	10.4	<50	13800	<0.05	0.05	0.173	0.384	0.608
6"	856	192.4							
1'	3286	50.8							
1.5'	2034	24							
2'	1446	509.8							
2.5'	1320	33.5							
3'	1762	24.9							
3.5'	1788	22.6							
4'	1985	49.6							
4.5'	1085	10.8							
5'	1192	27.6							
5.5'	1037	7.2							
6'	848	14.6	<10	<10					
6.5'	944	9.2	<10	<10

Point 2	CI-	PID	GRO	DRO	B	T	E	X	BTEX
SS	23000	192.4	<10	499	<0.05	<0.05	<0.05	<0.15	<0.3
6"	2921	47.5							
1'	969	88.8							
1.5'	378	66.7							
2'	224	12.6	<10	10.8	<0.05	<0.05	<0.05	<0.15	<0.3

Point 3	CI-	PID	GRO	DRO	B	T	E	X	BTEX
SS	13300	50.8	<10	10.1	<0.05	<0.05	<0.05	<0.15	<0.3
6"	688	33.9							
1'	1410	30.9							
1.5'	1457	6.5							
2'	957	2.3							
2.5'	896	11.2	<10	<10	<0.05	<0.05	<0.05	<0.15	<0.3
3'	48	28.6	<10	<10	<0.05	<0.05	<0.05	<0.15	<0.3

At Point 1, a vertical was installed on October 4th, 2013, to determine the depth of contamination. The vertical was installed to a depth of 6.5 ft where the laboratory chloride reading returned a result of 944 mg/kg (Appendix C).

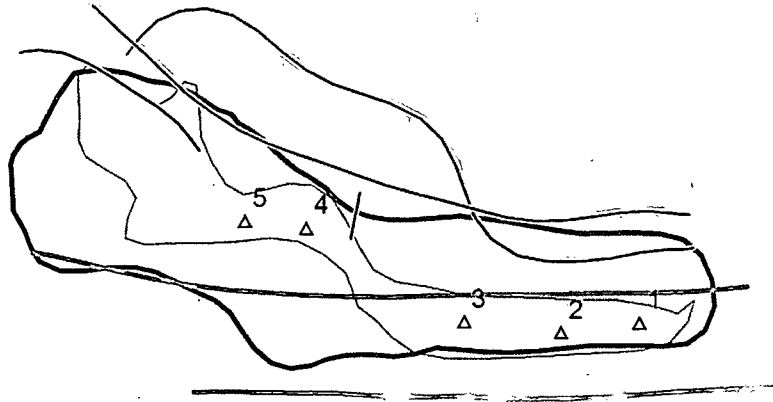
Figure 2

CAP work began on November 20th, 2013 (Figure 2). The site was scraped to 6 inches bgs and a total of 36 yards of soil was taken to a NMOCD approved facility for disposal. A 5 point composite of the bottom of the excavation was taken to a commercial laboratory for analysis (Appendix D). The 5 point bottom composite returned a chloride result of 304 mg/kg, GRO and BTEX results of non-detect and a DRO result of 243 mg/kg. Final wall samples of the scrape could not be taken; the scrape was too shallow and the wall composition too loose to allow adequate sampling. Therefore, the scrape was expanded north and west of the release to remediate areas without vegetation. A total of 36 yards of caliche and 12 yards of top soil were imported to the site. Samples of both the caliche and top soil were taken to a commercial laboratory for analysis. The caliche returned a chloride result of 32 mg/kg and the top soil returned a chloride result of non-detect (Appendix D).

Excavation Data

5 point composite Lab at 6 inches

CI-	PID	GRO	DRO	B	T	E	X	BTEX
304	14.6	<50	243	<0.05	<0.05	<0.05	<0.15	<0.3

Backfill Labs

CI-

Caliche 32

Top Soil <16

The lease road was backfilled with the imported caliche and the pasture was backfilled with the imported top soil. On December 10th, 2013, soil amendments were added to the pasture area and the area was seeded with LPC mix.

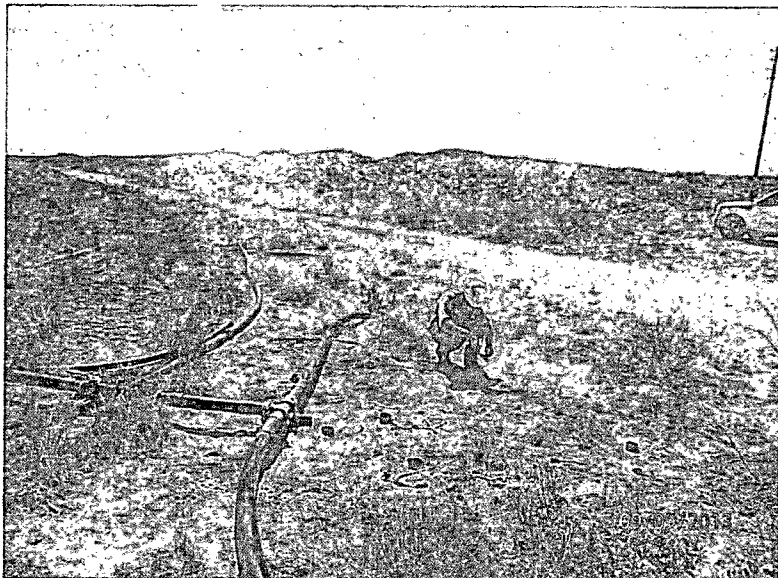
9/9/13

Sampling the surface, facing southeast

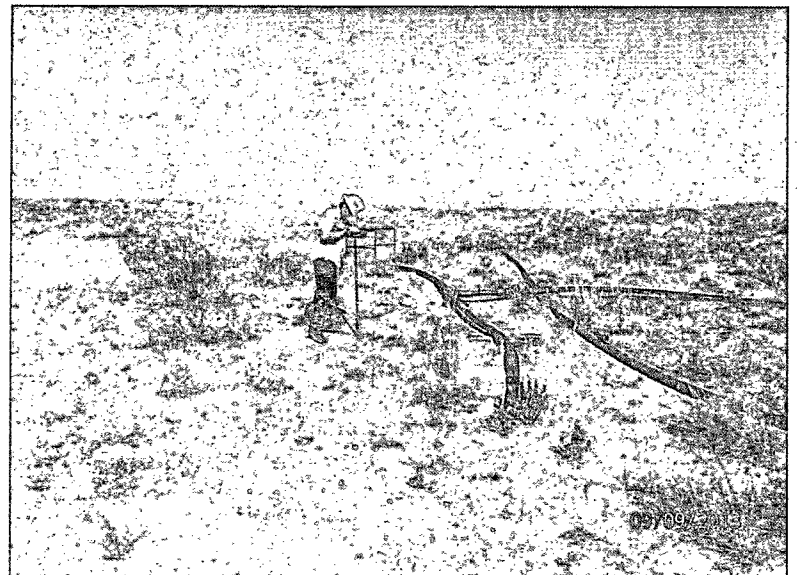
9/9/13

Auguring for depth, facing northwest

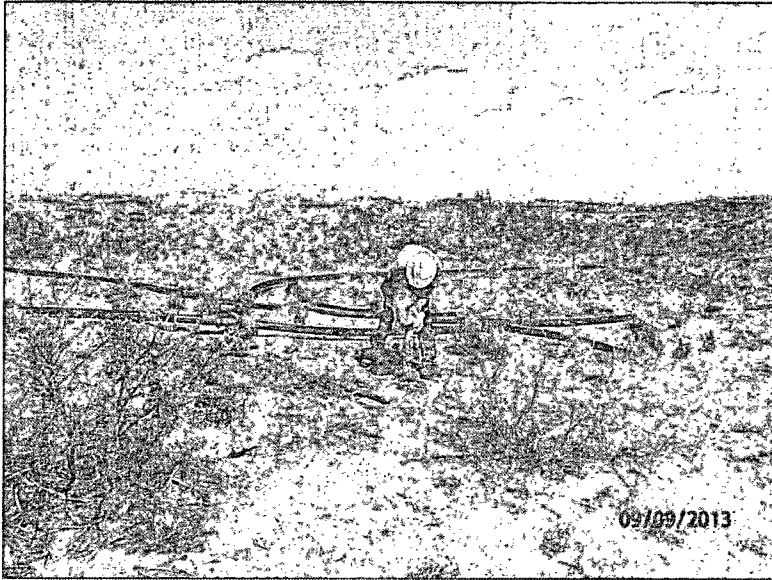
Plugging auger points in total with bentonite, facing
northeast 9/9/13

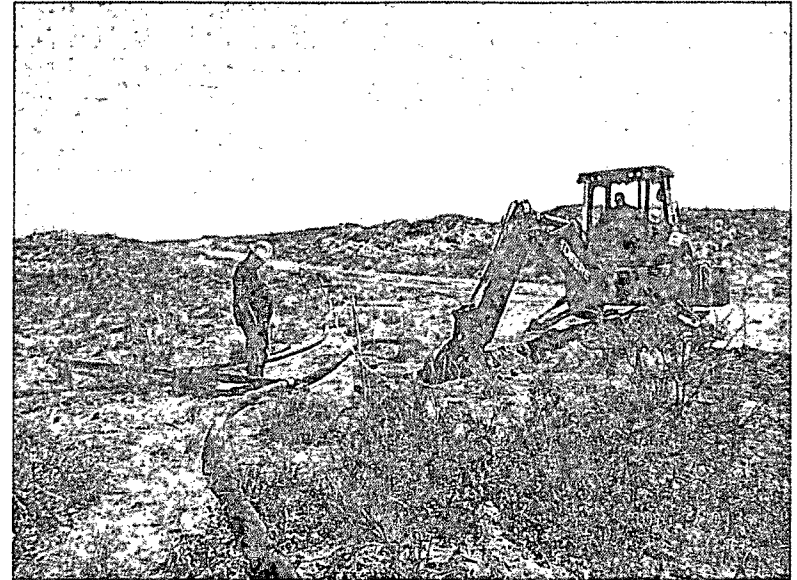
Installing vertical at Pt. 1, facing east 10/4/13

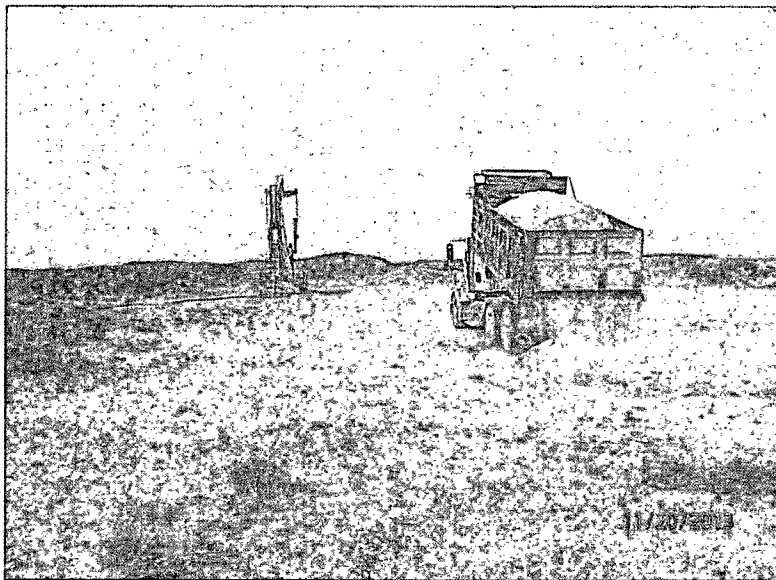
Importing caliche, facing west 11/20/13

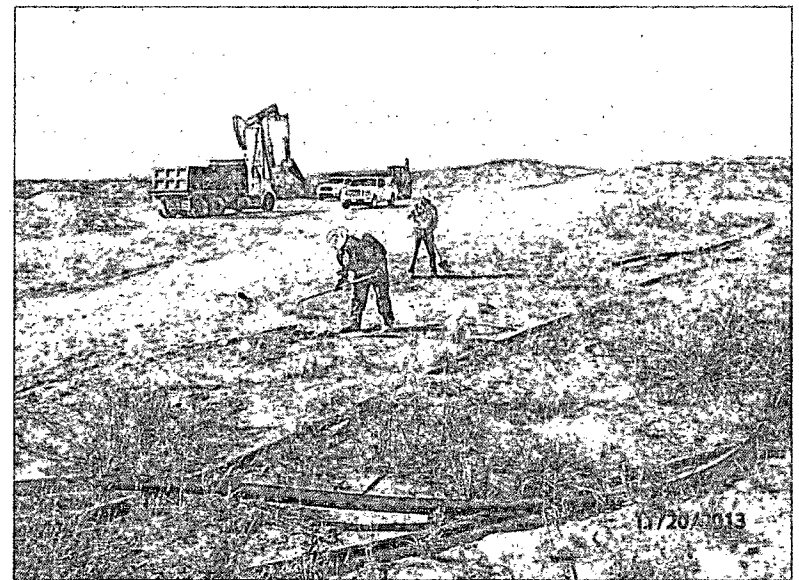
Spotting lines, facing southwest 11/20/13

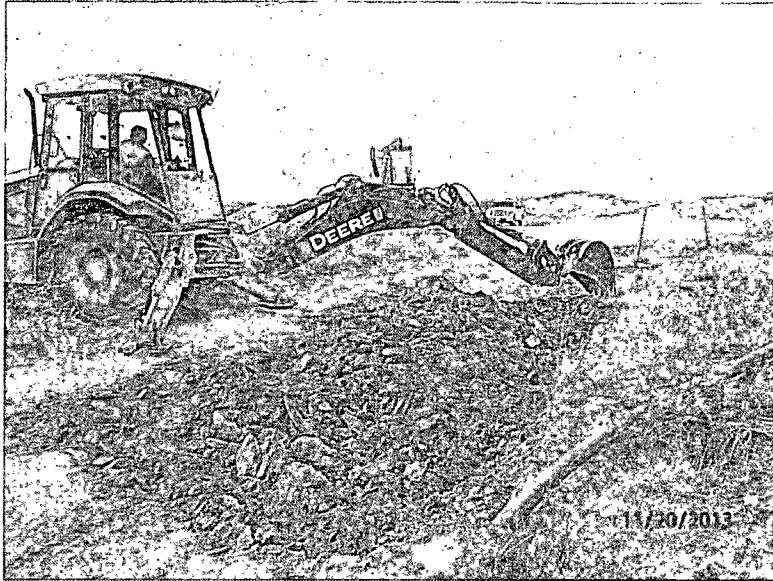
Conducting 6 inch scrape, facing southwest 11/20/13

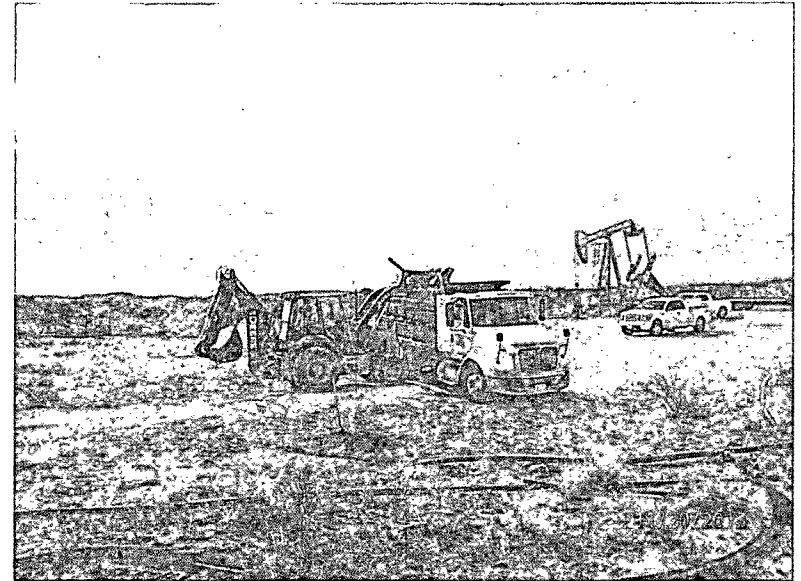
Exporting soil, facing southwest 11/20/13

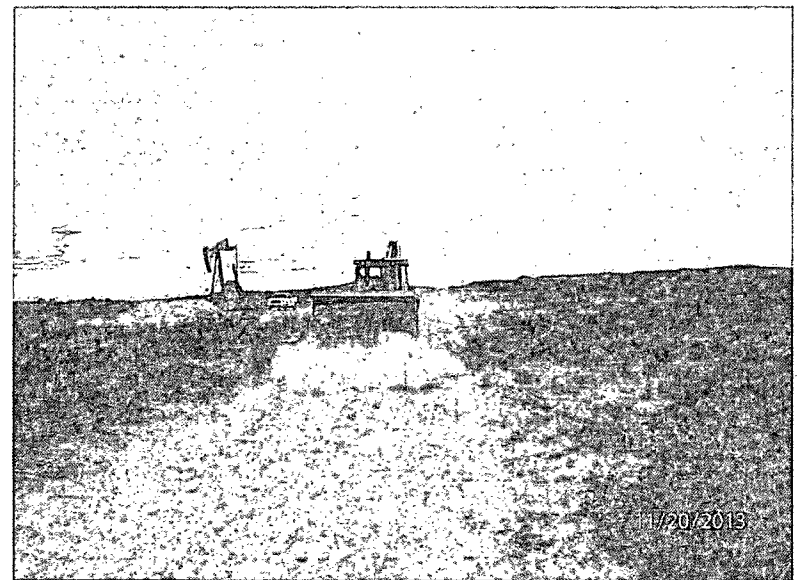
Backfilling road scrape, facing west 11/20/13

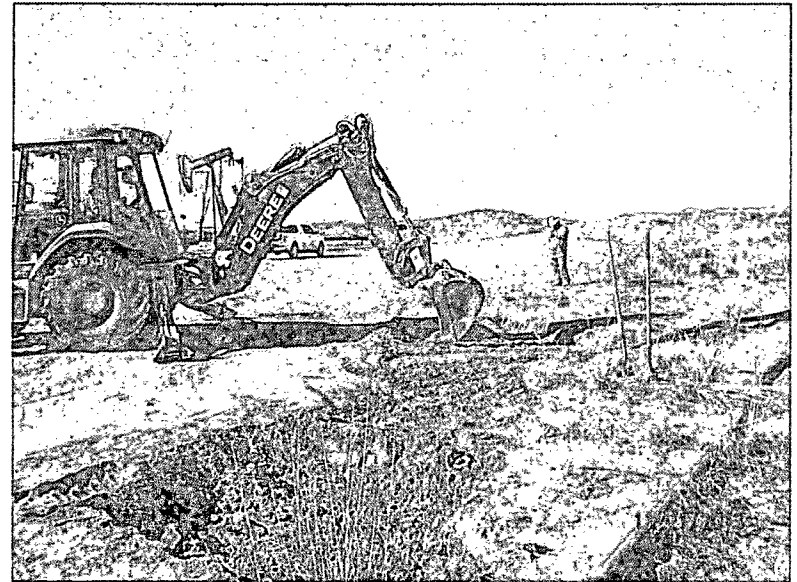
Conducting pasture scrape, facing southwest 11/21/13

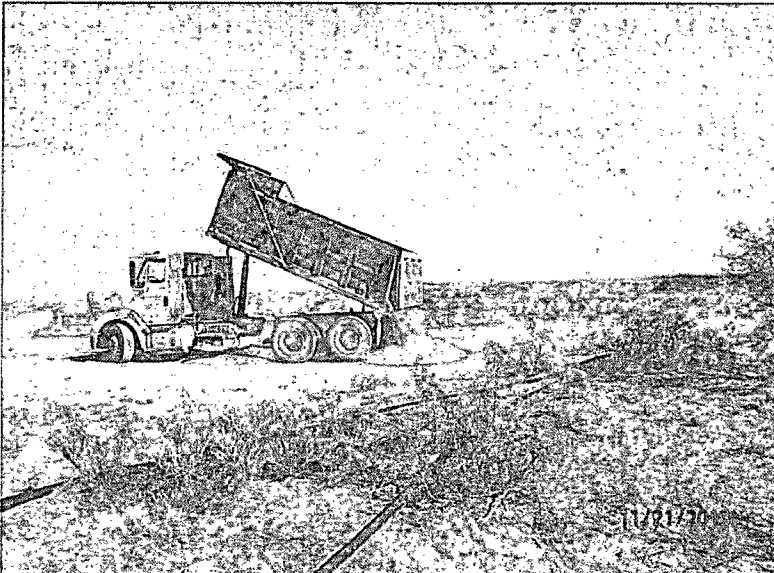
Importing top soil, facing north 11/21/13

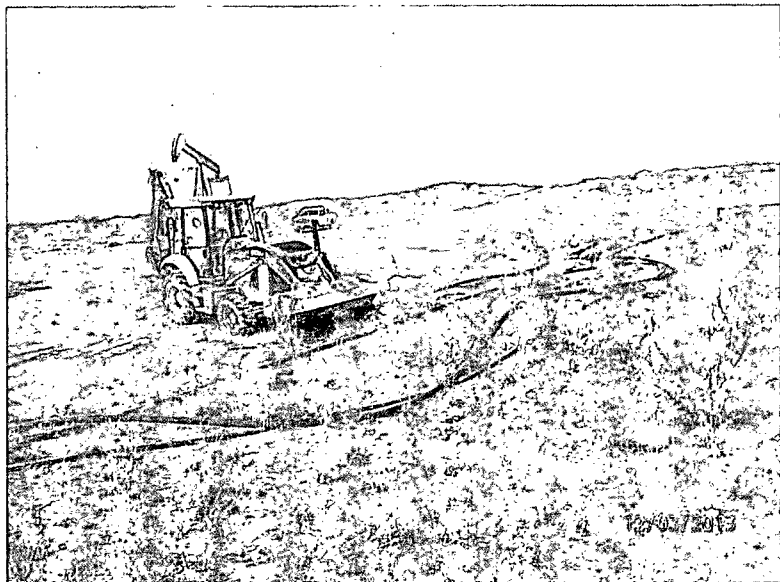
Backfilling pasture scrape, facing southwest 12/3/13

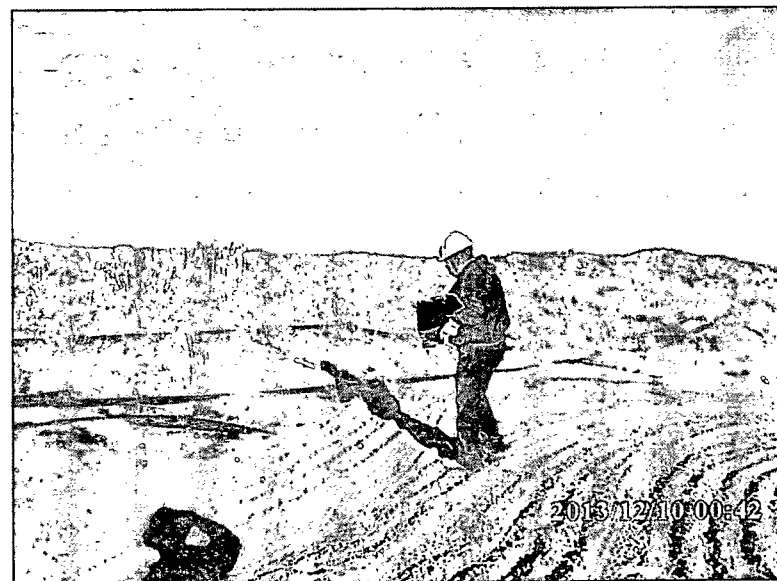
Seeding site facing west 12/10/13

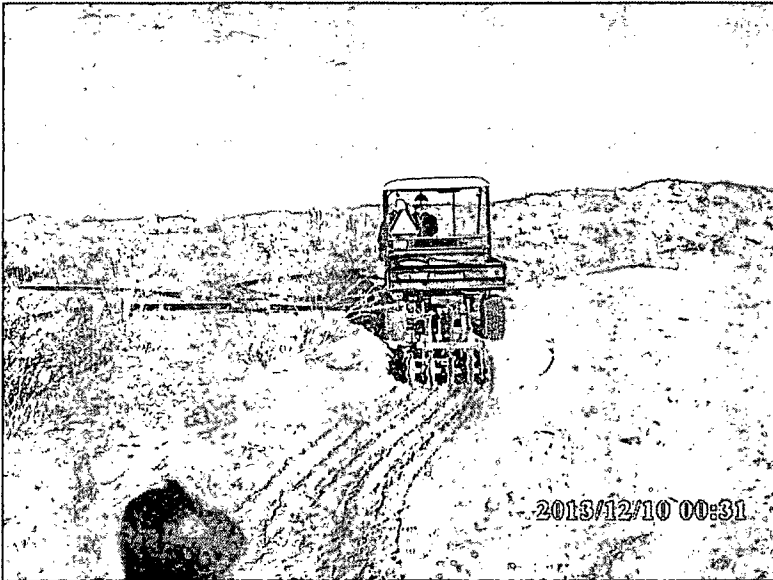
Tilling in amendments and seed, facing north 12/10/13

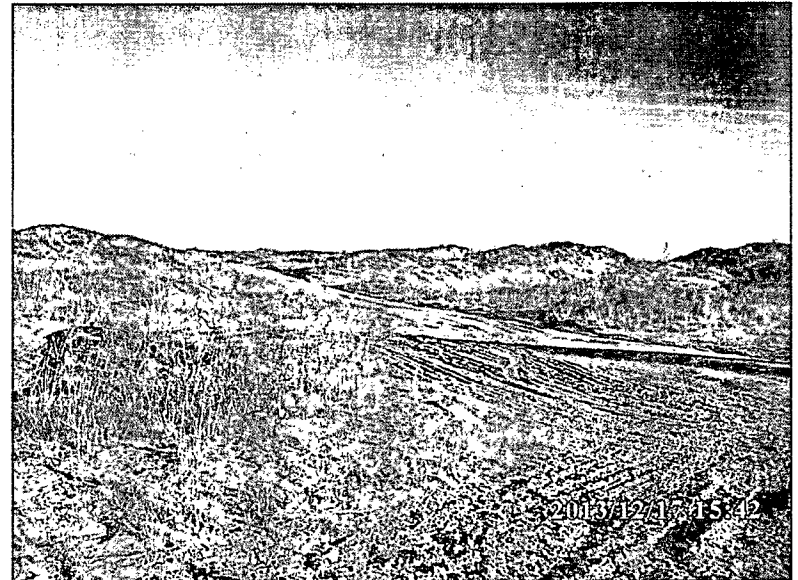
12/17/13

Site completed, facing southeast
