Linn Energy Skelly Unit #33

CLOSURE REPORT

2RP-2045

March 25, 2014

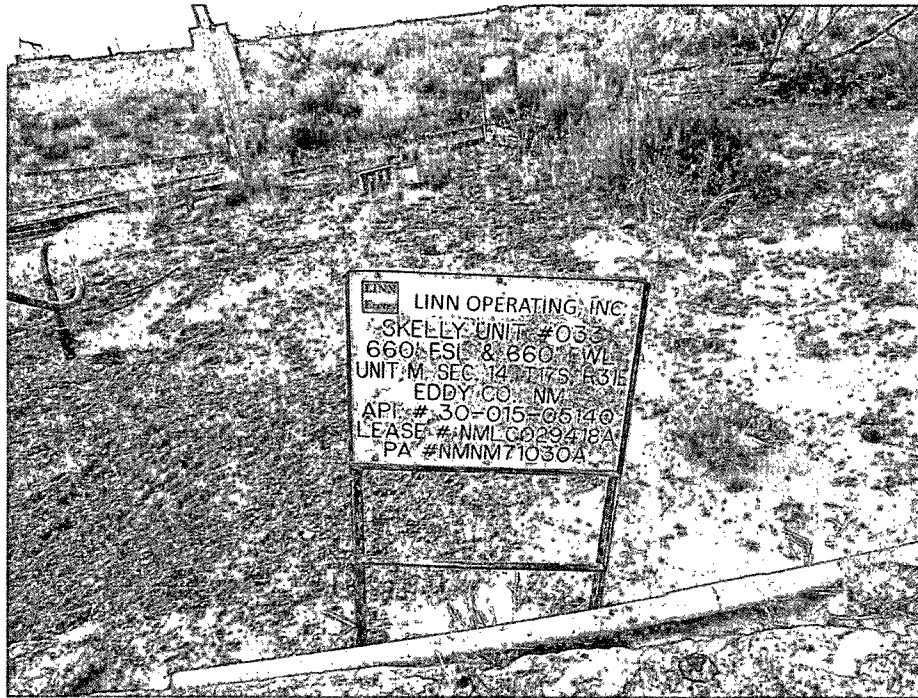
Sign marking location 12/05/13

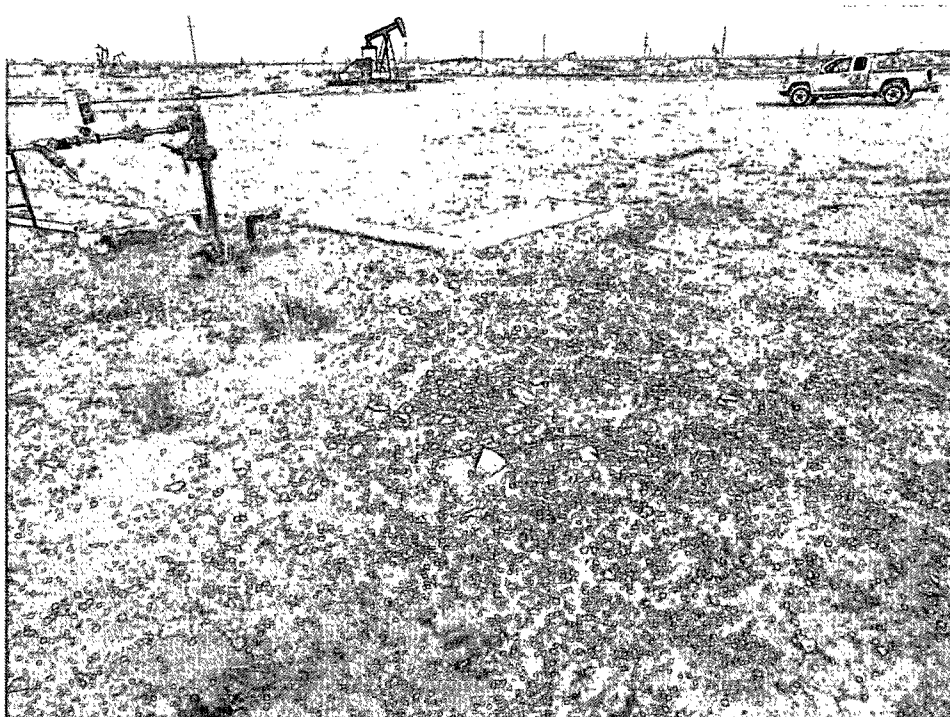
Spill location SW of lease road 12/05/13

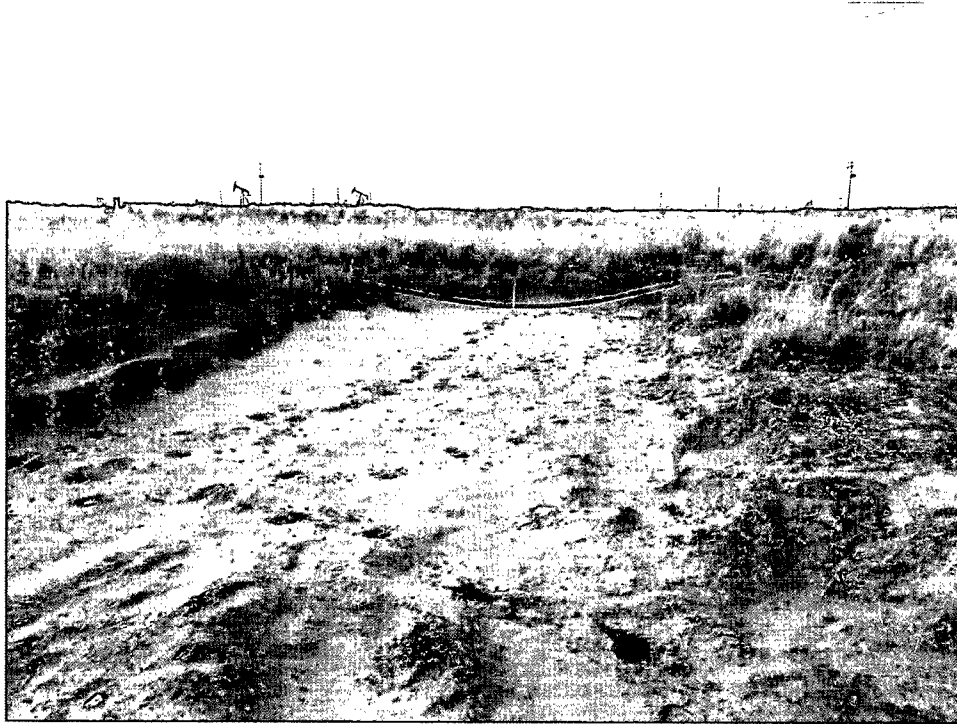
Excavated soil on site 12/05/13

On January 05, 2013 DFSI personnel notified the NMOCD and BLM respectively of the plans to excavate the site. Whereby, written approval was received to excavate SP1 thru SP5 to 4ft bgs., and install a 20 mil. liner. However, the BLM requested an excavated floor sample verification of SP3 prior to lining. The lab returned a confirmed finding, in that SP3 was indicating a decline in Chloride 3560 mg/kg, at 4ft bgs. (Appendix IV). Visually impacted soils were excavated throughout the entire leak area and removed to a NMOCD approved disposal facility. TPH totaled less than 10.0 mg/kg GRO and less than 10.0 mg/kg DRO, and BTEX totaled less than 0.300 mg/kg in all samples. Photographs of site activities can be viewed in Appendix II.

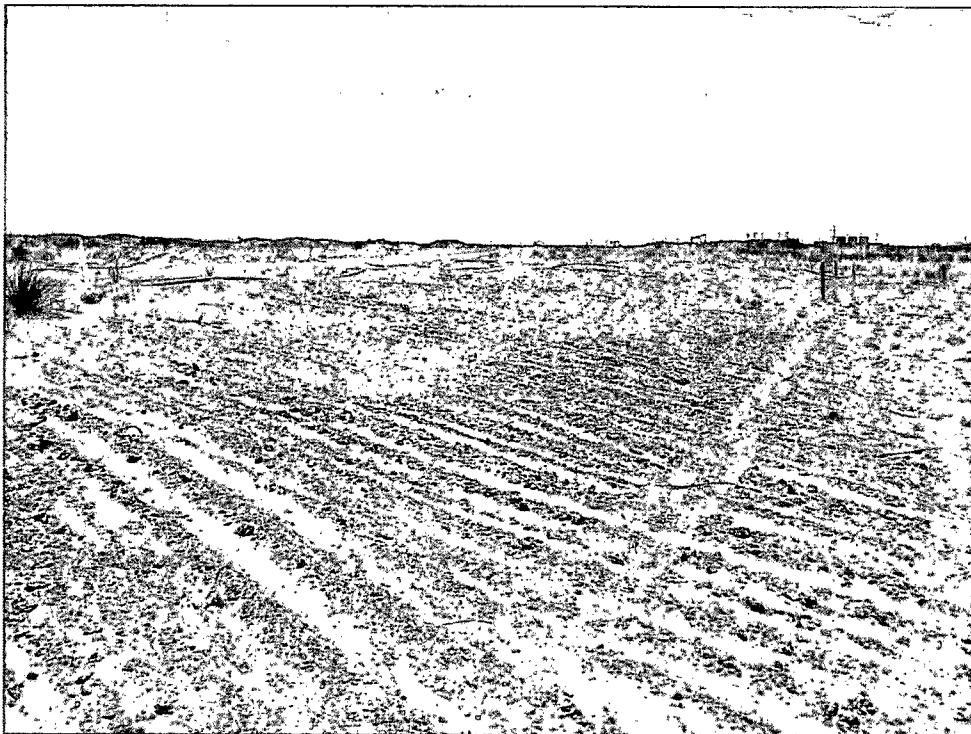
Tilled and seeded site at completion 3/24/14

pasture excavation was backfilled with imported topsoil and the site was contoured to the surrounding landscape. On February 27, 2014, the site was seeded with 125 lbs. of Lesser Prairie Chicken seed mix per BLM requirements.
